**Operational Phase Monitoring of Threatened Flora
Translocations, In-situ Threatened Plants and Slender Marsdenia and Woolls'
Tylophora Habitat Condition on the Warrell Creek to Nambucca Heads Highway
Project – Year 5 (2022)**

Prepared by:

ECOS Environmental Pty Ltd

14/4/2023

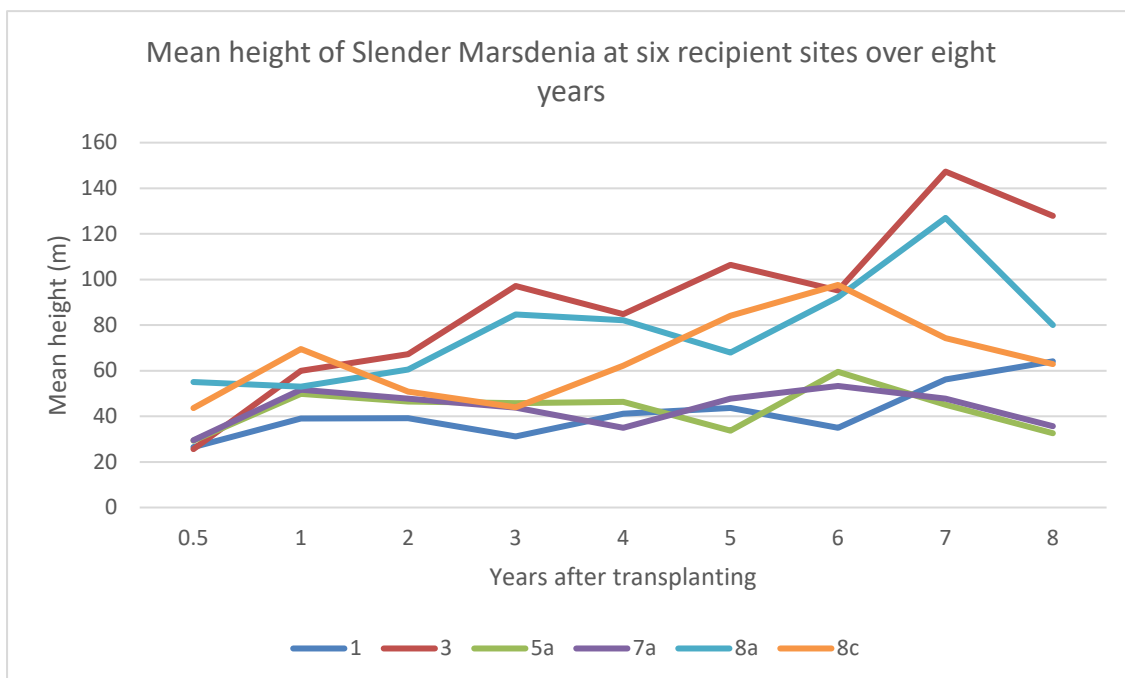
Figure 3: Mean height of Slender Marsdenia at 6 recipient sites between 2015 and 2022.

In 2021-2022, mean stem height decreased in five sites and increased in one site (Site 1) (Figure 3). However, from inspection of Figure 3 it appears there was little synchronisation between sites in the pattern of stem growth over 8 years. In a given year, it was common for mean height to increase in some sites and decrease in others. (Figure 3).

In sites 5a and 7a, after increasing in the first year, mean height did not change much for five years (Figure 3). In sites 1 and 8c, there was a small to moderate increase in mean height, and in sites 3 and 8a, a large increase in mean height then a decline in mean height in 8a in the last two years (Table 7). Possible reasons for different patterns of mean height change include:

- Variation in understorey light intensity or other fine-scale, microhabitat differences between recipient sites (note - landscape-scale habitat variables such as vegetation type, soil type and topography were relatively uniform across sites).
- Differences in the plants introduced to each site.
- Herbicide spray drift from maintenance of the watermain easement track may have affected Site 8a.

Table 7: Mean height (cm) \pm standard error of Slender Marsdenia at 6 recipient sites from June 2015 to December 2022 (approx. 8 years after translocation). This data is plotted in Fig 3. Decline in mean height this year is partly related to decrease in survivorship and more zero's in the height data.

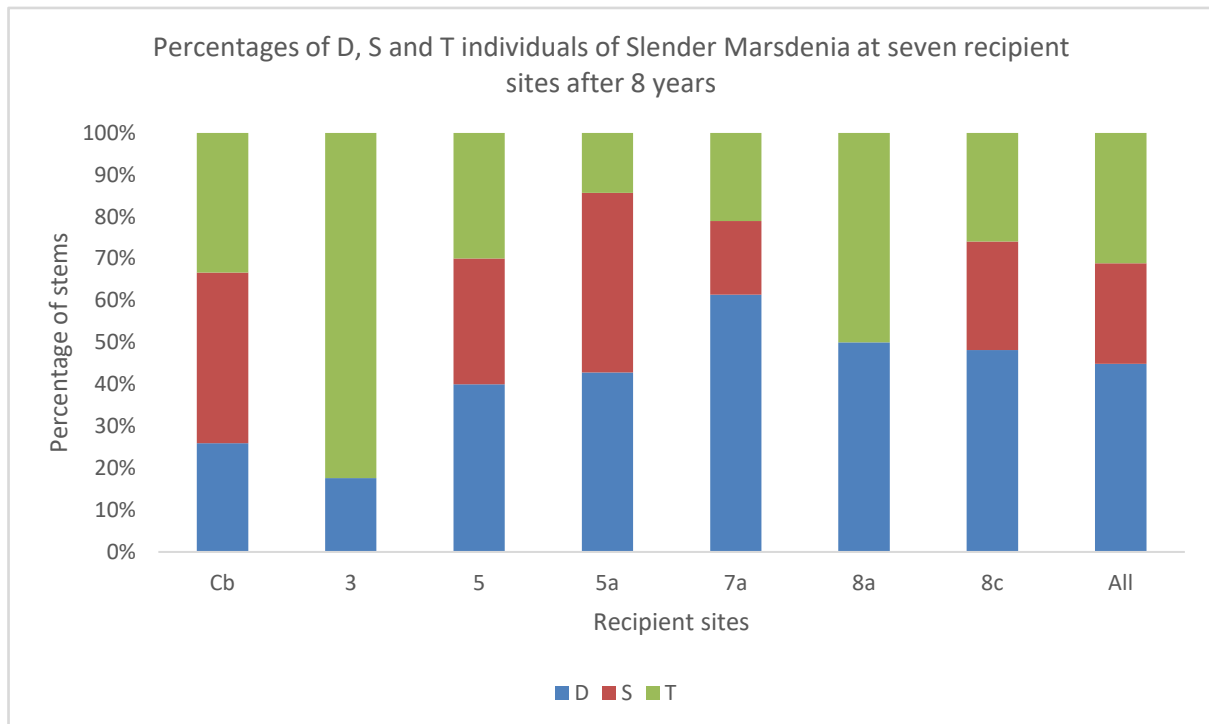
Figure 4 shows the percentage of D, S and T plants within recipient sites. The percentages are fairly constant amongst the 7 sites except for sites 3 and 8(a). Site 8 (a) was probably affected by herbicide spray drift. Site 3 was exceptional in the rapid growth and height of plants, suggesting that the greater openness of this site promoted stem growth. It is possible that variation in height growth response was due to the size of plants introduced. However, the initial size of rescued plants in terms of volume of soil supporting stem and root system (i.e. ~30 cm x 10 cm x 10 cm) did not vary greatly. Large stems were rare and only a few transplanted. It is interesting that for the other 5 sites, percentages of D, S and T plants are similar in each site (Figure 4). This could be interpreted as the effect of random variation in plant size when transplanted, or random variation in planting microsites within the recipient site. The thickness or volume of rhizomatous roots within the slab (not recorded) may have affected individual performance.

Figure 4: Percentage of D (ht = 0), S (small) and T (tall) plants at each of the recipient sites and all sites combined at the Dec/2022 monitoring, 8 years after translocation. The percentages are fairly constant amongst the sites except for sites 3 and 8(a).
