Appendix B10.5

Jali Borrow Site Management Plan

Woolgoolga to Ballina (sections 3 to 11)

Pacific Highway Upgrade

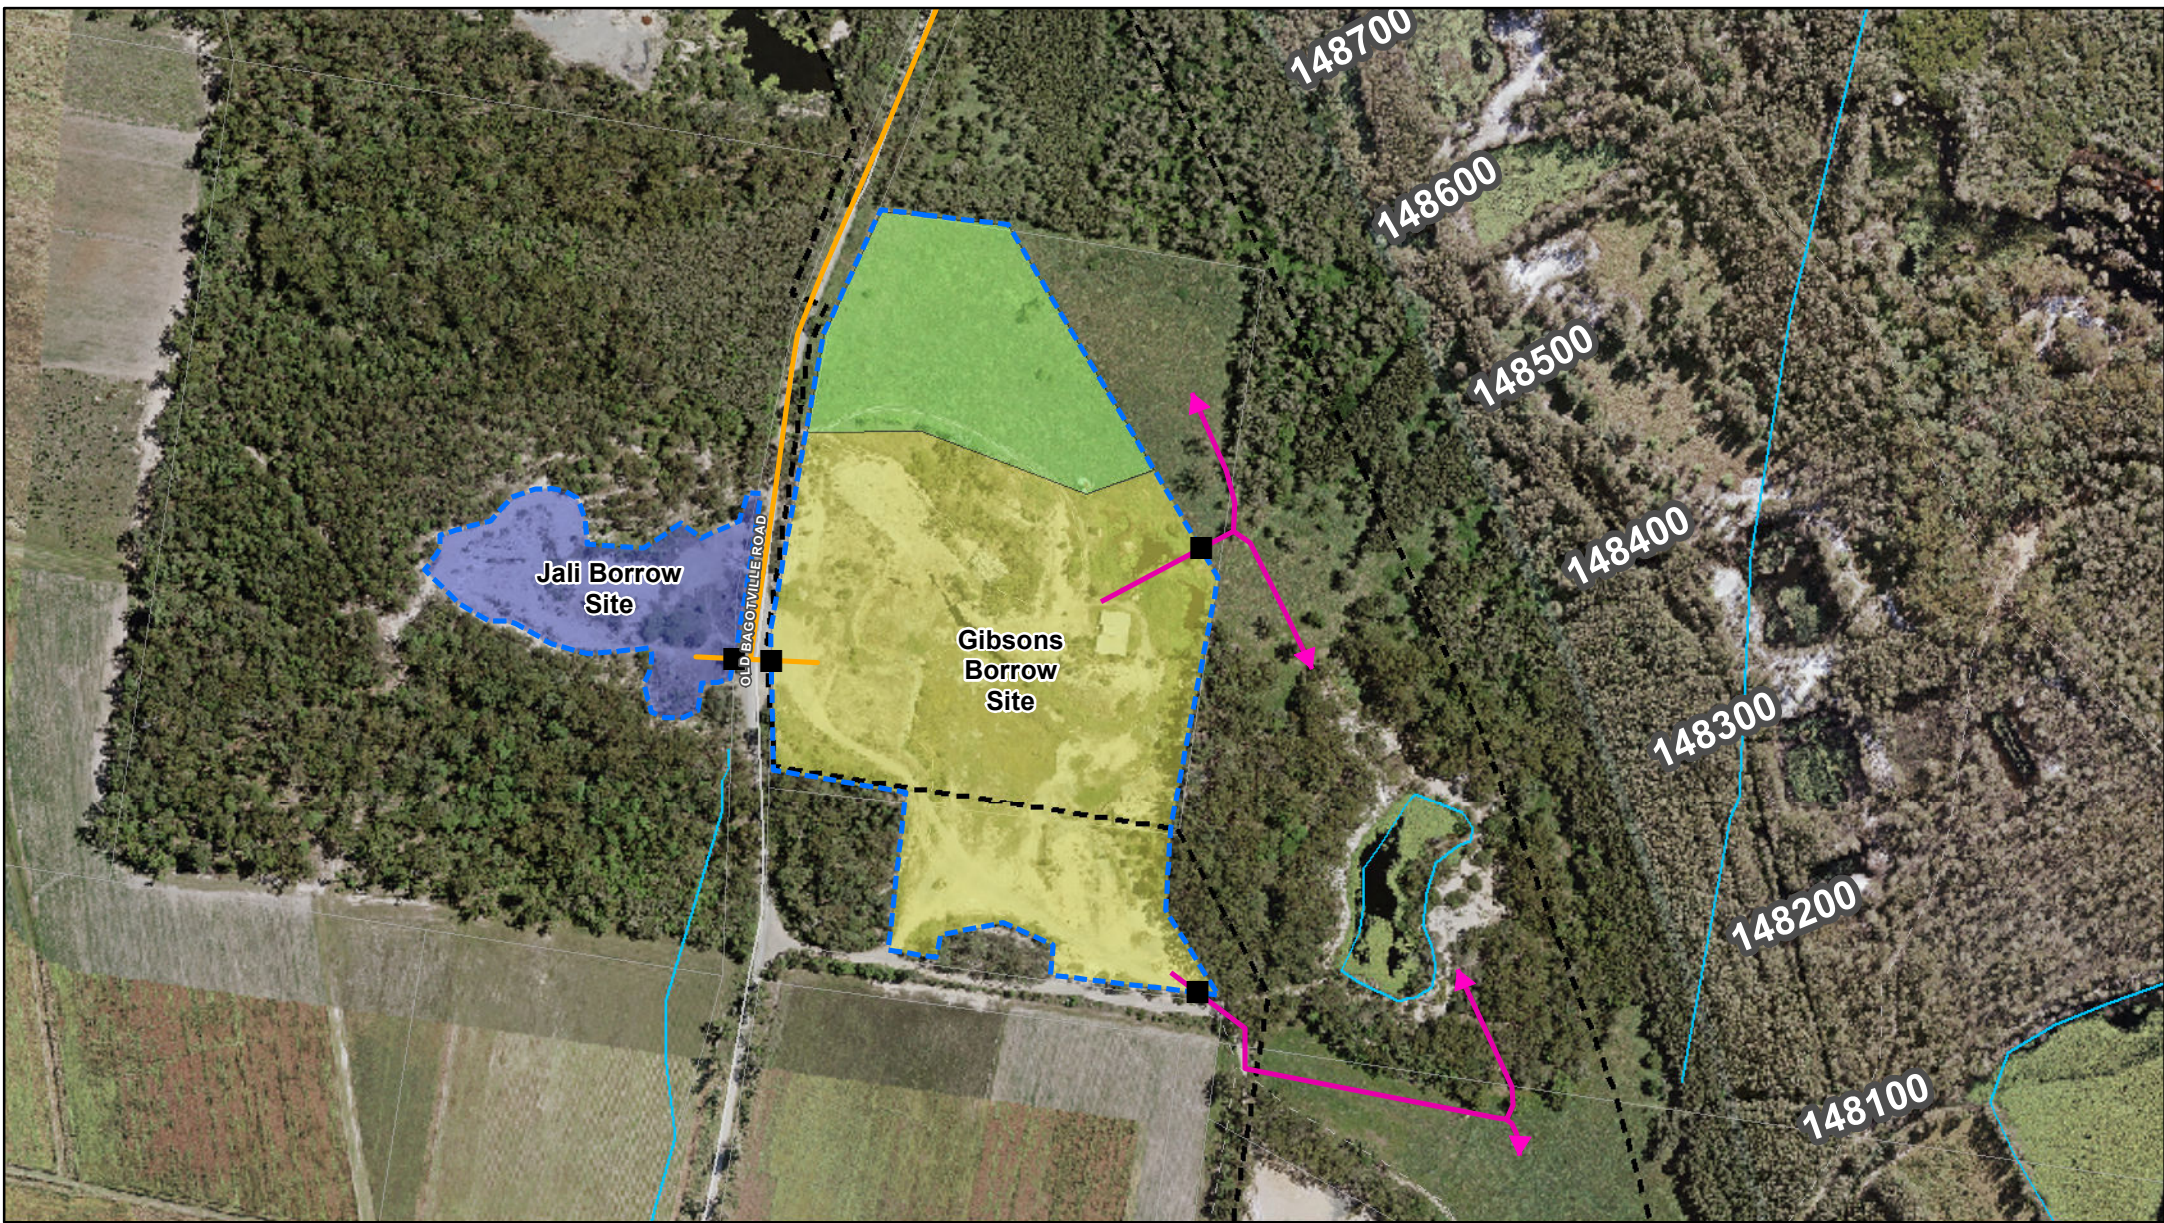
Figure 3-2

- Koala grid
- Drainage
- - - Exclusion fencing
- Access during establishment and prior to the opening of the construction corridor
- ➔ Access once construction corridor is operational
- ⬜ Approved Project Boundary Version 11 (June 2016)
- Staff office/amenities and stockpile area
- Gibsons Borrow Site excavation area
- Jali Borrow Site excavation area

Access to the site establishment and early operation would be from Old Bagotville Road, as shown in Figure 3-2, and utilised until the construction corridor has been cleared and accessible for construction vehicles. Old Bagotville Road is currently used for the haulage of materials from nearby quarries and has been used previously for the supply of material for other Pacific Highway projects including Alstonville Bypass and Ballina Bypass.

Temporary fauna (koala) exclusion fencing would be established around the boundary of the site, as shown in Figure 3-2. Fauna (koala) fencing is considered to be appropriate for the exclusion of Potoroos. Koala grids would be implemented at all entry points to allow traffic movements in and out of the site whilst maintaining a barrier between the site and any koalas potentially in the area. Mitigation measures outlined in the approved Koala Management Plan (RMS, 2016) with regards to speed zones and traffic requirements would be implemented for traffic entering and leaving the site. Any clearing of remnant/ regrowth vegetation within the site would also be carried out in accordance with the Koala Management Plan and the approved Pacific Complete Construction Flora and Fauna Management Plan (sections 3 to 11) (CFFMP), Appendix B8 of the CEMP.

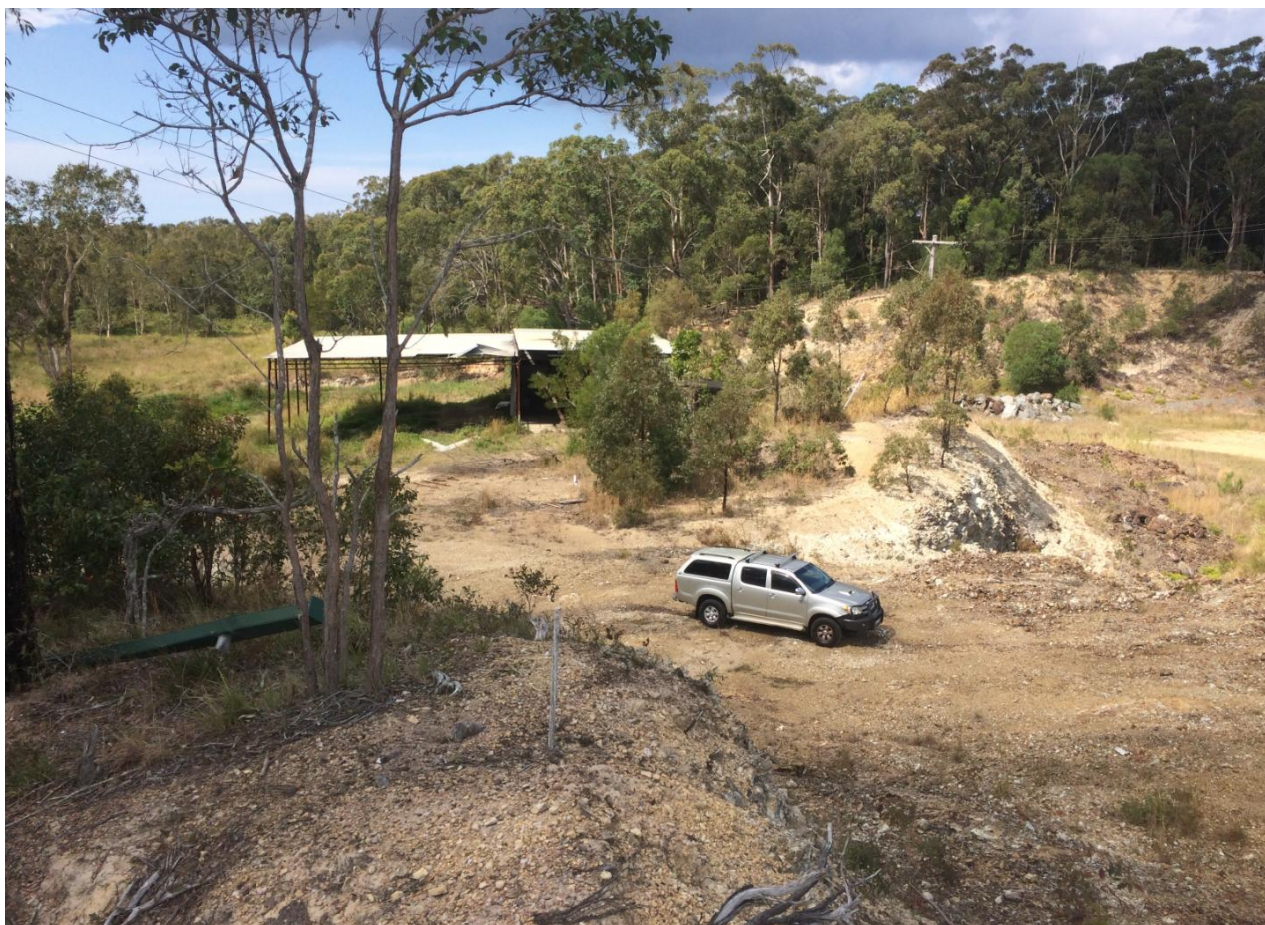
Plate 1: Looking northeast towards the NE Gibson pit boundary located in the background behind the building structure.

Plate 1 shows a view towards the northeast boundary of the proposed Gibsons Pit. It shows historic quarry works in the foreground with the location of the shallow sand aquifer on the Gibsons Pit margin shown in the low lying area in the background.

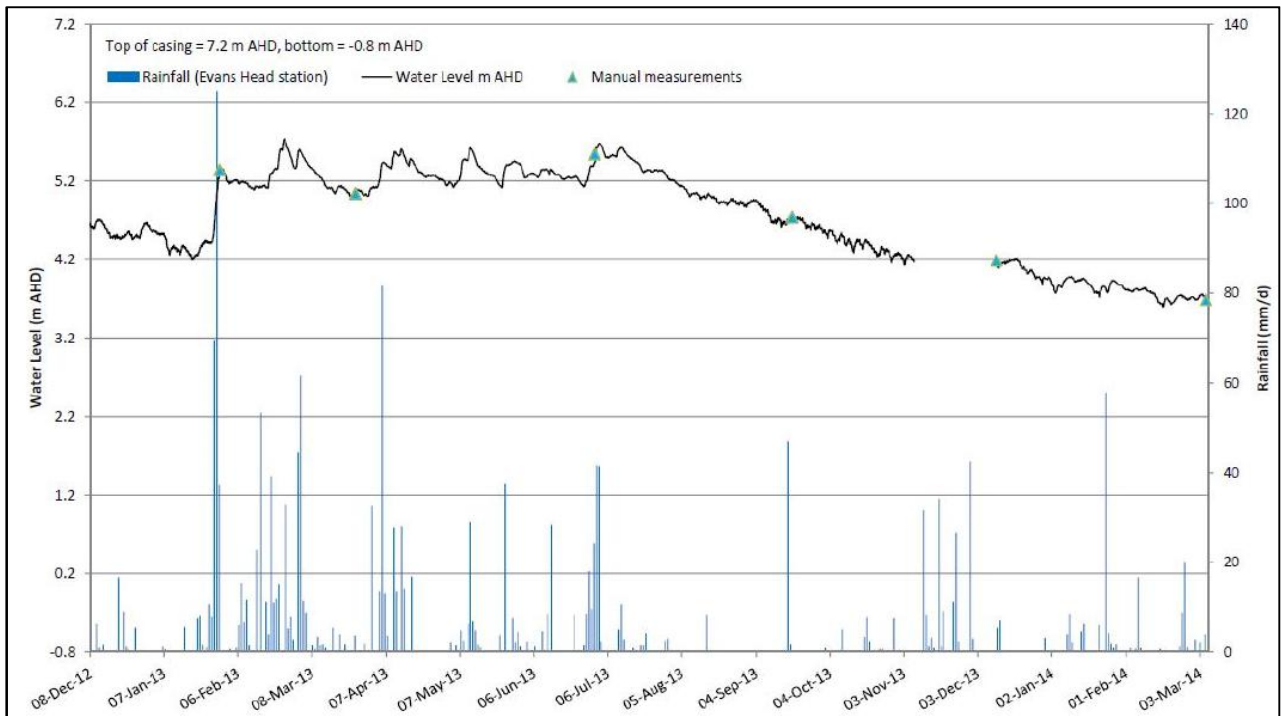
Figure 7 Bore GWB10-05 groundwater levels and response to rainfall

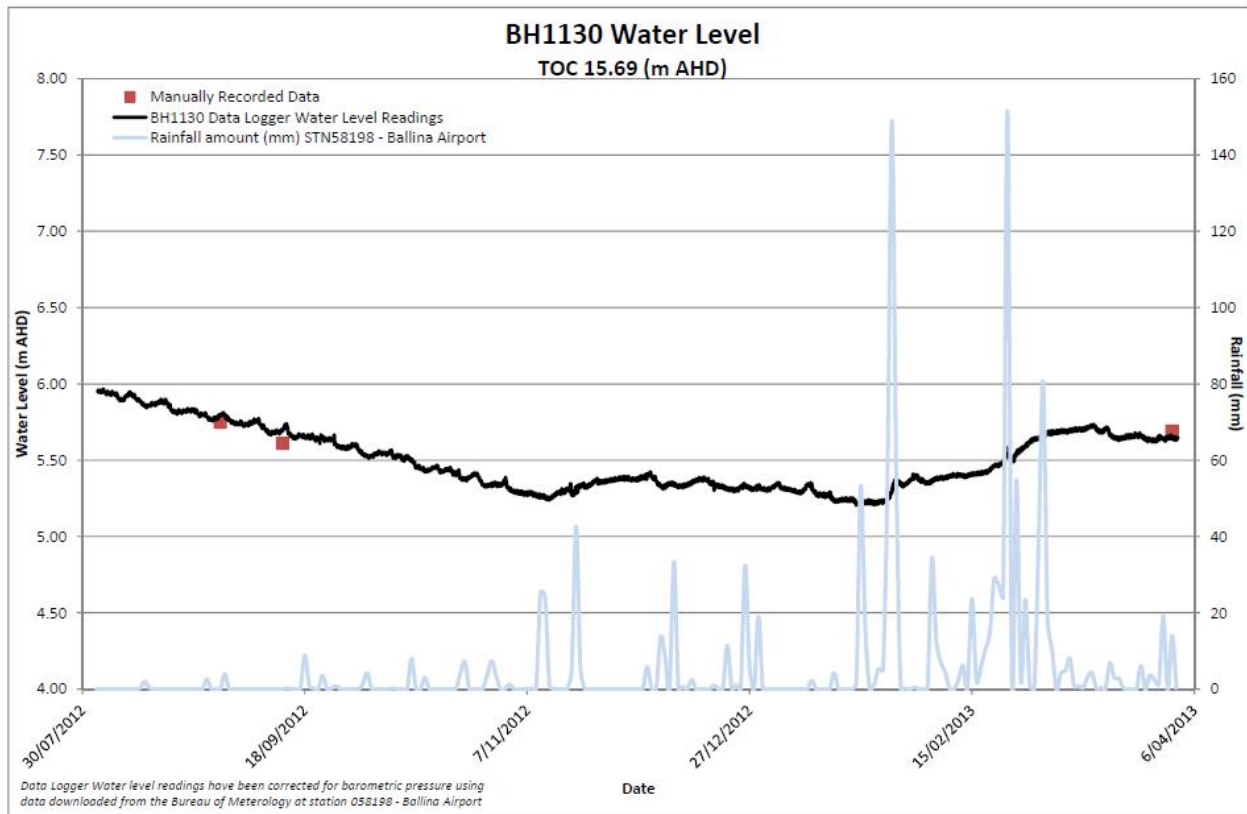
Figure 8 Bore BH1130 groundwater levels and response to rainfall (Source: Golder, 2013)

The deeper bedrock groundwater system is a slow flowing deep system which reacts slowly to rainfall events, in most instances and, as such, do not typically fluctuate much over time (Figures 6, and 8). Because of its depth beneath the Borrow Site, this groundwater system does not sustain the local ecology to any meaningful degree.

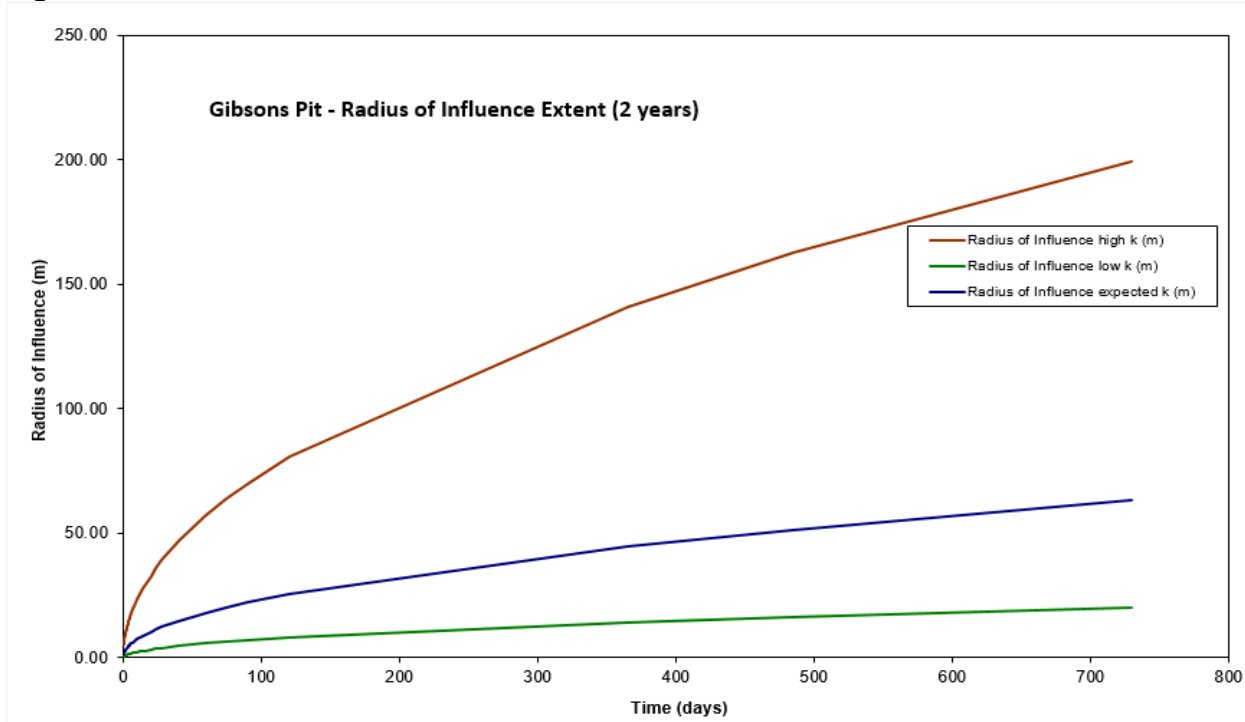
Figure 6 Radius of Influence curve for Gibsons Pit

The calculation of the total water take from the two pits and estimation of the radius of influence indicates that under likely (expected case) hydrogeological conditions, the GW056965 landholder water supply bore will not be impacted by the quarrying activities after the 2-year operation period (radius of influence is <50m at that time). In the unlikely circumstance that high inflow (*High K Case*) applies, bore GW056965 lies within the calculated radius of influence. As such it may be impacted and will therefore be the subject of groundwater monitoring, trigger criteria and 'make good (if impacted) (refer to Water Monitoring and Management Plan described in the next section). Figures 4 and 5 illustrate the likely drawdown impact extent as measured for the edge of each pit.

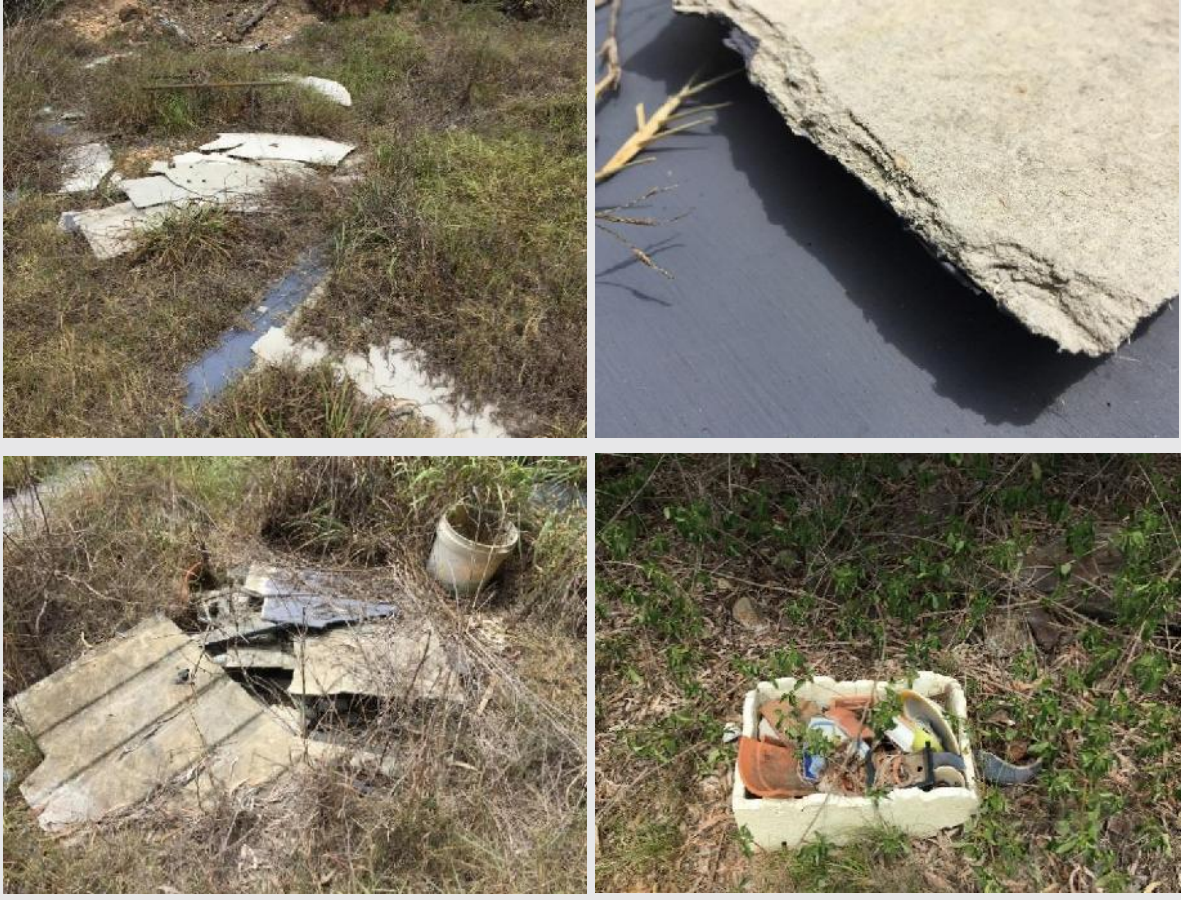
Area of demolition and household waste near the entrance to Gibsons Quarry, including ceramic, plastic, metal, electrical wire, fibro (potential ACM), glass and a small transformer.	1

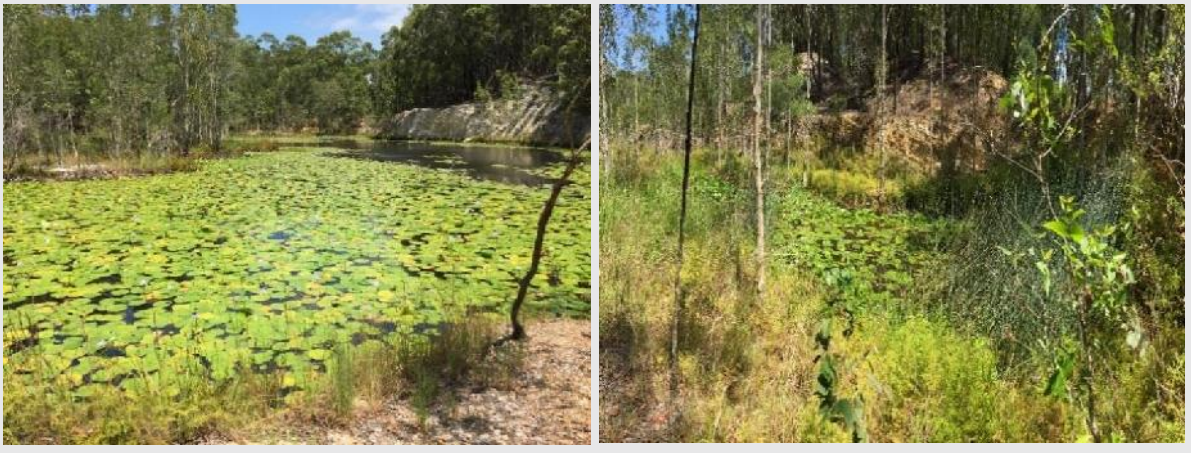
<p>Pit on eastern portion of Gibsons Quarry that has filled with water. Vegetation appeared healthy.</p>	<p>11</p>

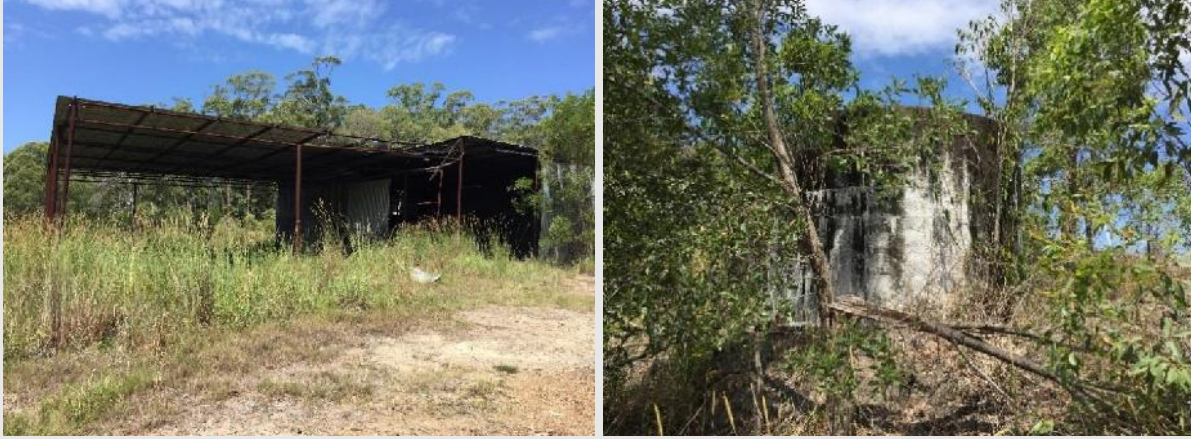
<p>Shed in the north eastern portion of the main quarry area, possibly used for fuel/oil/chemical storage. The shed had a steel and timber frame and was corrugated iron clad. The shed consisted of an enclosed area with concrete floor and a front canopy with bare earth surface. Oil stains and odour were noted within the shed on the concrete floor. Possible hydrocarbon stains were also noted on the ground surface beneath the canopy. Household garbage was also observed in the shed, including a TV, heater,</p>	<p>13</p>

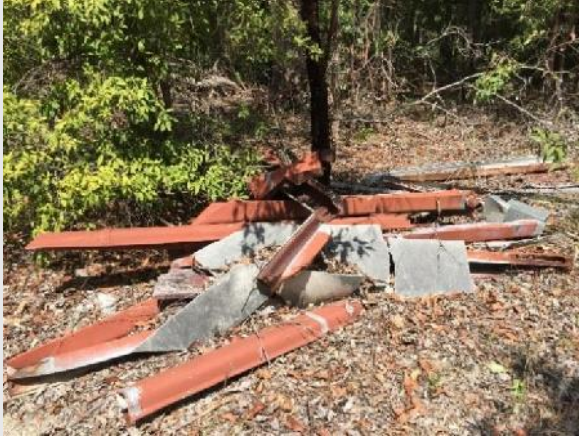
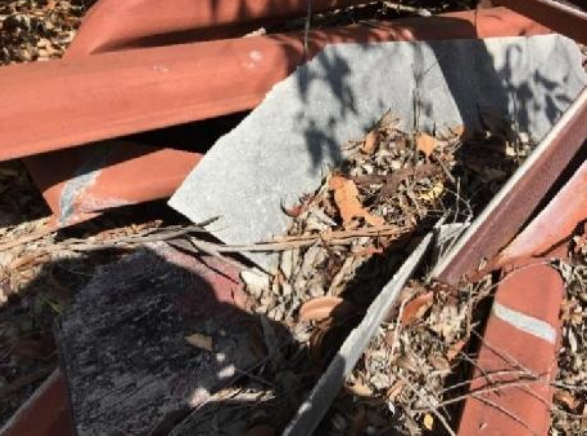
A stockpile containing metal and fibro (potential ACM) was located in the western portion of Jali Quarry.	24

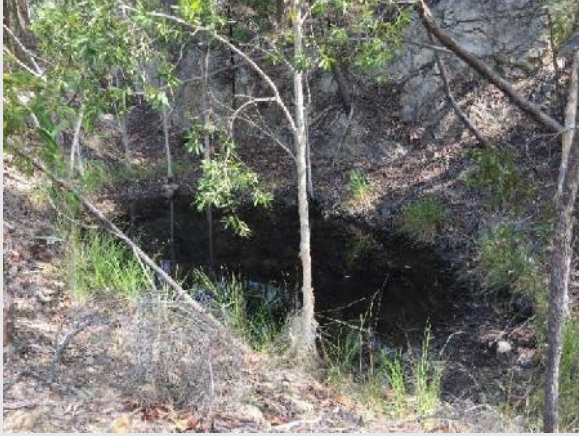
A small waterhole was located on the southern portion of Jali Quarry. No evidence of contamination was observed.	25

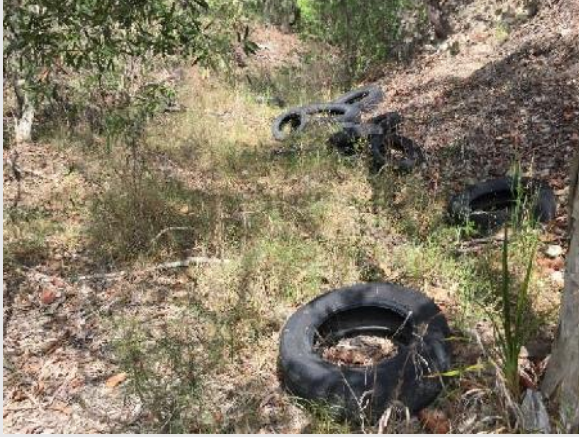
An area of dumped tyres, as well as some metal and household waste was located on the southern portion of Jali Quarry next to Old Bagotville Road.	26

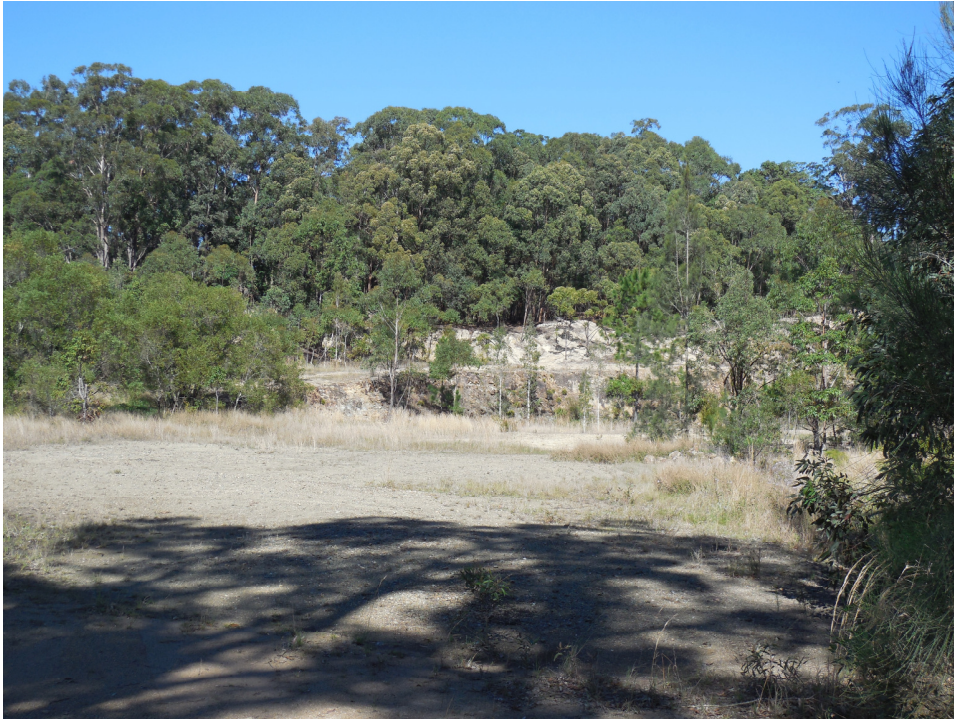
Photograph A1. View to south west across the centre of quarry floor. The site is delineated by the quarry walls pictured.

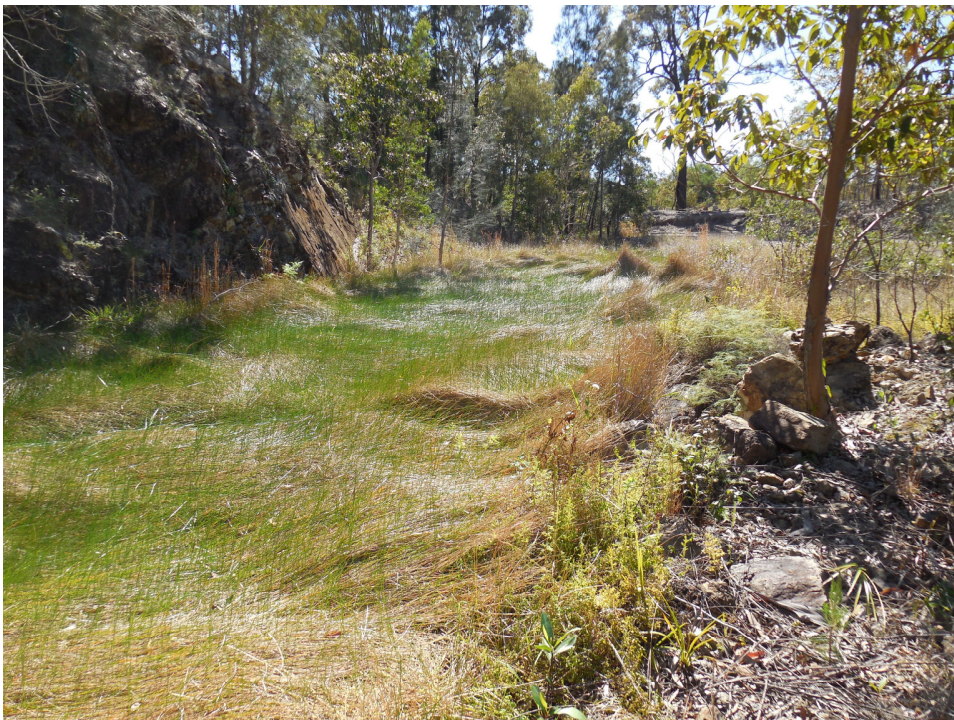
Photograph A2. Small wetland on northern edge of quarry floor.

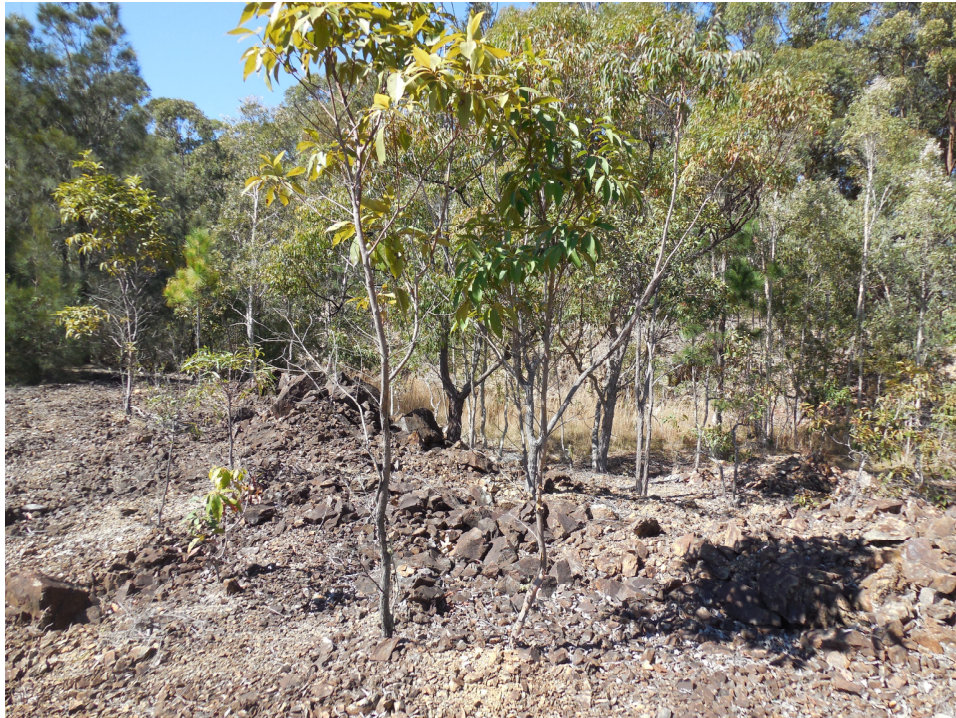
Photograph A3. View of regrowth vegetation in south eastern corner of quarry floor.

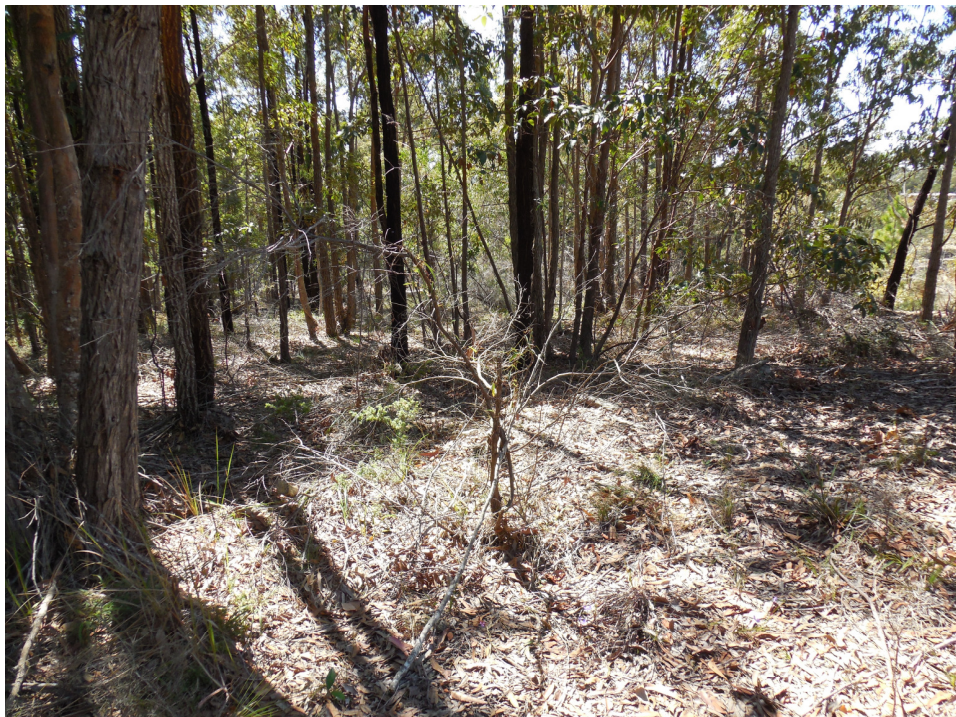
Photograph A4. View of regrowth vegetation along southern 10m buffer.

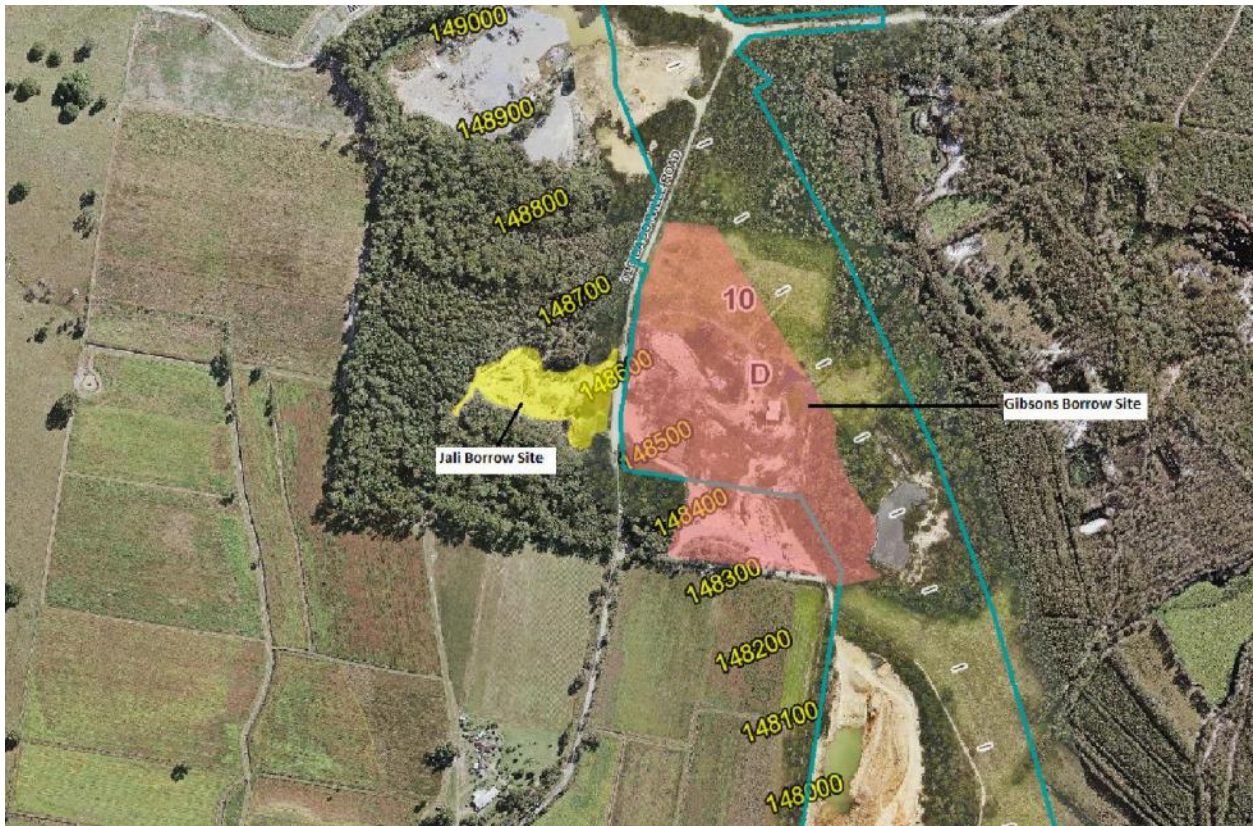
Figure 1 Proposed Site Layout Plan for Jali and Gibsons Borrow Sites

The proposed Jali and Gibsons Borrow Sites (the Site) is located within Lot 244 DP 755691 Bagotville, Lot 2 DP585377 and Lot 5 DP843369, Wardell, in the Ballina Council Local Government Area which is situated in Section 10 of the W2B project. The Site is approximately 9 hectares in size and would be accessed from Old Bagotville Road, Bagotville. The concept layout for the proposed Jali and Gibsons Borrow Sites are shown in **Figure 1**.

Note 1: Drawing provided by the client.

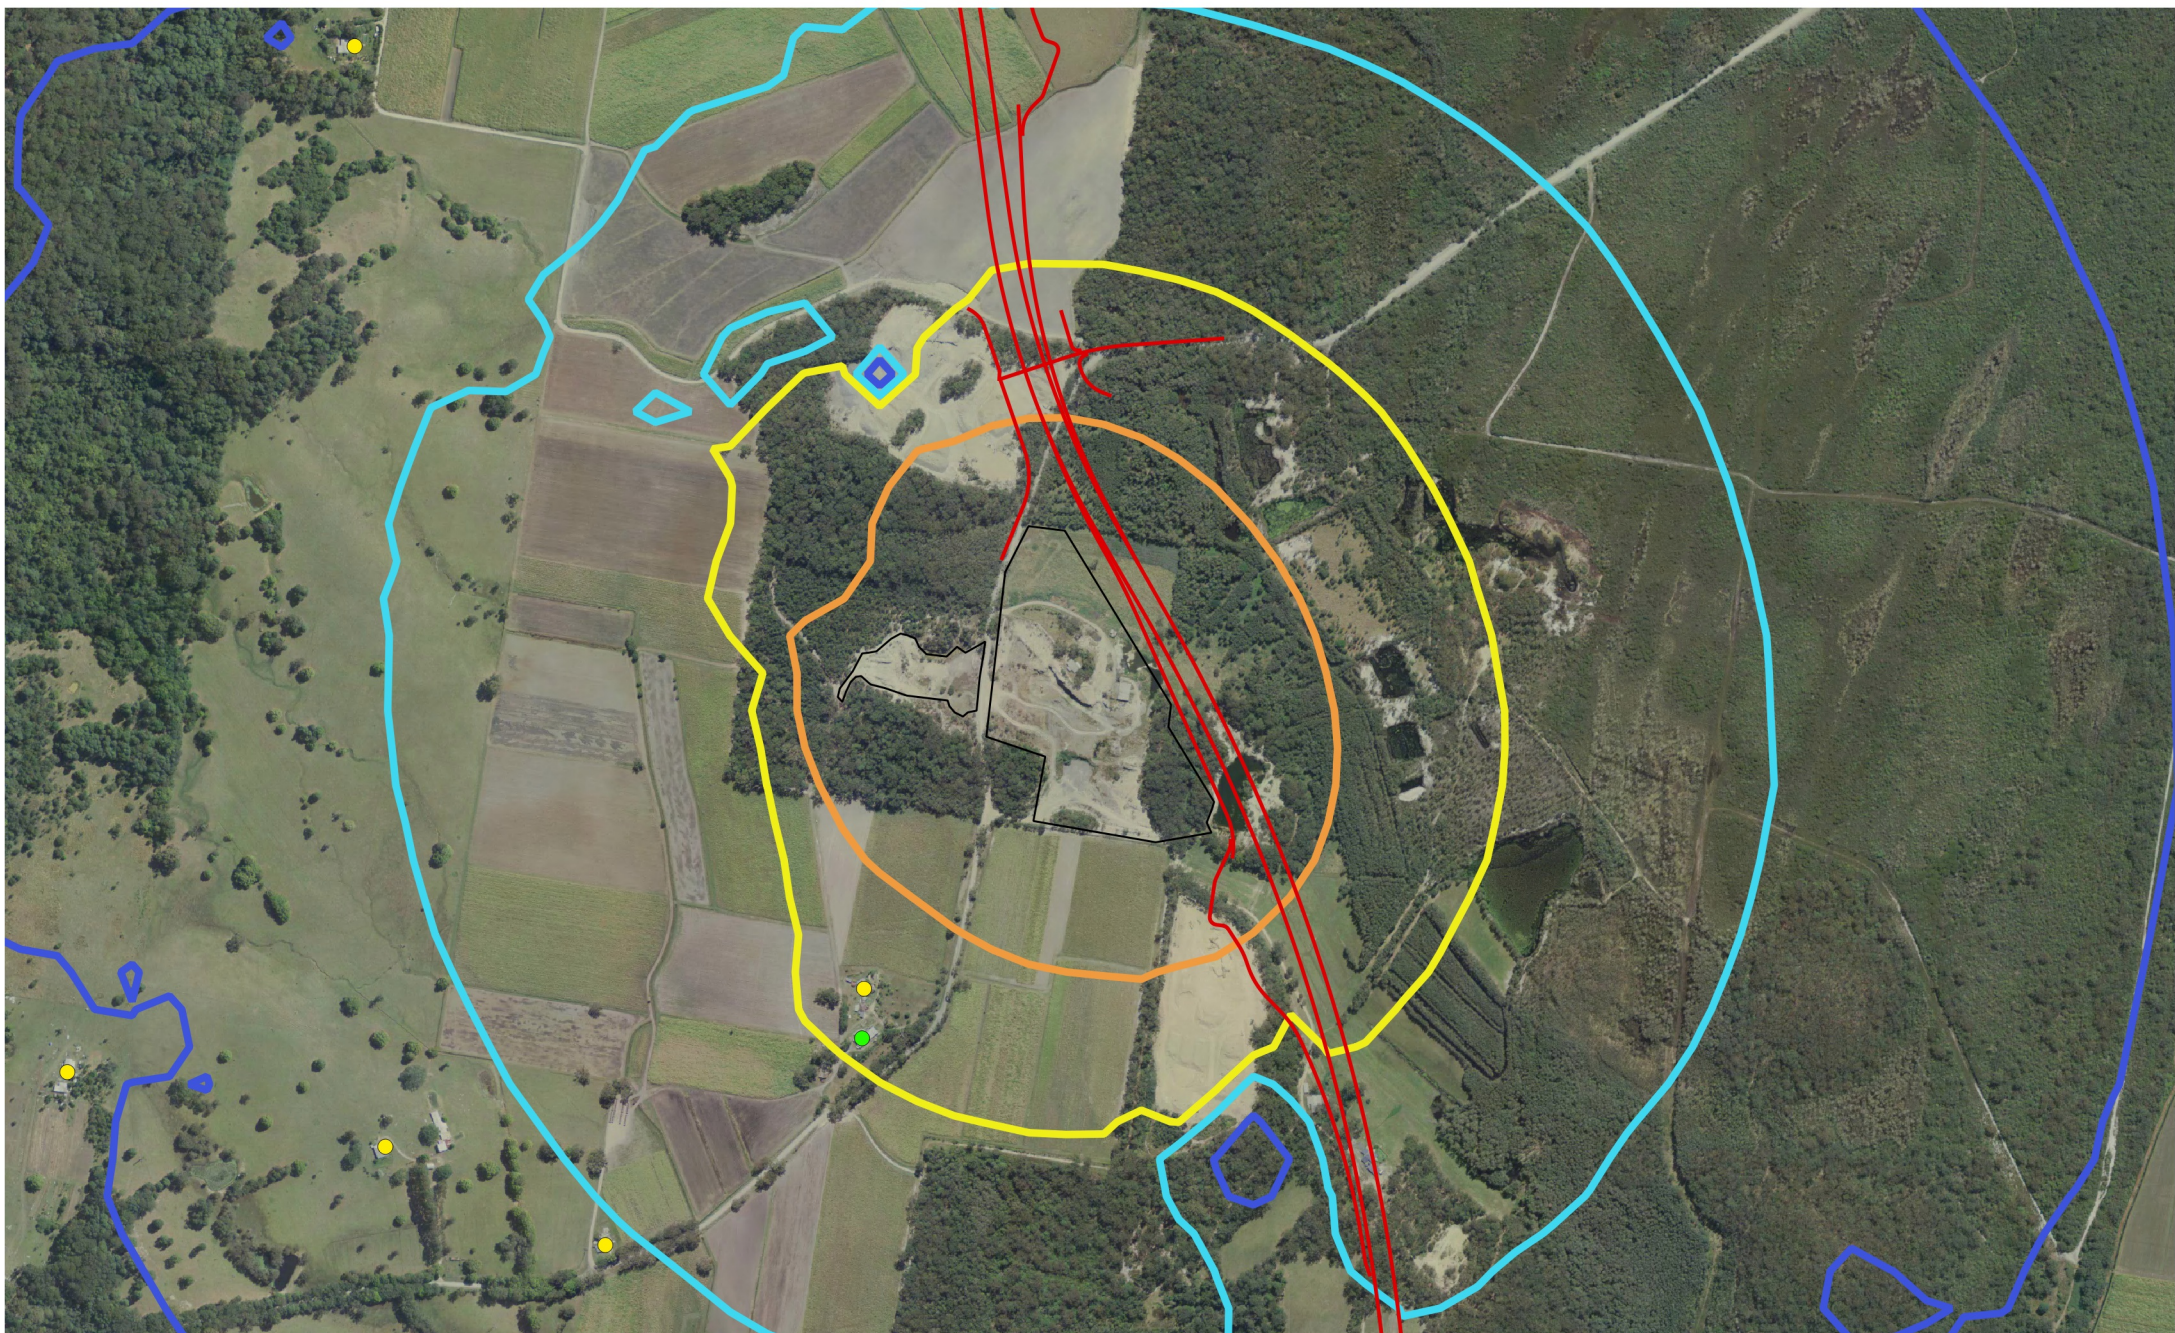
**Construction Noise Assessment
Extraction Operations LAeq(15minute)
Jali and Gibsons Borrow Site**

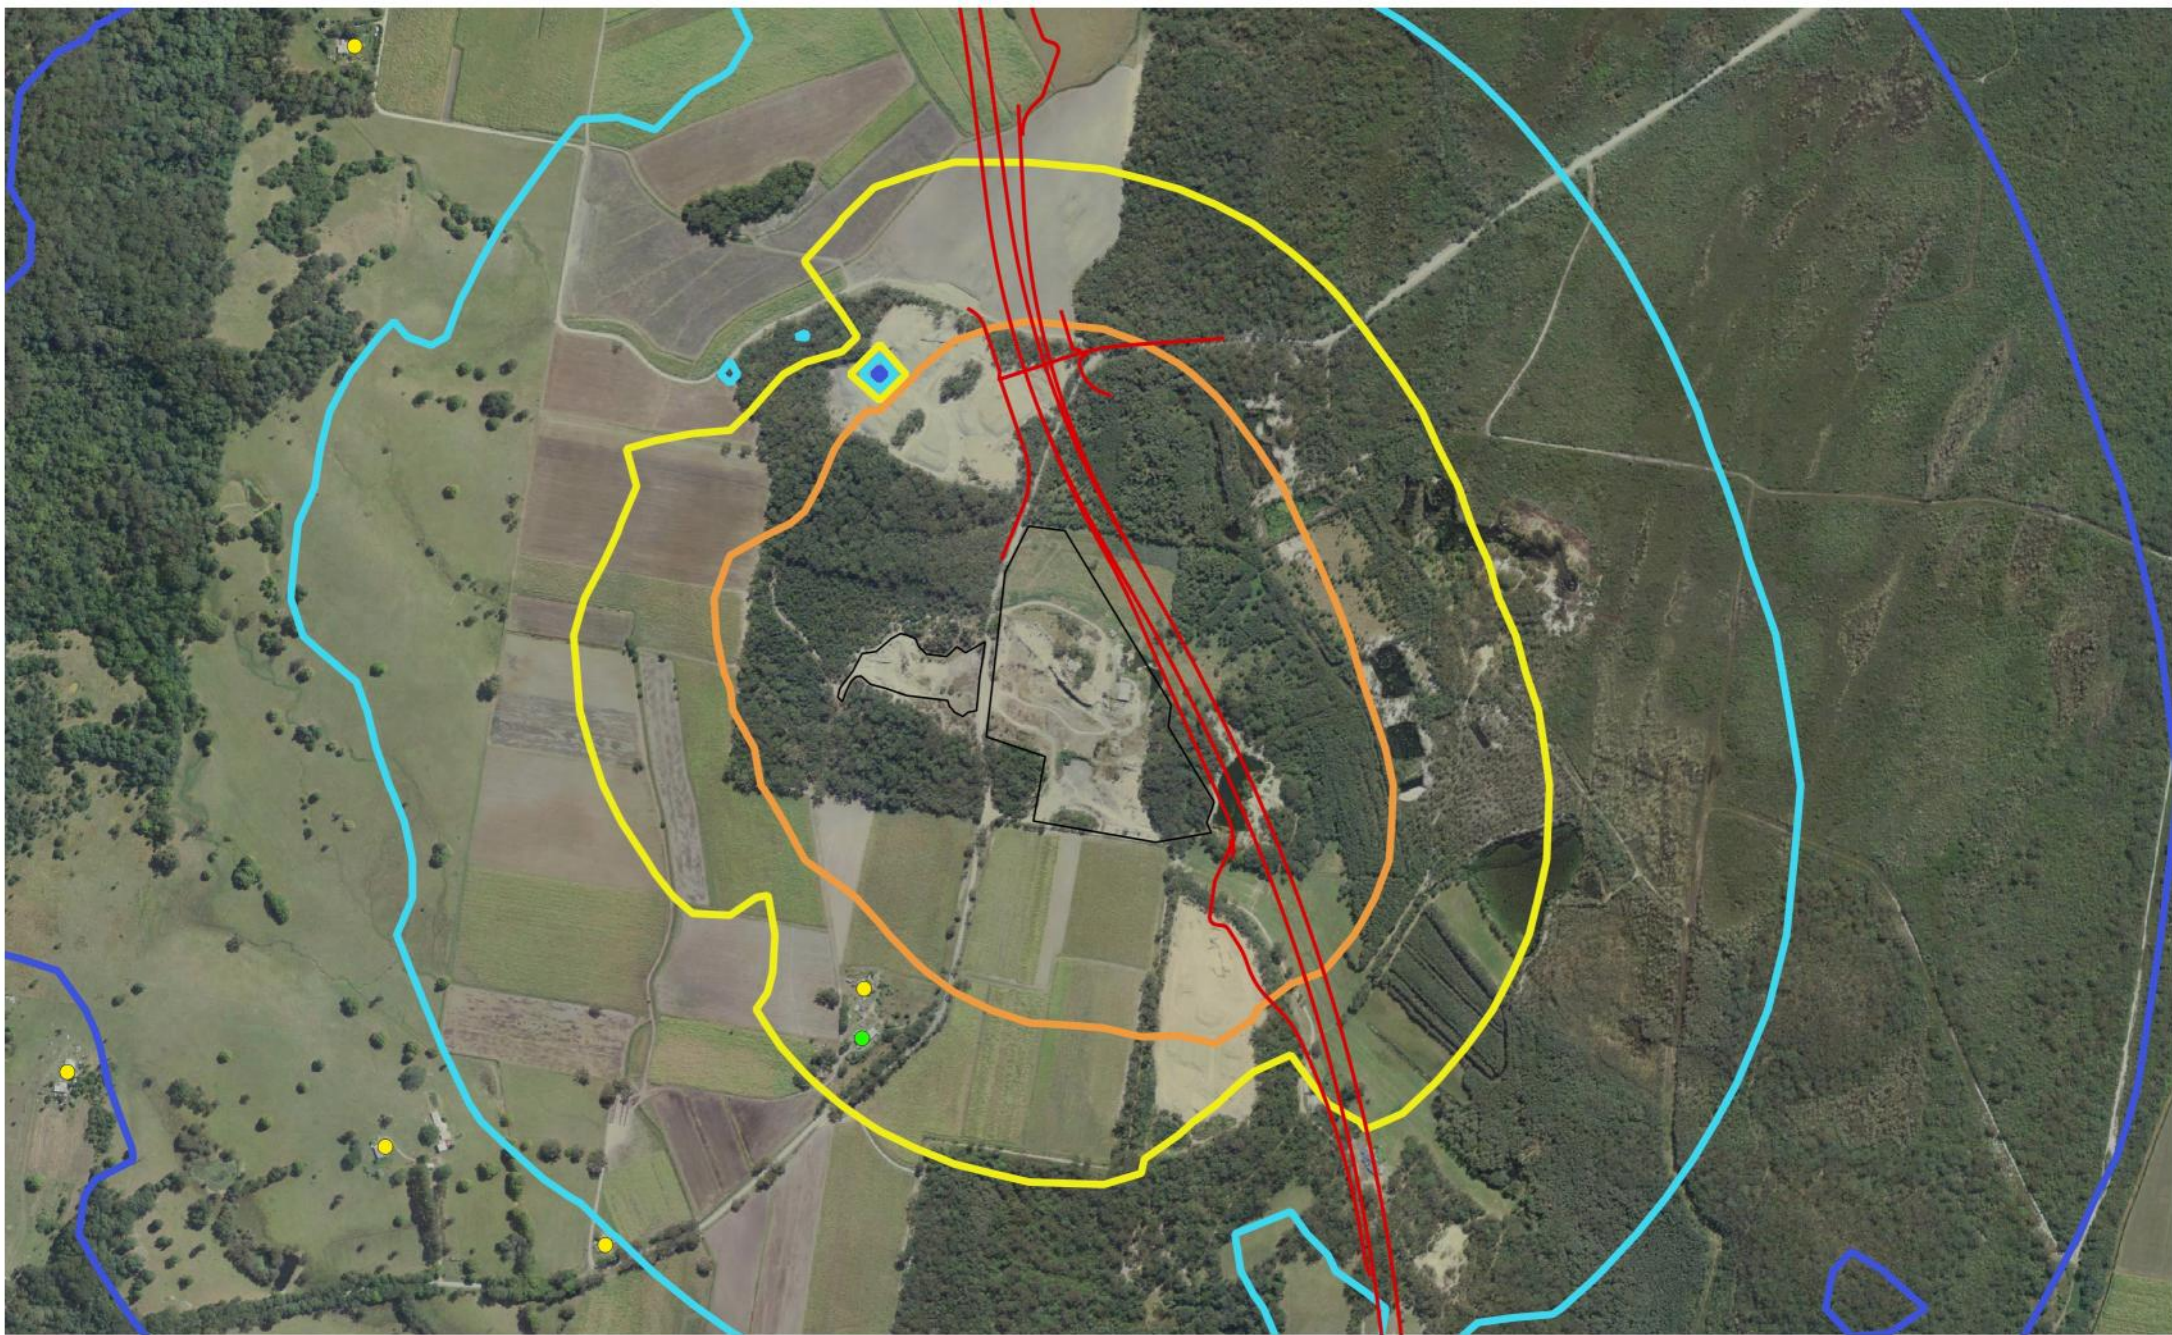
**Construction Noise Assessment
Crushing and Screening LAeq(15minute)
Jali and Gibsons Borrow Site**
