Woolgoolga to Ballina Pacific Highway upgrade

Annual Threatened Flora Translocation Monitoring Report 2021

Woolgoolga to Ballina Threatened Flora Translocation Project

Annual Monitoring Report 2021

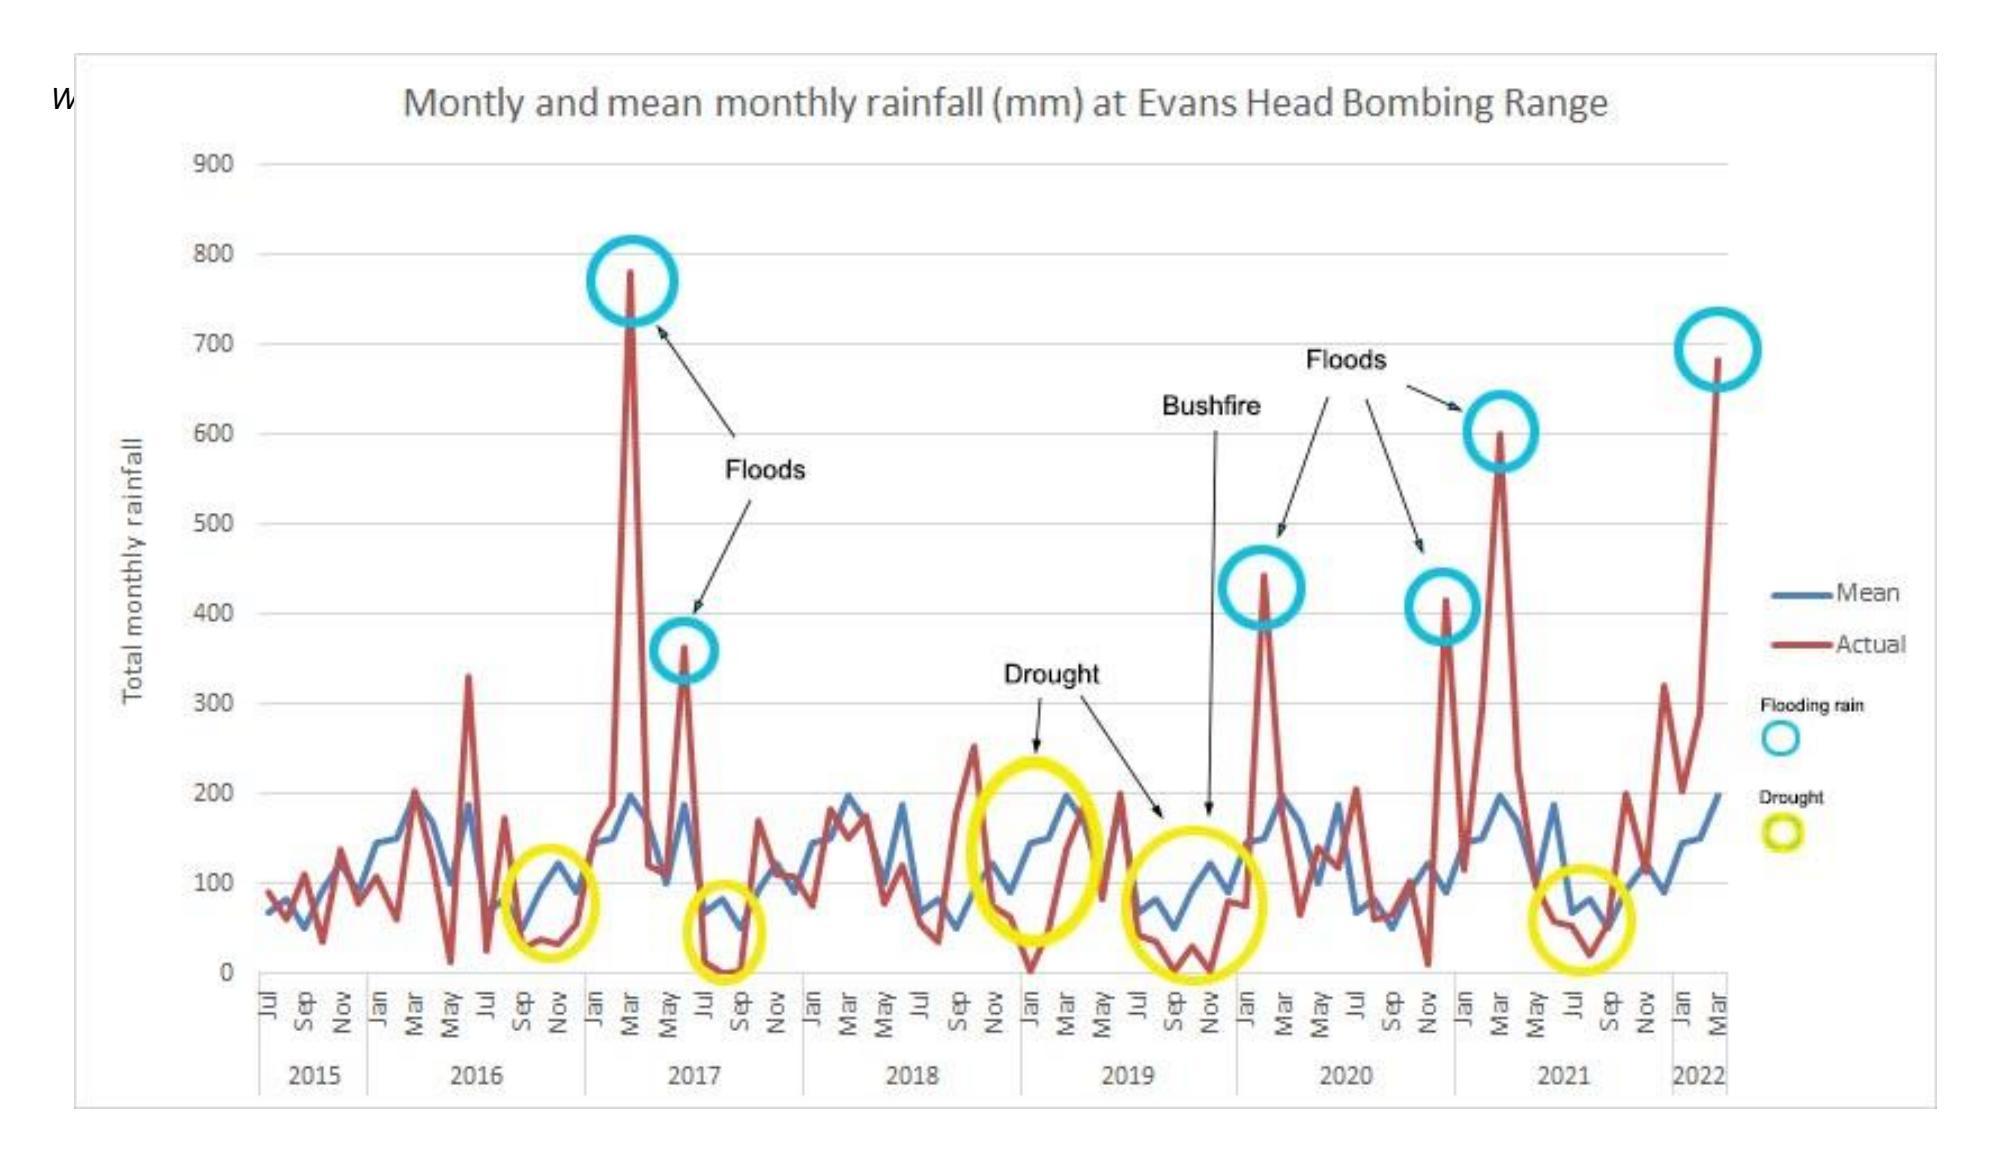
Figure 4: Actual monthly and mean monthly rainfall for Evans Head Bombing Range, representing rainfall on Sections 3-11 from 2015 to 2022. The weather pattern was characterised by high rainfall variability with frequent droughts and floods, and a major bushfire which burnt recipient sites for Singleton Mint Bush, Slender Screw Fern and Weeping Paperbark in the Tabbimoble Creek area north of Illuka turnoff in November 2019.

Monthly and mean monthly rainfall between 2015 and 2021 at Evans Head (<u>www.bom.gov.au/climate/data/</u>) are plotted in Figure 4. This six-year period included droughts, which were defined as three or more consecutive months of below average rainfall, floods and a major bushfire (see Figure 4). Periods of below average monthly rainfall were in winter-spring, except for 2018 & 2019 when drought extended into summer, culminating in the bushfires of 2019-2020. Leaves on species such as *Lindsaea incisa* and *Prostanthera cineolifera* wilted and shrivelled up, indicating severe water stress. Additional watering was carried out to alleviate stress. Heavy rainfall events causing flooding and soil water logging adversely affected some species such as *Lindsaea incisa* and *Persicaria elatior*.

The highest maximum temperature on record for the Far North Coast of NSW was recorded on 11/2/2017 (mid to high 40s). This event caused leaf scorching and mortality to several transplanted *Cryptocarya foetida* at Lumleys Lane. The high temperature occurred during a drought that ended in March 2017 when 800-1000 mm of rain fell from Ballina to Maclean, causing flash floods and prolonged flooding of low lying recipient sites. Wet conditions persisted to the end of June 2017.

An exceptionally long dry period occurred from October 2018 to December 2019 along much of the east coast of Australia and bushfires were widespread. A bushfire burnt from the Richmond Range to the coast, crossing the W2B corridor between Ballina and Maclean, including the recipient sites for *Lindsaea incisa*, *Prostanthera cineolifera* and *Melaleuca irbyana* at Tabbimoble Ck, near the Iluka turnoff in Nov/2019. The bushfire provided an opportunity to record how translocated plants were affected by bushfire, and whether this affected their establishment.

Overall, weather patterns between mid-2015 and mid-2021 were notable for several large deviations from average monthly rainfall. In 6.5 years, there were five drought periods, defined as more than three consecutive months of below average rainfall, and six very high monthly rainfall events (see Figure 4). Intervening periods were about average with respect to rainfall, although higher than average in some months. Exceptionally high temperatures were recorded at the start of 2017, as noted above. The saying "a land of droughts and flooding rains " is as true for the high rainfall North Coast of NSW as the dry inland.

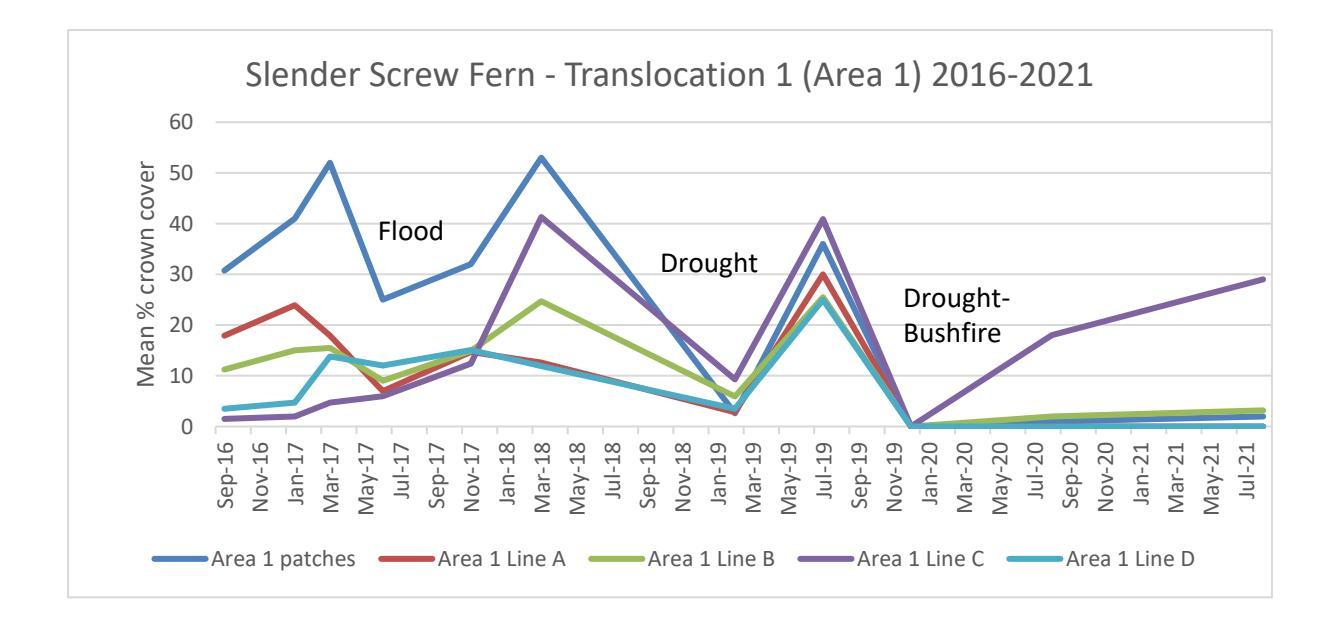
Figure 5: Slender Screw Fern - Translocation 1, Area 1, 2016-2021. Dips or declines in crowncover relate to environmental disturbance events, the first (on the left) to flash flooding and prolonged inundation, the second to unseasonal drought and the most recent to drought and bushfire. After this event, Slender Screw Fern recovered to near pre-disturbance abundance only on Line C. (Note that monitoring was only carried out frequently enough to pick up some of the drought and flood events in Figure 4.)

In Area 1 prior to the fire, mean cover-abundance was highest on Line C and less on the other lines (see Fig 5; Table 8), suggesting that factors associated with micro-elevation affect *L. incisa* growth and survival. Of the four lines in Area 1, Line A was lowest in elevation and Line D the highest. Small differences in elevation may be related to gradients of soil moisture or species composition/competition. Similar sensitivity to micro-elevation was recorded during the translocation of *L. incisa* on the Sapphire to Woolgoolga Project (Ecos Environmental 2011b).

As plot markers were burnt and we were unable to determine the exact location of many plots and patches, clumps of regenerated *L. incisa* were re-tagged and re-numbered in Aug/20 for on-going monitoring. In Area 1, 38 discrete clumps of Slender Screw Fern with a mean percentage crown cover of 12.8% (i.e. clump area/plot area x 100) were marked and given a new number for monitoring. In area 2, 21 discrete clumps of Slender Screw Fern with a mean percentage crown cover of 6.1% were tagged and numbered. There were also other tagged but unnumbered clumps (not monitored). The renumbered clumps were

equated approximately with the lines and patches recorded the previous year (pre-fire) for purposes of extending the graphs below (see Figs 5 & 6).

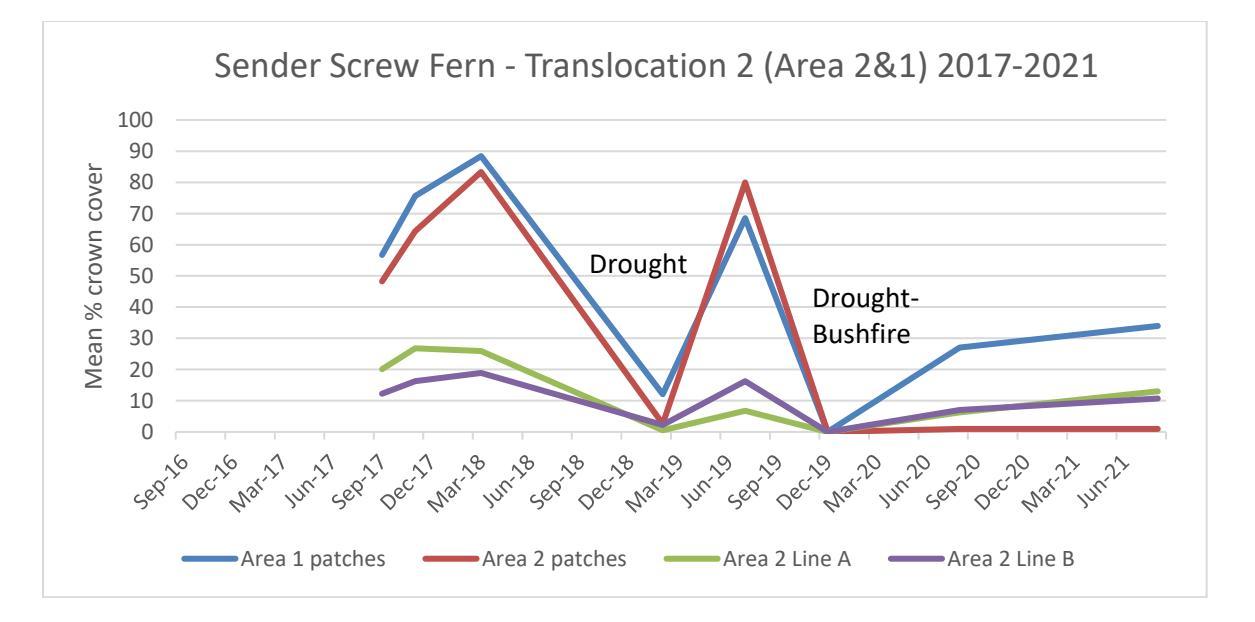
Figure 6: Slender Screw Fern - Translocation 2, Area 2 & 1, 2017-2021. Declines in crowncover relate to drought (left hand side), also seen in the graph above and most recently, to drought and bushfire (see also with Fig 5). Overall, post-fire recovery of Slender Screw Fern was better on Translocation 2, particularly Area 1 patches that happen to be in the same part of Area 1 as Line C (Figure 5) which also performed well. This is probably due to favourable micro-habitat parameters including soil moisture and water table dynamics.

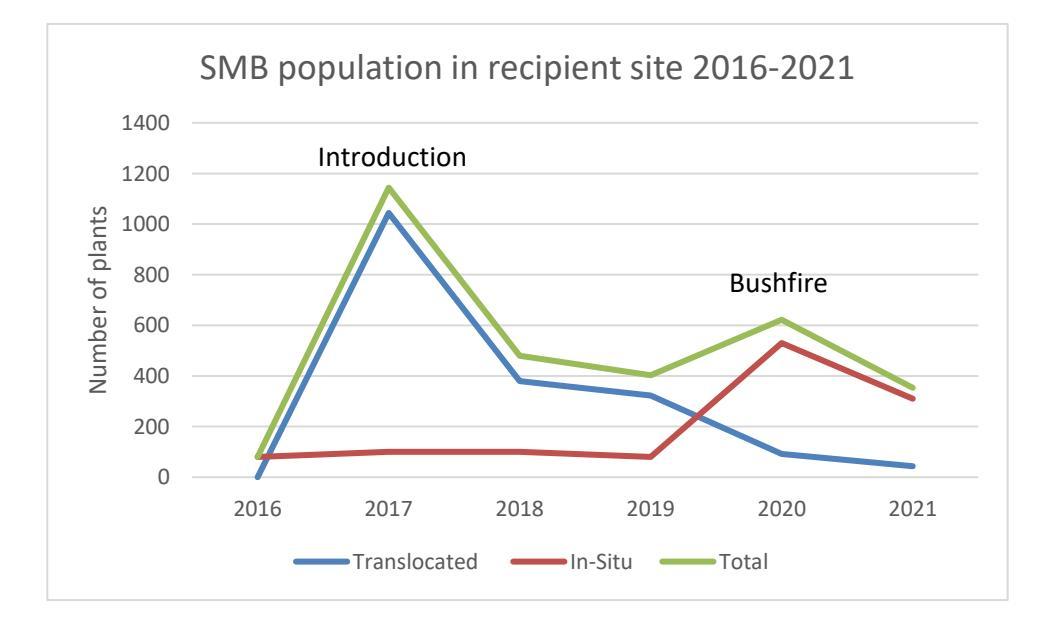
Figure 7: SMB population in the recipient site between 2016-2021 indicating numbers originating from translocation and the in situ population. The aim of this translocation was to augment and extend the original population. As the graph indicates, only minor augmentation was achieved by 2021. The graph does not include an additional 100 plants introduced to the part of the site most suited to SMB in 2021.

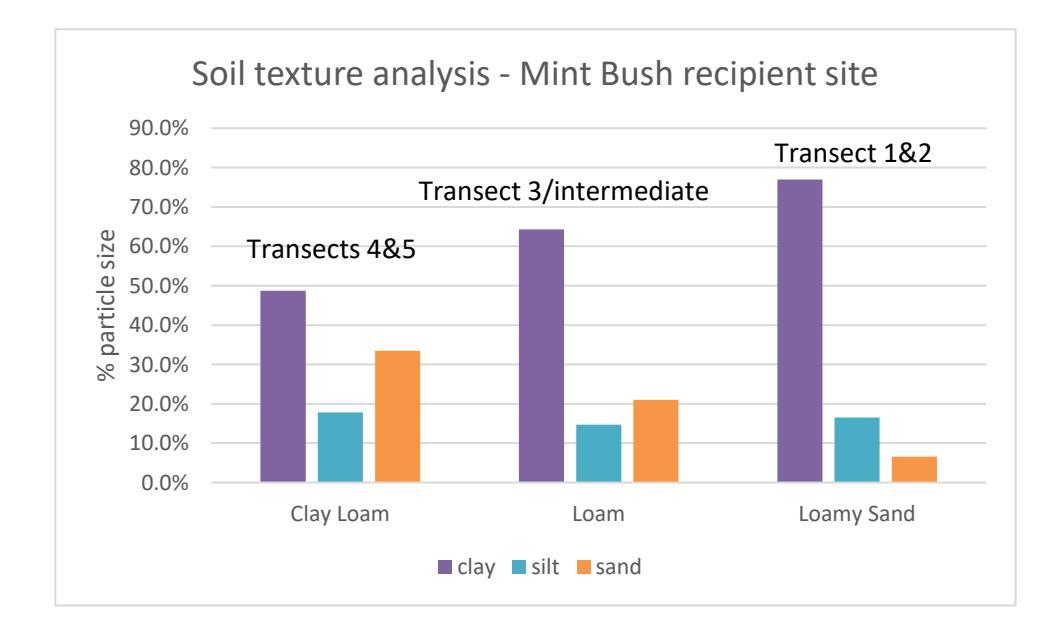
Figure 8: Soil textural classification at the Singleton Mint Bush recipient site as determined by EAL, consisted of clay loam over most of the site, grading into loam and loamy sand close to the main creek and along small tributary gullies, confirming initial observations.

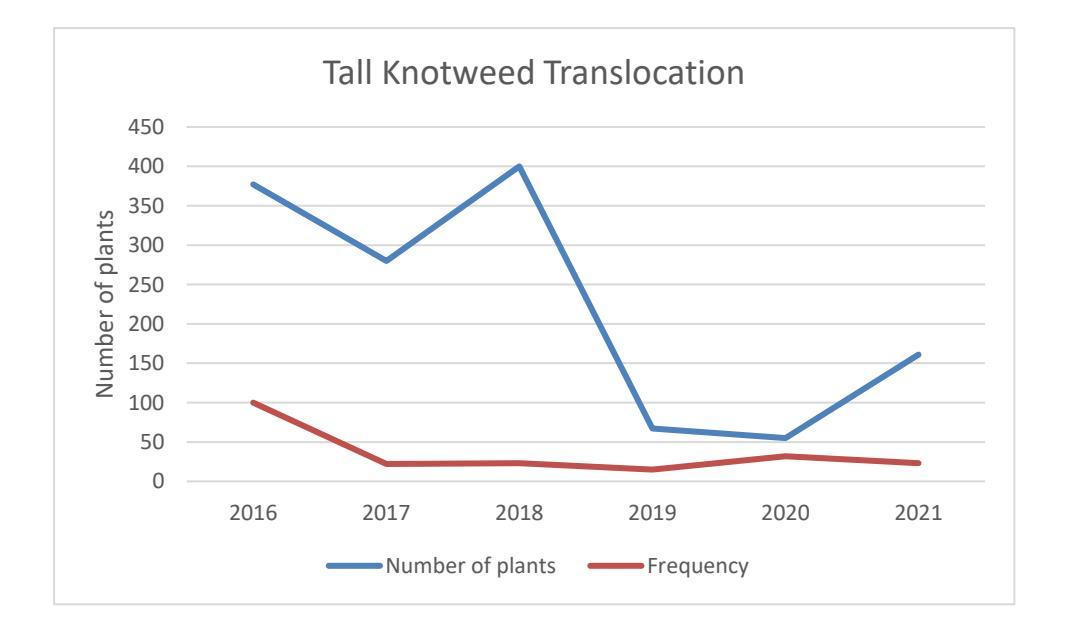
Figure 9: Changes in Tall Knotweed abundance after translocation over five years, combining results of the three translocations. The frequency curve gives the number of plots with Tall Knotweed present after translocation as a percentage (i.e. 0-100 on vertical axis). It can be seen that frequency has remained about constant at around 25% while abundance in terms of number of plants fluctuated, declining steeply in the strong drought year 2019. The previous dip largely reflects earlier below average spring-summer rainfall.

It was not possible to maintain the large numbers of Tall Knotweed plants recorded at the impact site (opposite the southern Maclean exit) at the recipient site, although the impacted population was largely artificial and a result of clearing and heavy soil disturbance at the site concerned. The translocation established a low-density population, with yearly recruitment and growth to maturity taking place naturally for four successive years (with a bit of help by spraying out dense herbaceous ground layer to create open sites). On-going recruitment from year to year depends on the ground layer vegetation not becoming too dense and soil conditions not becoming too dry during the spring-early summer dry season. Tall Knotweed appears to be favoured by a wet spring and above average annual rainfall. This year numbers increased after declining in previous drought years (see Figure 9).

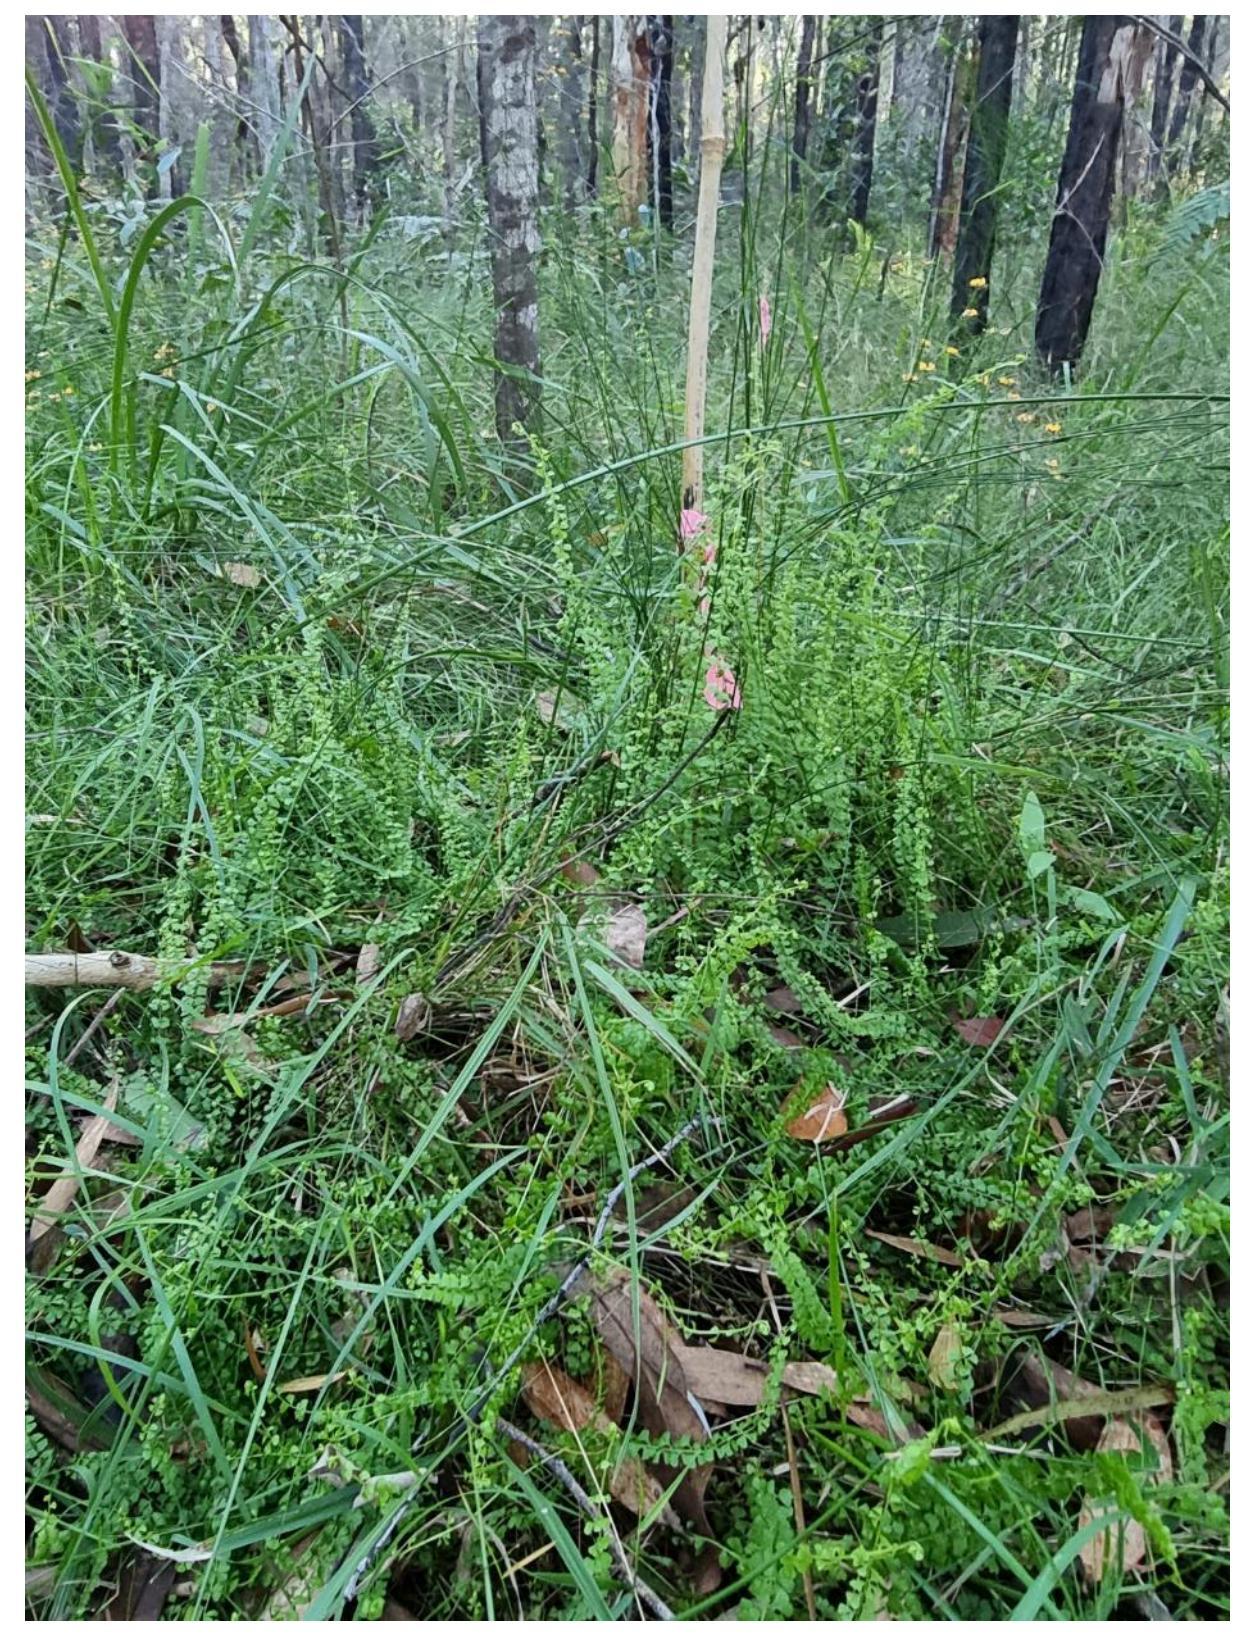
Plate 1: Translocated Slender Screw Fern (*Lindsaea incisa*) in Area 1 Recipient Site, Bundjalung National Park, two years after the Nov/19 fire and four years after transplanting from construction footprint. *L. incisa* regenerated after the moderate to high intensity bushfire by resprouting from its rhizomes which are only 2-3mm in diameter and spread horizontally through the topsoil. This clump is on 'a patch' introduced from unexpected finds in 2017 (four trays per patch). Nov/2021

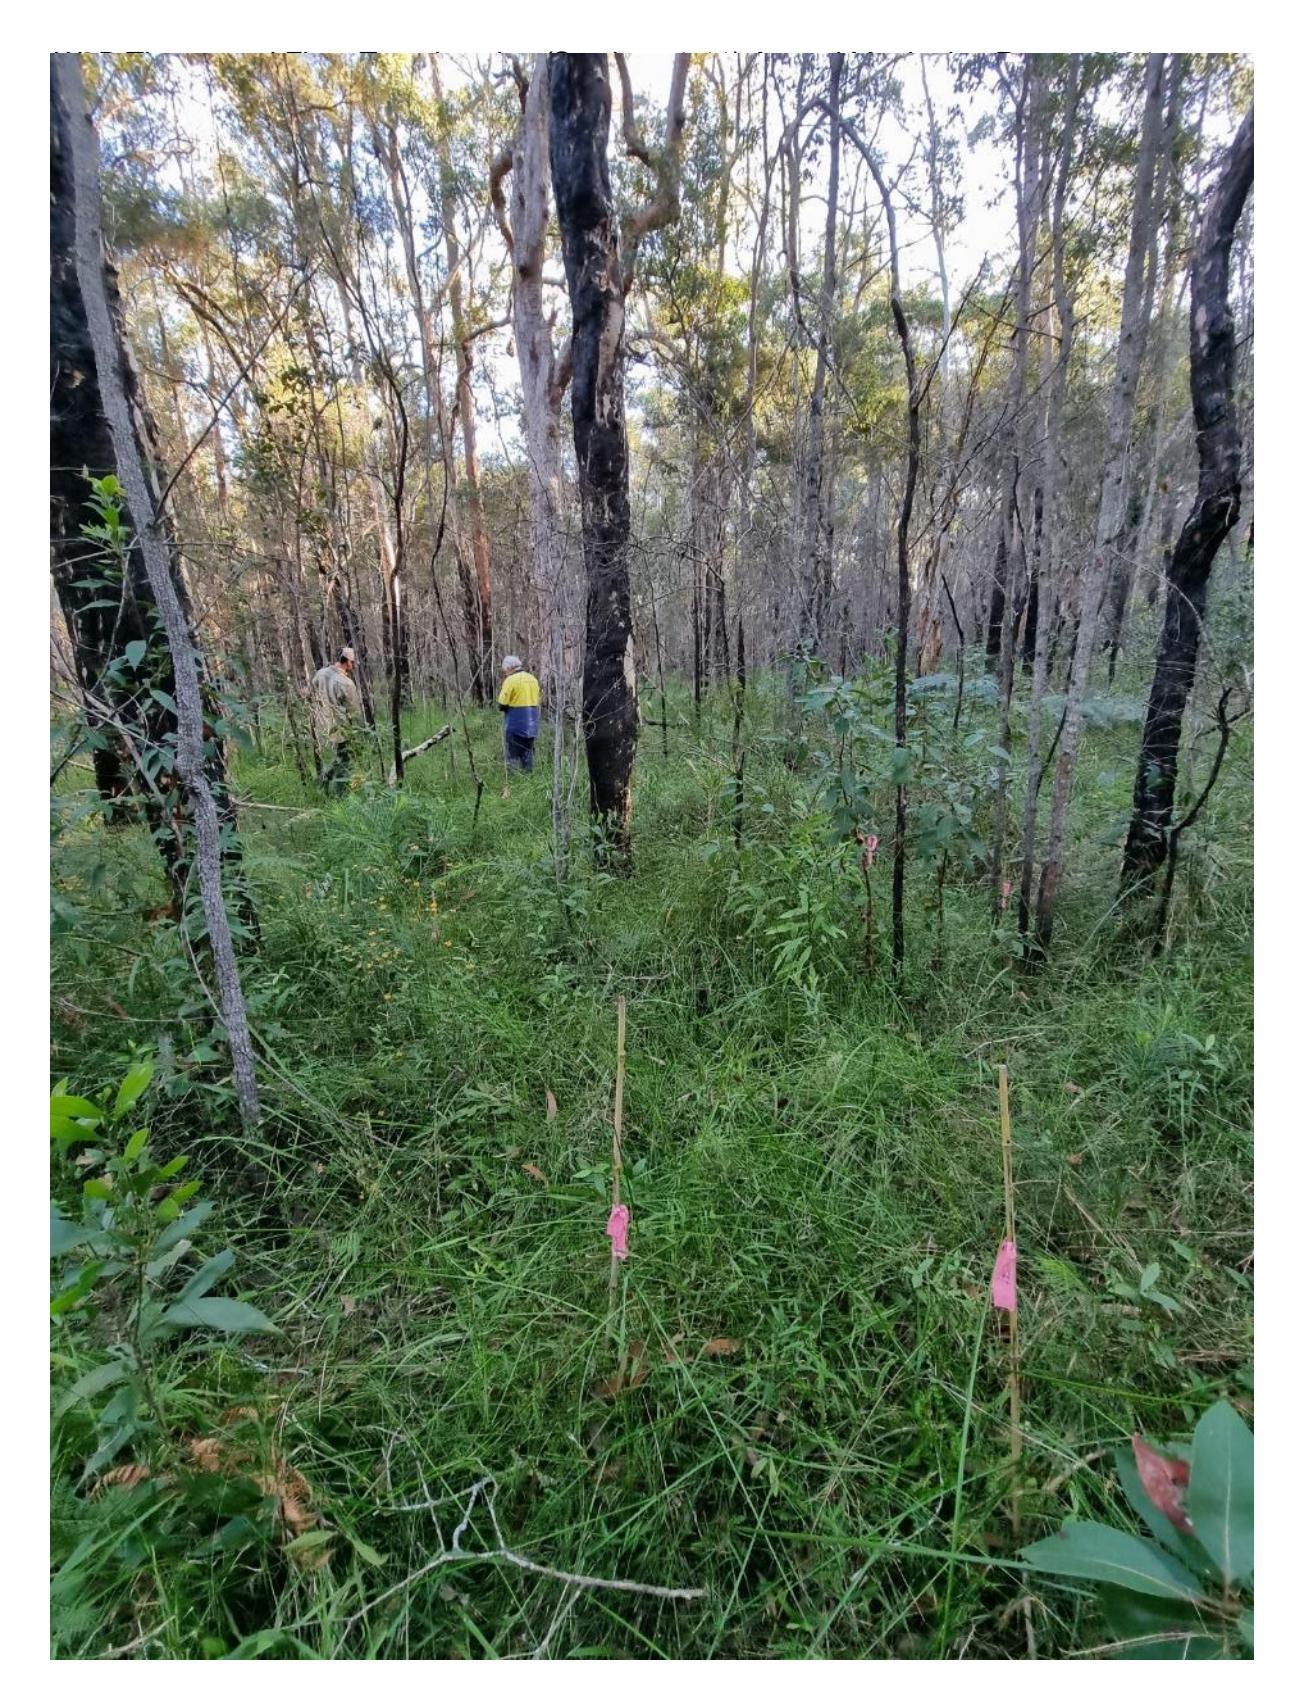
Plate 2: Stakes mark Slender Screw Fern in the Area 1 Recipient Site, Bundjalung National Park, amongst dense ground layer regrowth two years after the Nov/19 fire. Clumps of Slender Screw Fern that resprouted after the fire were re-staked and given a new identification number for monitoring. We were able to allocate clumps of fern to the Lines of introduced plants set out in 2016 and 2017 before the fire, to estimate and compare crown cover pre- and post-fire. Nov/2021

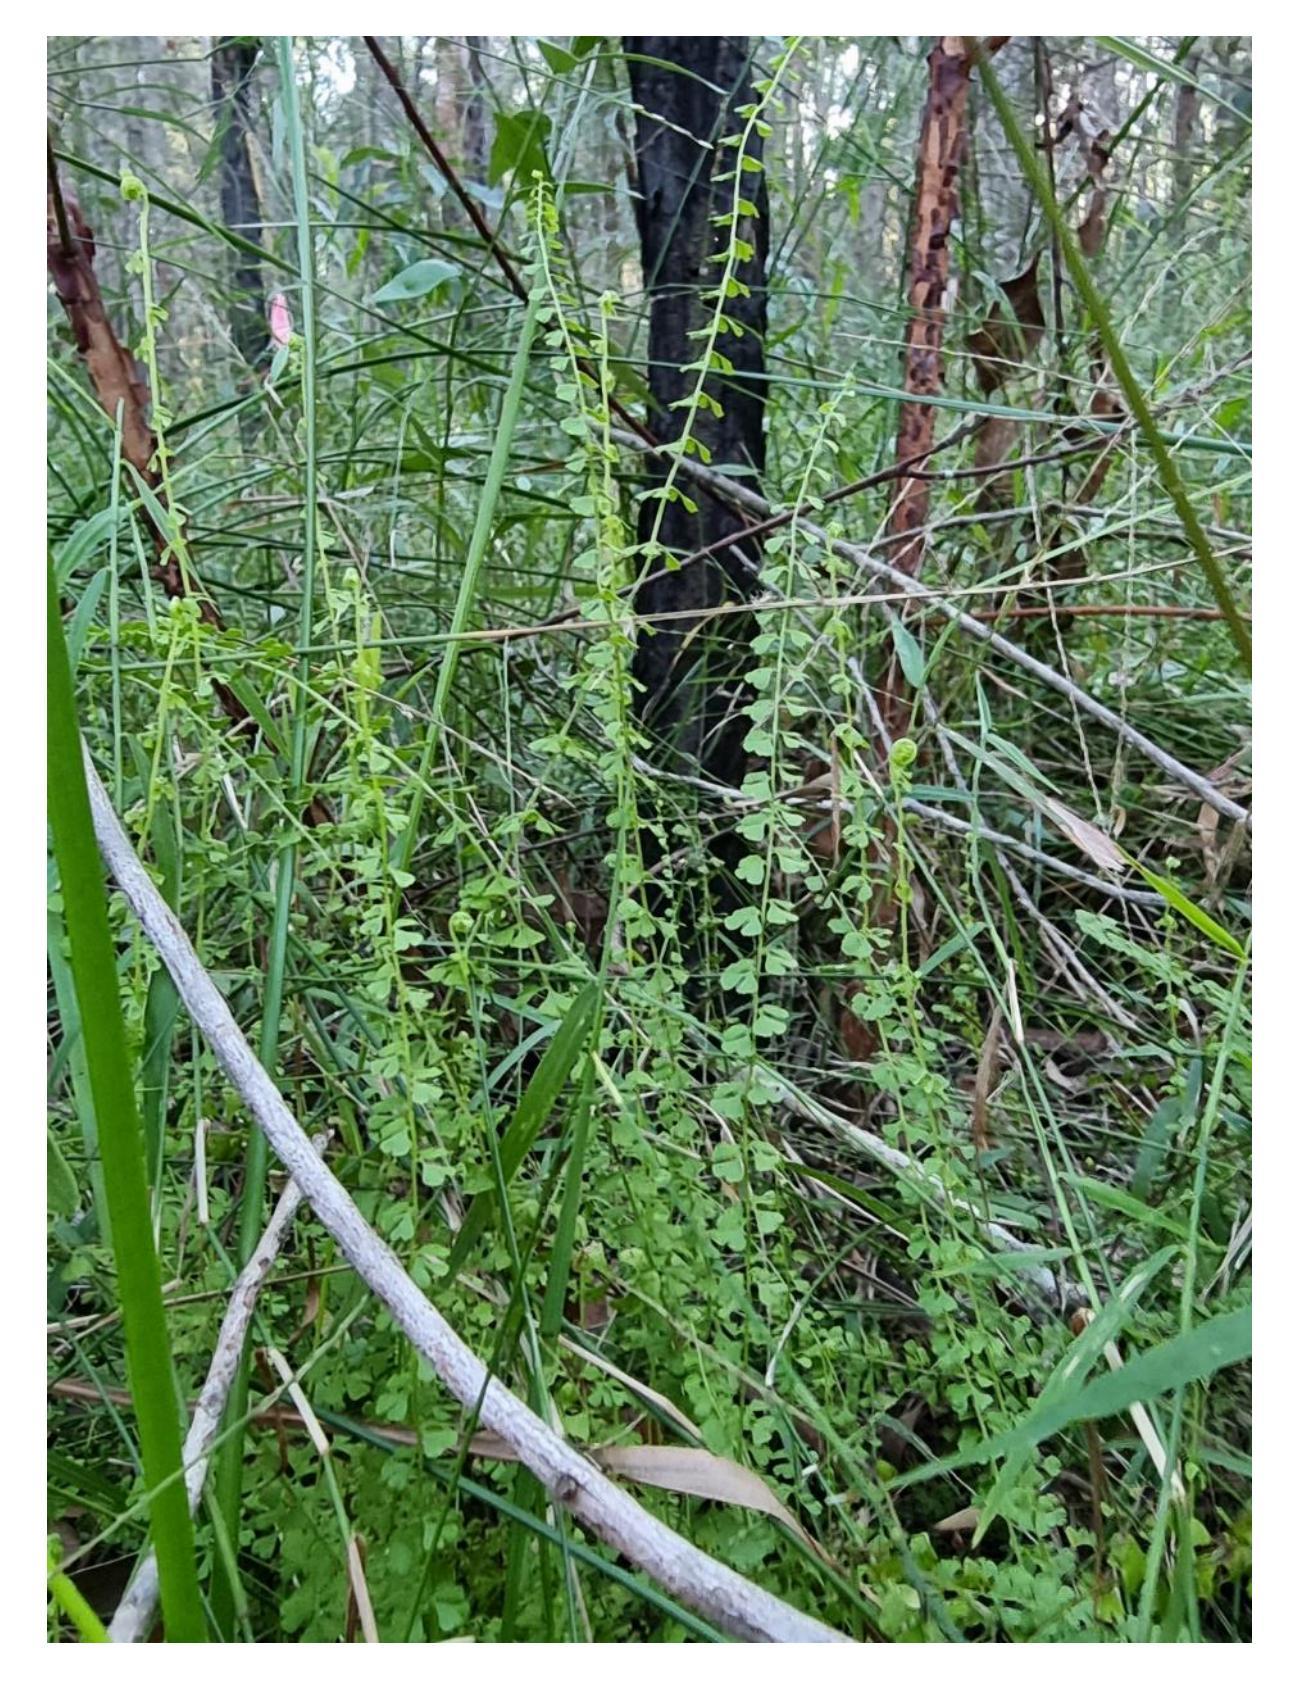
Plate 3: Slender Screw Fern in Area 2 Recipient Site, Bundjalung National Park, two years after the Nov/19 fire. Slender Screw Fern on Line A in Area 2 responded positively to fire, increasing in coverabundance two years after fire compared to pre-fire (cover 6.6% vs 13%, Table 8). Nov/2021

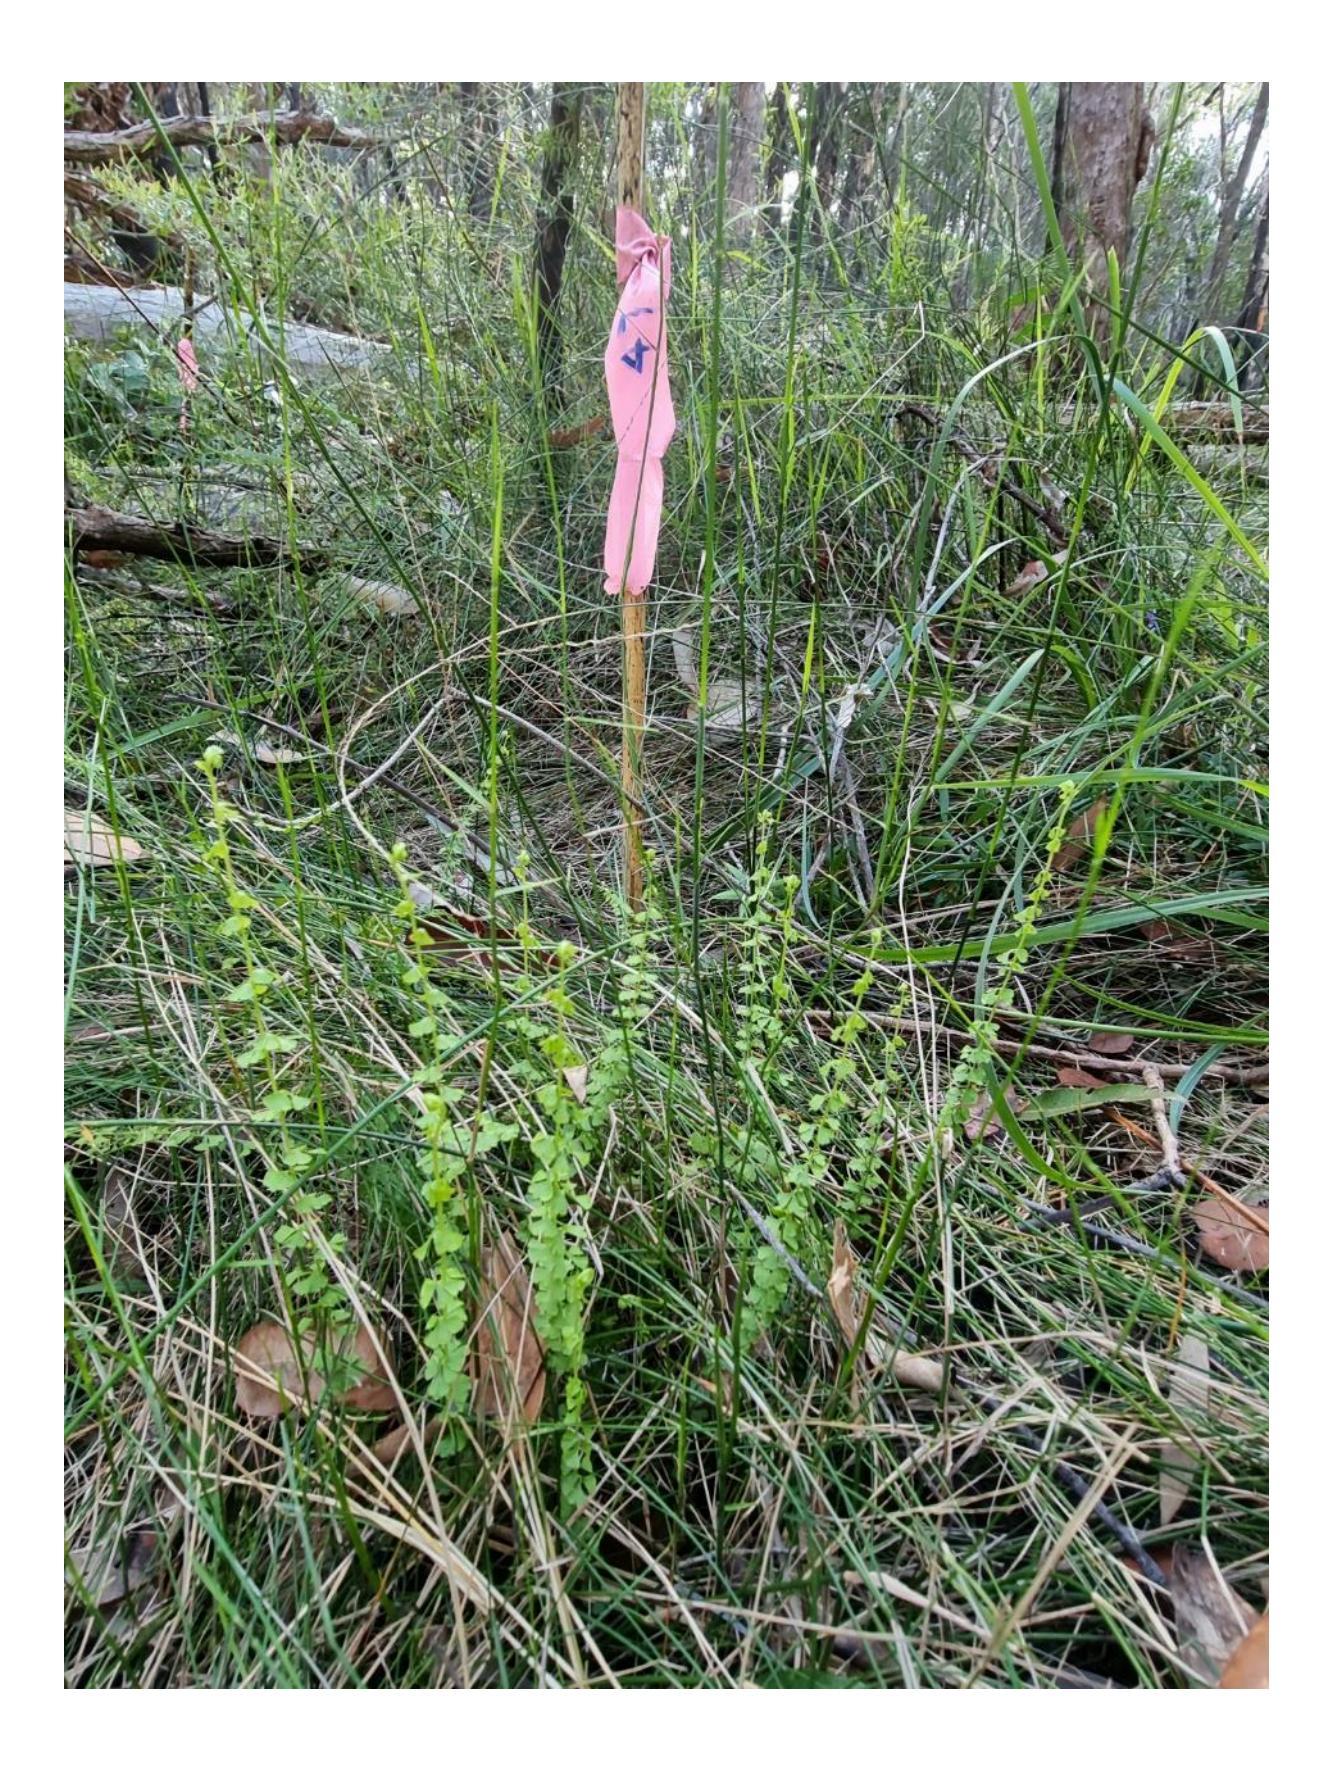
Plate 4: Slender Screw Fern in the Area 2 Recipient Site, Bundjalung National Park, two years after the Nov/19 fire. Clumps of Slender Screw Fern resprouting after the fire were re-staked and given a

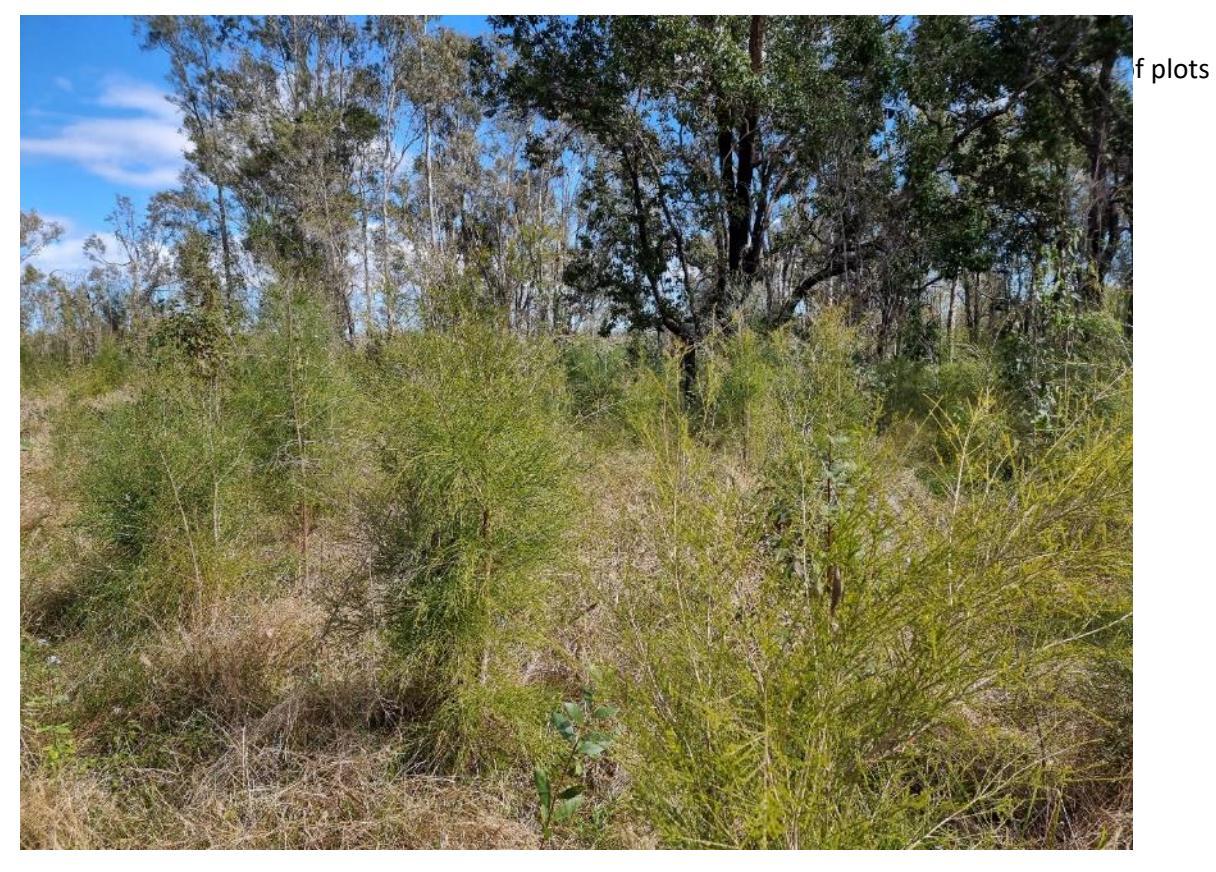
Plate 5: *Melaleuca irbyan*a saplings two years after the Nov 2021 fire. The fire killed the stem which reshot from the ground. Height in 2021 averaged about 2m or about the same height as before the fire. This is the Area 2 Receival Site on Offset land south of Tabbimoble Creek.

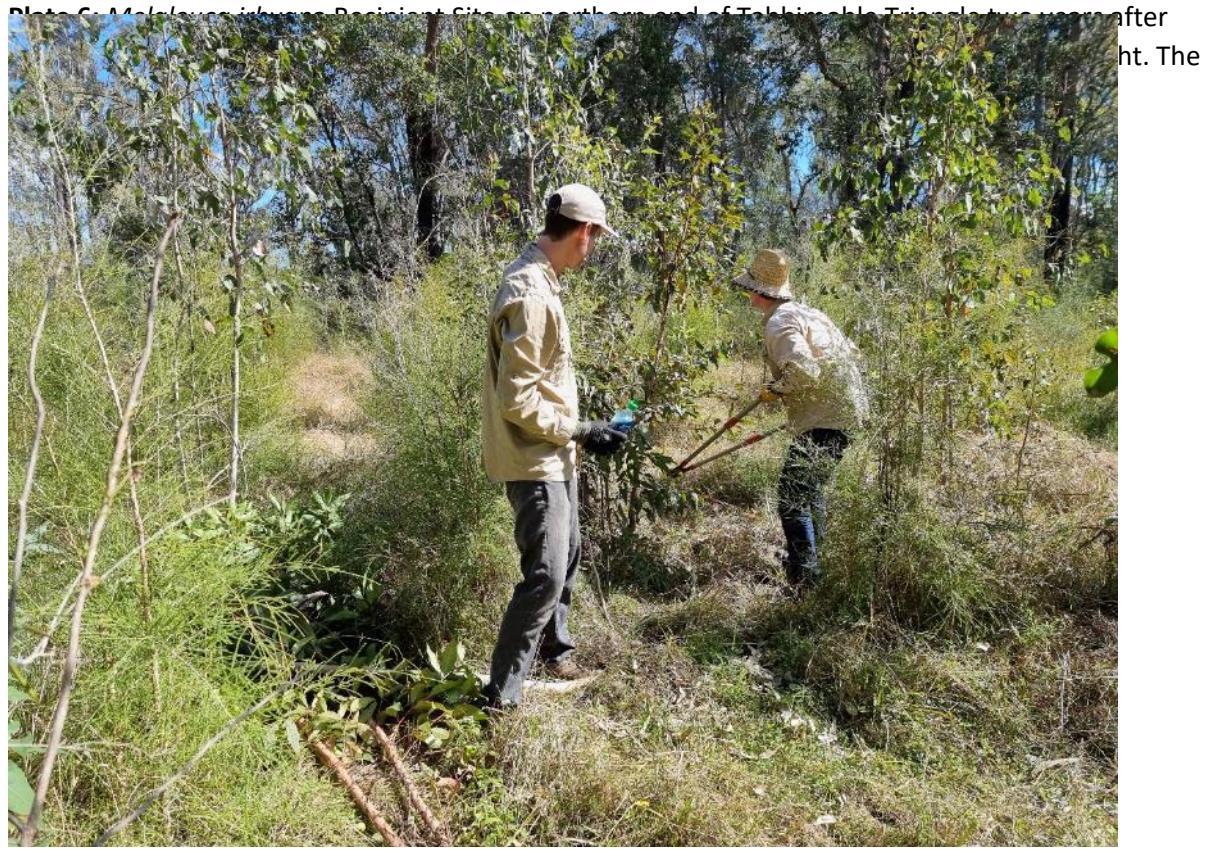
Plate 7: Lopping competing saplings of Eucalyptus and Casuarina at *Melaleuca irbya*na Recipient Site B south of Tabbimoble Creek. This was the third treatment since seedlings were planted in 2017.

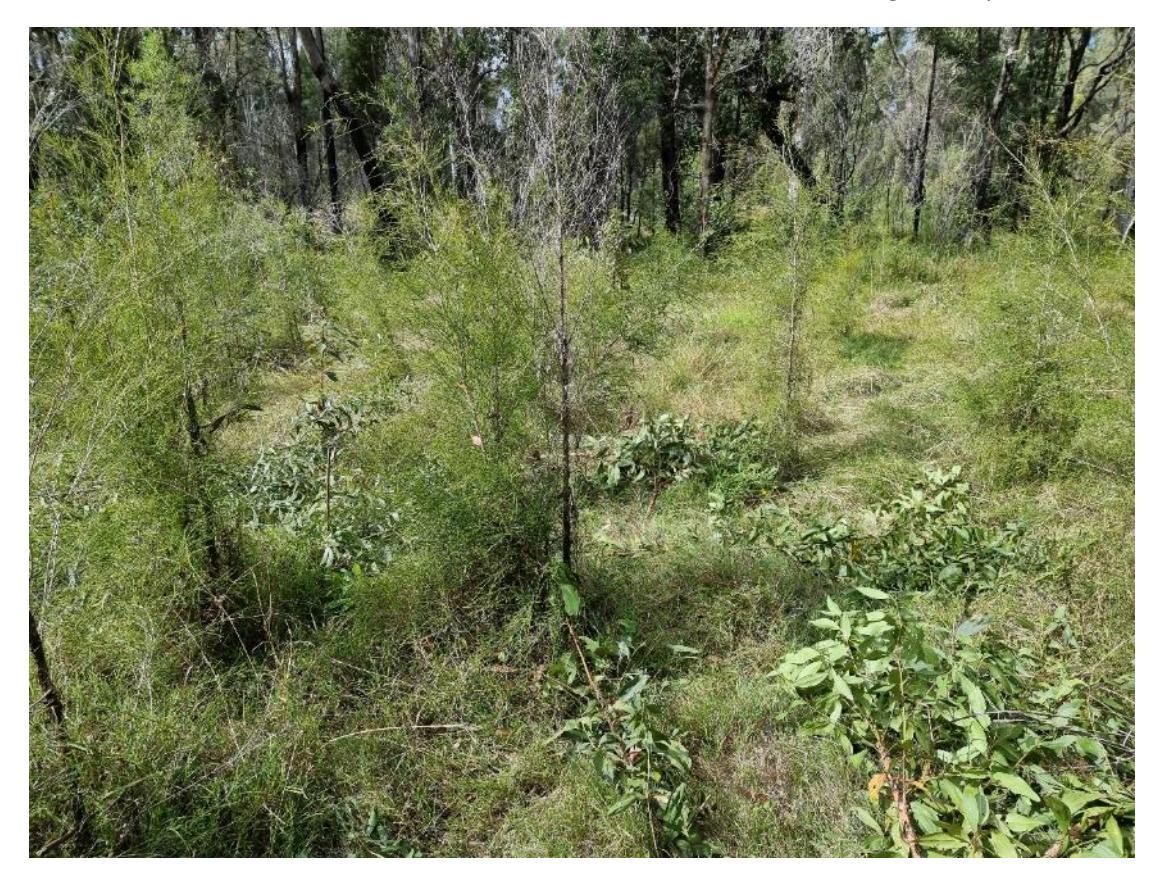
Plate 8: *Melaleuca irbyana* recipient A on offset land south of Tabbimoble creek, after lopping competing saplings (see on the ground). The dead standing stem in centre is a *M. irbya*na stem killed

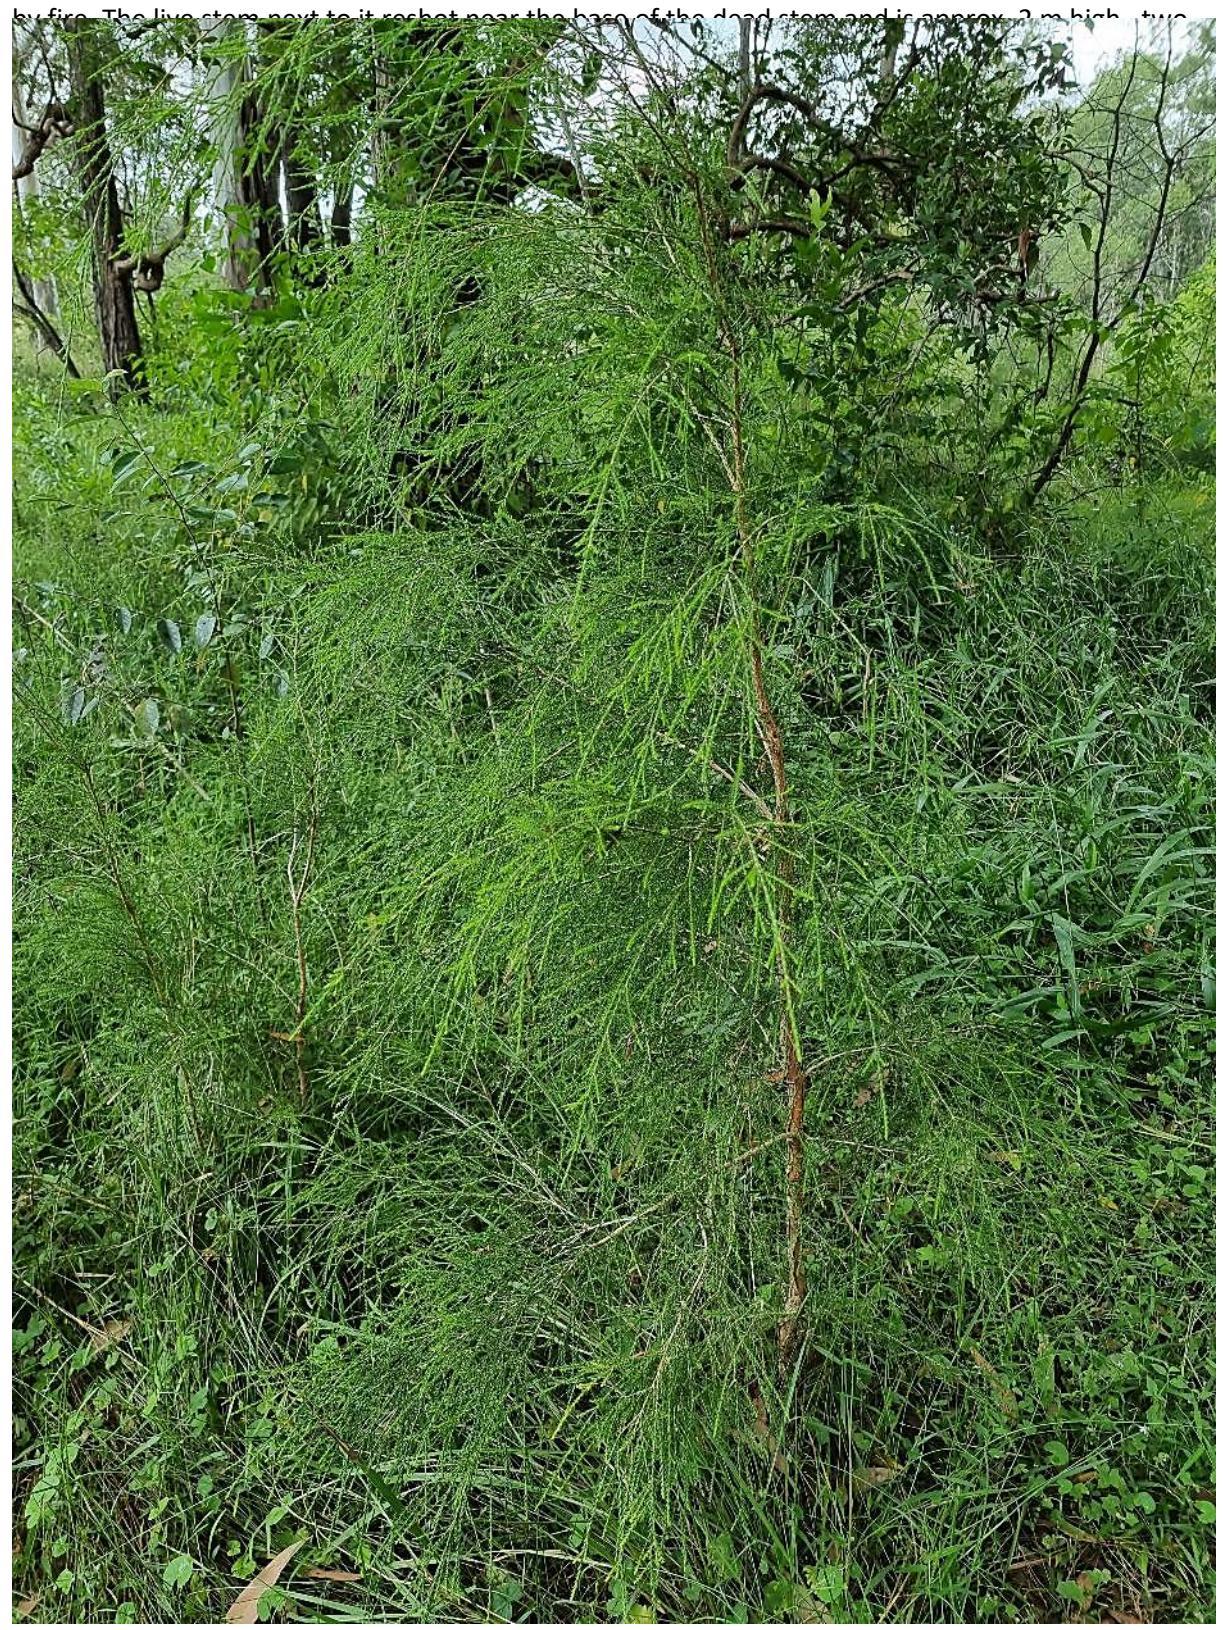
Plate 9: *Melaleuca irbyana* sapling two years after fire at the Tabbimoble Triangle recipient site. Sapling stems were killed by fire, but >90% regenerated by resprouting at ground level. Some reshot to more than their pre-fire height in two years. This species was translocated by propagating from seed collected at the rescue site at New Italy. This species is easy to propagate from seed, fast growing when planted-out and a vigorous post-fire resprouter, which begs the question, why does it
