Woolgoolga to Ballina Pacific Highway upgrade

Annual Threatened Flora Translocation Monitoring Report 2021

Woolgoolga to Ballina Threatened Flora Translocation Project

Annual Monitoring Report 2021

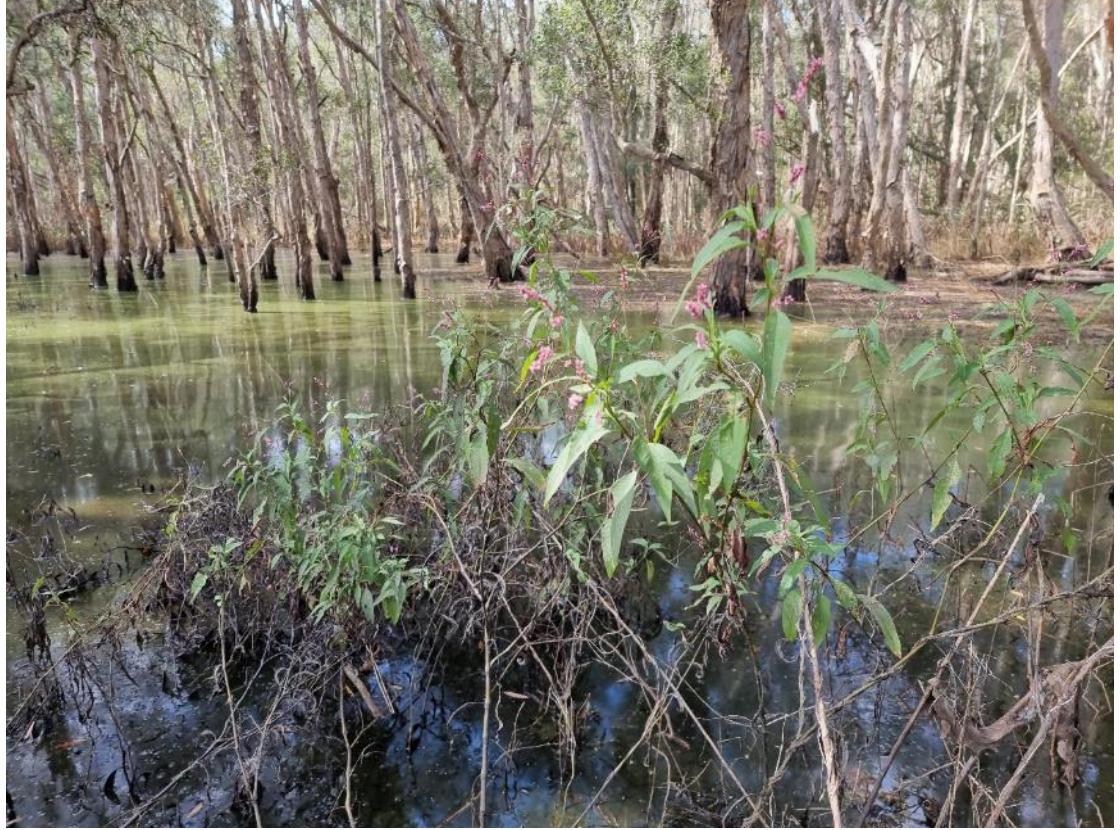
Plate 10: Tall Knotweed (*Persicaria elatior*), Yaegl Nature Reserve Recipient Site flooded in March/2022 with Tall Knotweed plants growing in standing water 0.5 m deep along the edge of the Paperbark swamp. Plants of this short-lived, annual species are nearly always in flower.

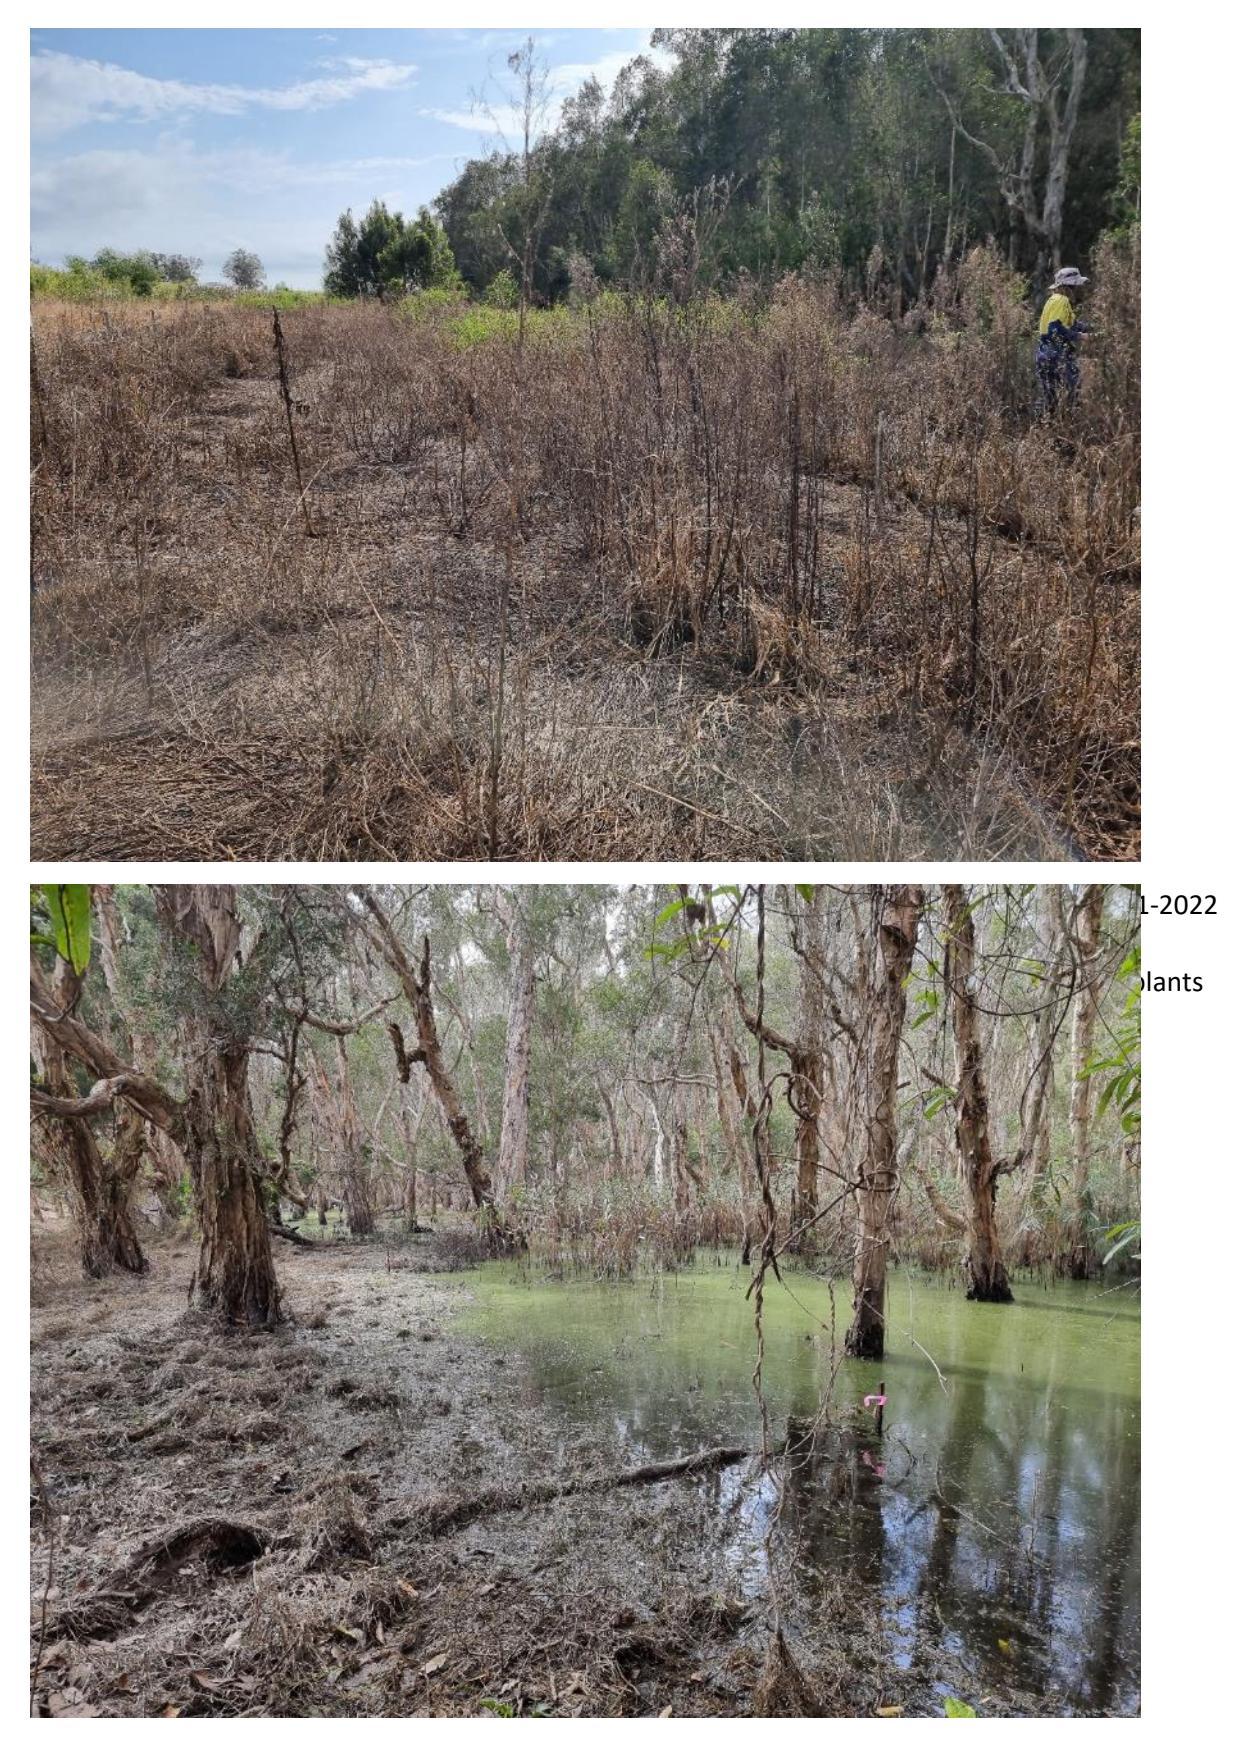
Plate 12: Yaegl Swamp Recipient Site showing effects of long flood season in summer 2021-22. Herbaceous vegetation dominated by the exotic *Paspalum conjugatum* is dead and bare ground should encourage Tall Knotweed recruitment from seed. A plot stake can be seen with pink tape.

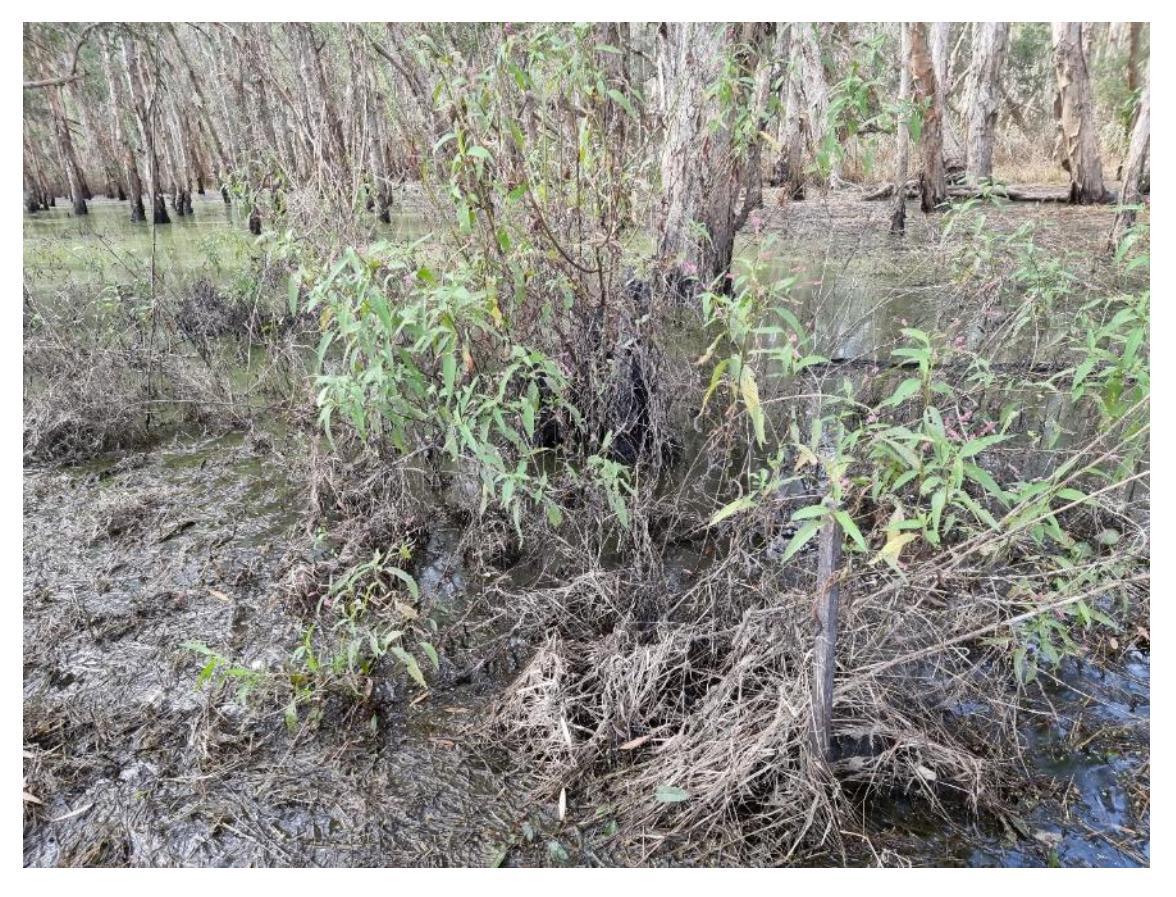
Plate 13: Tall Knotweed in plot – see stake – these plants had leaves above the water level so were not killed (see Plate 14). Pink flowers can be seen

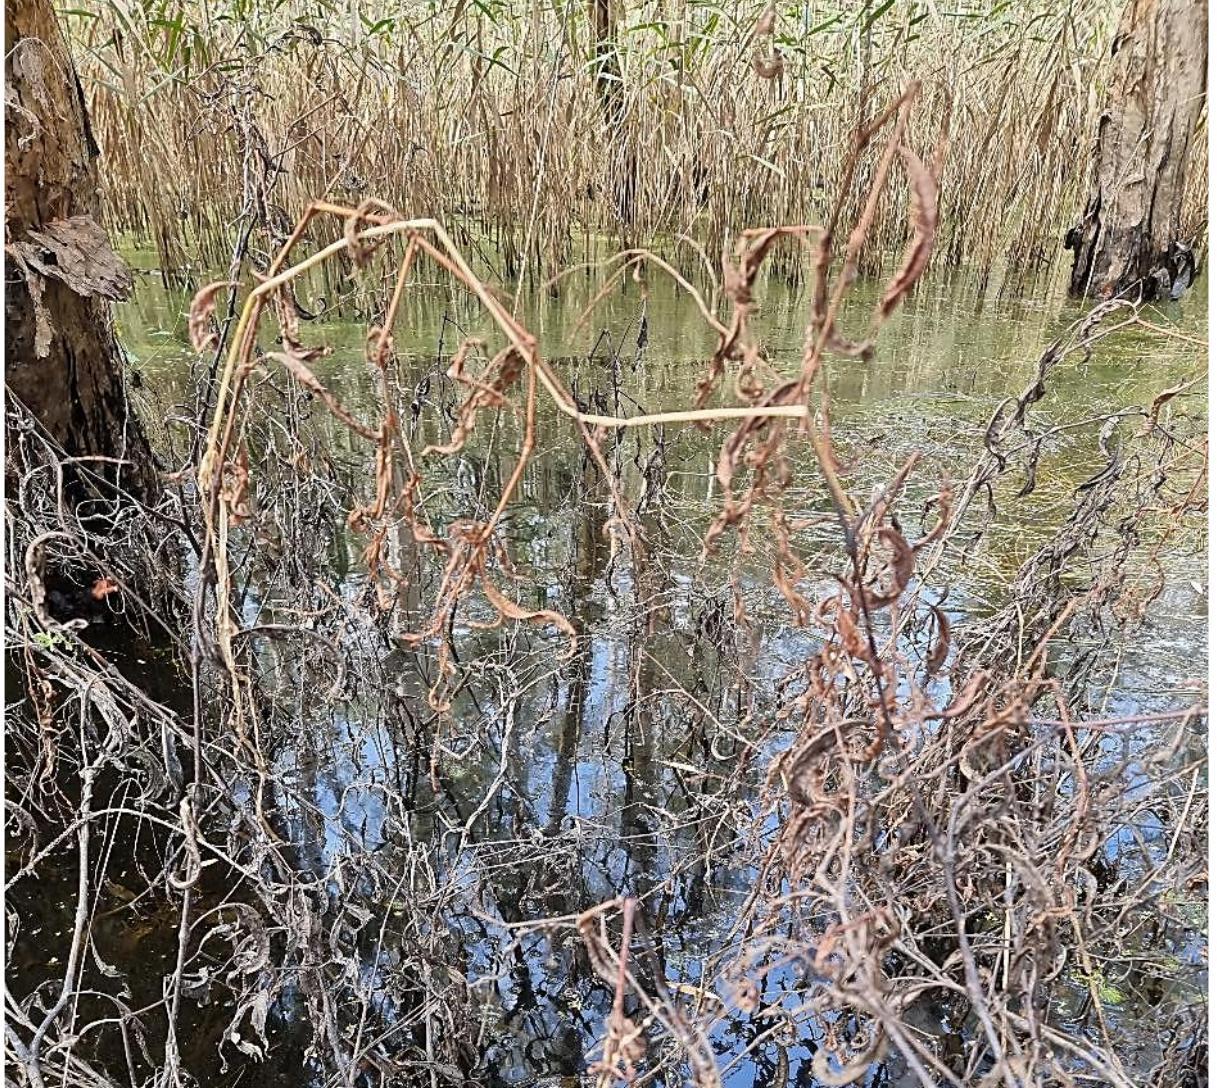
Plate 14: A dead Tall Knotweed plant identified from the swollen nodes along the main stem and dead leaves with glandular hairs (hand lens needed). If fully submerged, Tall Knotweed dies, but if

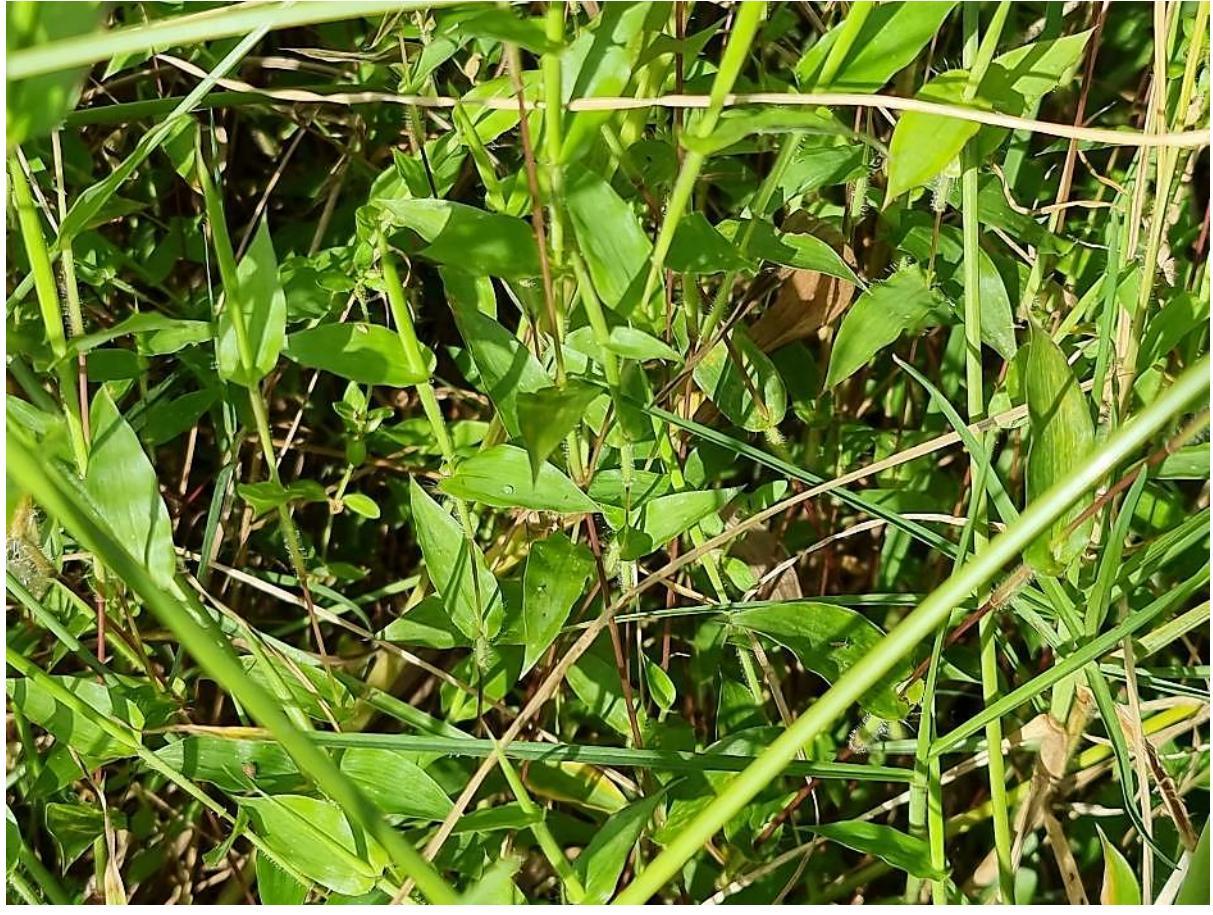
Plate 15: Hairy Joint Grass clump at Lumleys Lane, Section 10, growing in large, cleared paddock.

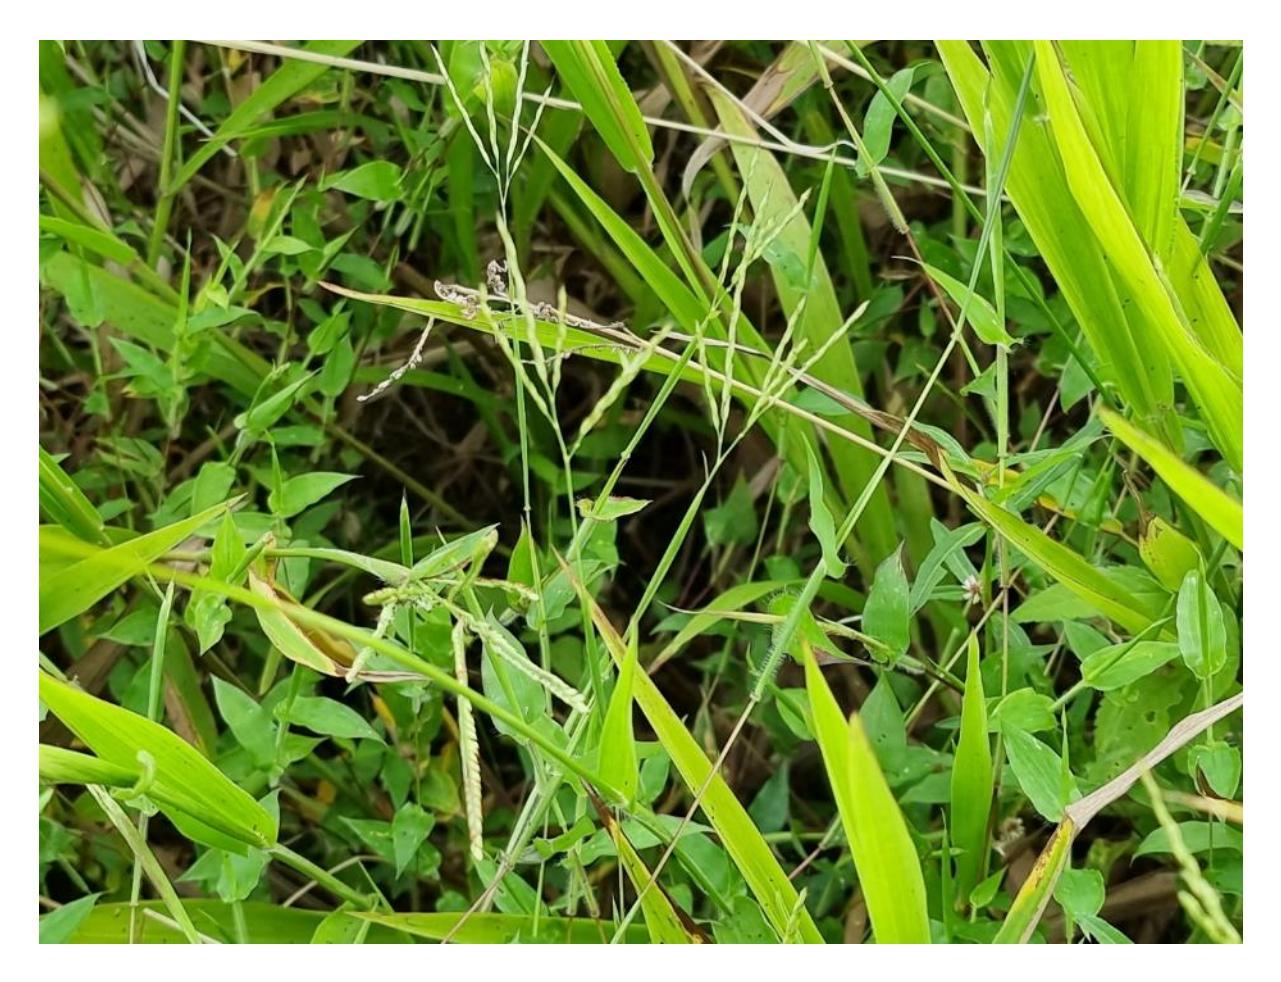
Plate 16: Hairy Joint Grass (grass with short leaf blades) in flower at Lumleys Lane Recipient Site

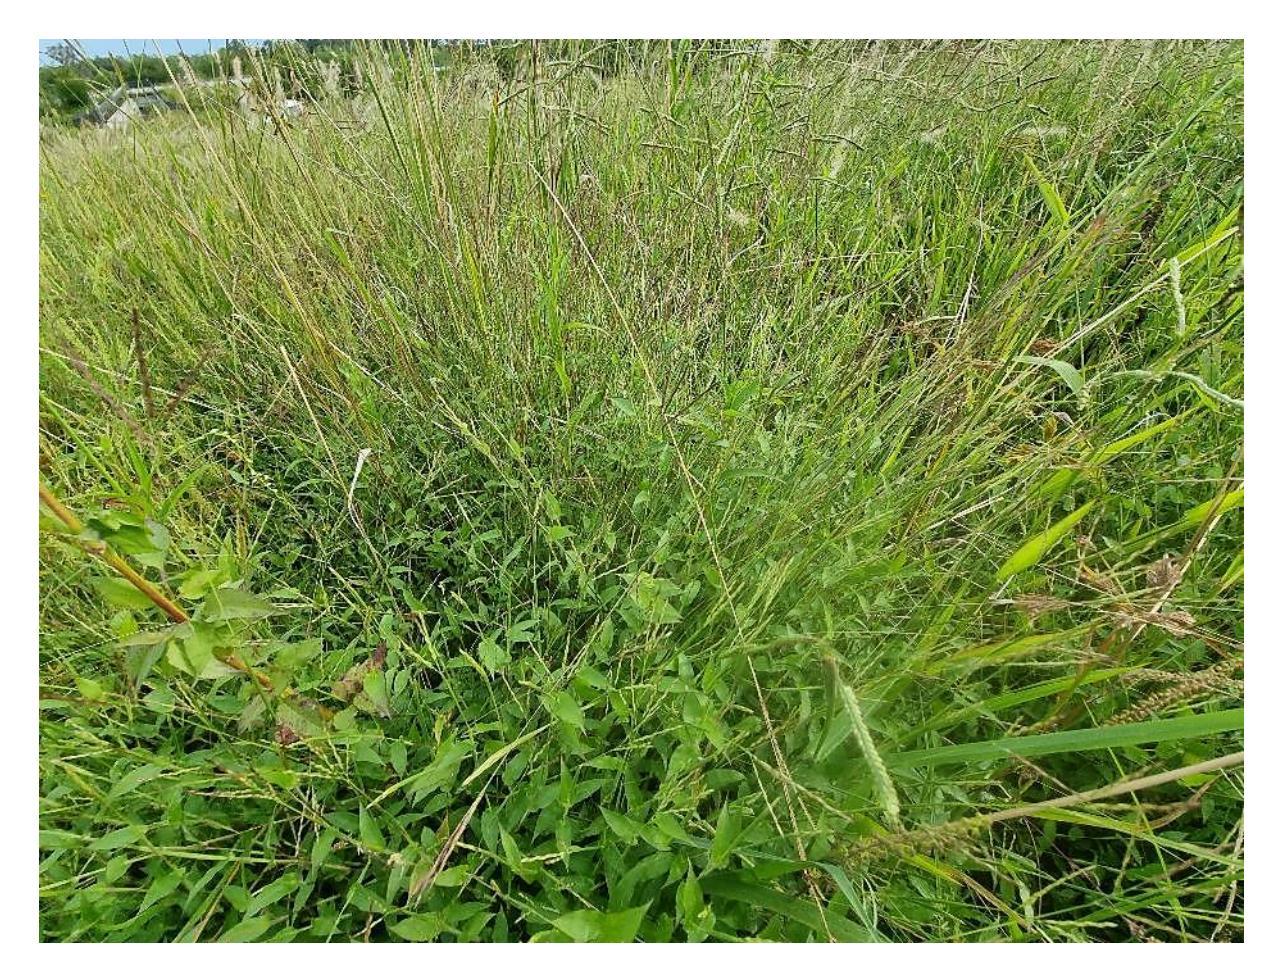
Plate 17: In Situ Hairy Joint Grass (grass with short leaf blades) in flower at Lumleys Lane, growing in a large, ungrazed paddock. No cows have been in the paddock for about 5 years, since construction of the project started in 2015-6. A very large population of HJG was present in the paddock when the cows were taken off, as non-intensive grazing usually promotes HJG by keeping pasture relatively low with plenty of gaps where annual recruitment can occur. HJG cover decreased after the cows removed but annual slashing reduced biomass enough for HJG to persist as a smaller population. Recently it appears to have increased again due to maintenance slashing around some eucalypts planted in the lower part of the Lumleys Lane paddock (BOS 22).

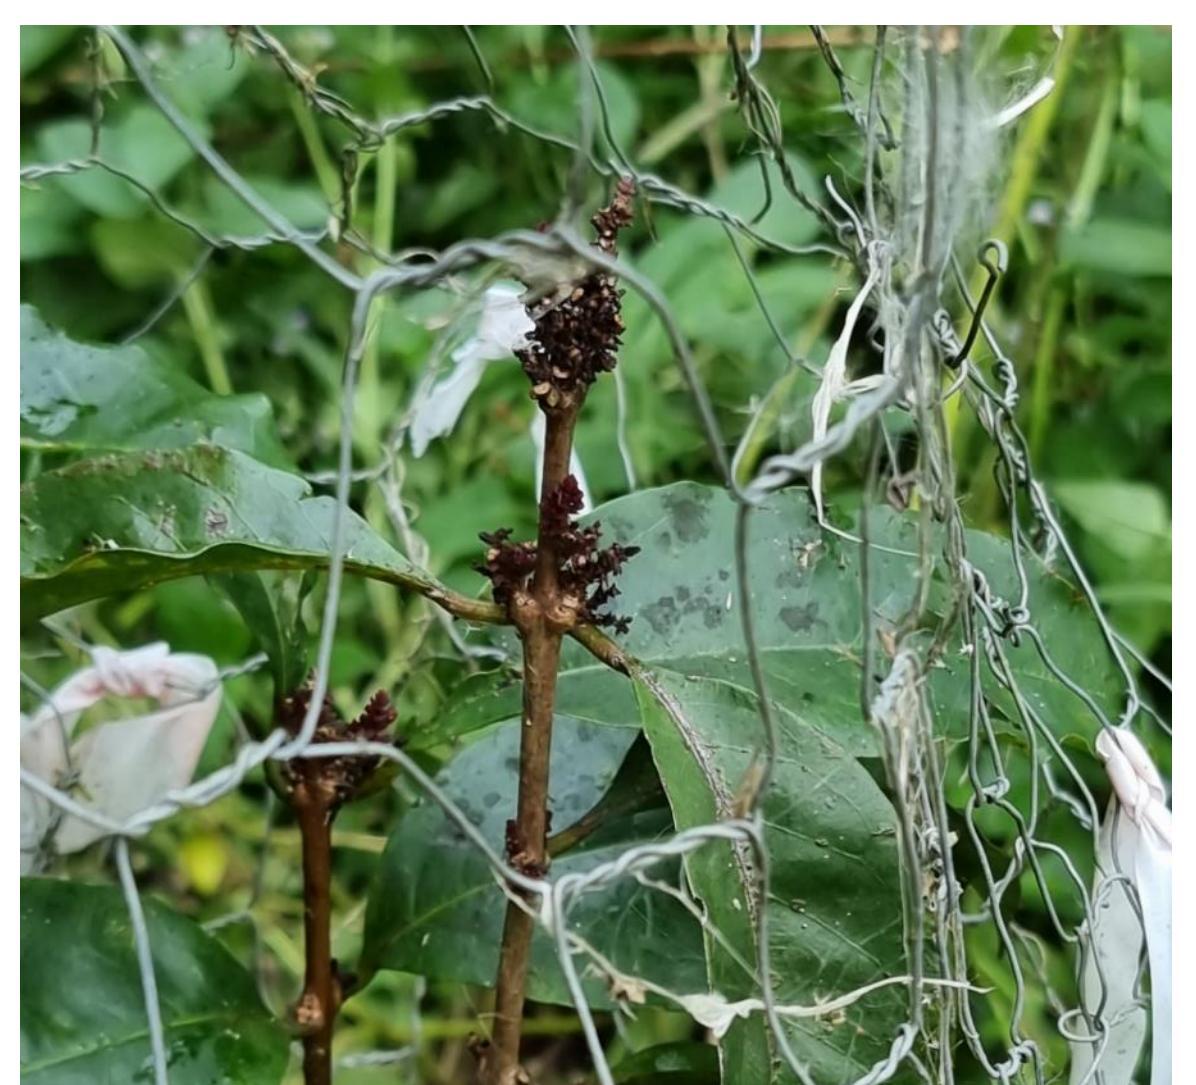
Plate 18: Red Lilly Pilly in wire cage to prevent wallaby grazing at the Lumleys Lane rainforest species recipient site. This species had a much higher survival rate at the latter site compared to the Coolgardie Rd rainforest species recipient site, probably because of differences in soil texture and drainage, as geology, landform and maintenance regimes were similar at both sites. Growing tips are infected with red tip (turned dark brown at this site) and leaves are unhealthy. Although survival rate was relatively high after five years, only one or two plants were reasonably healthy. Mar/2022.

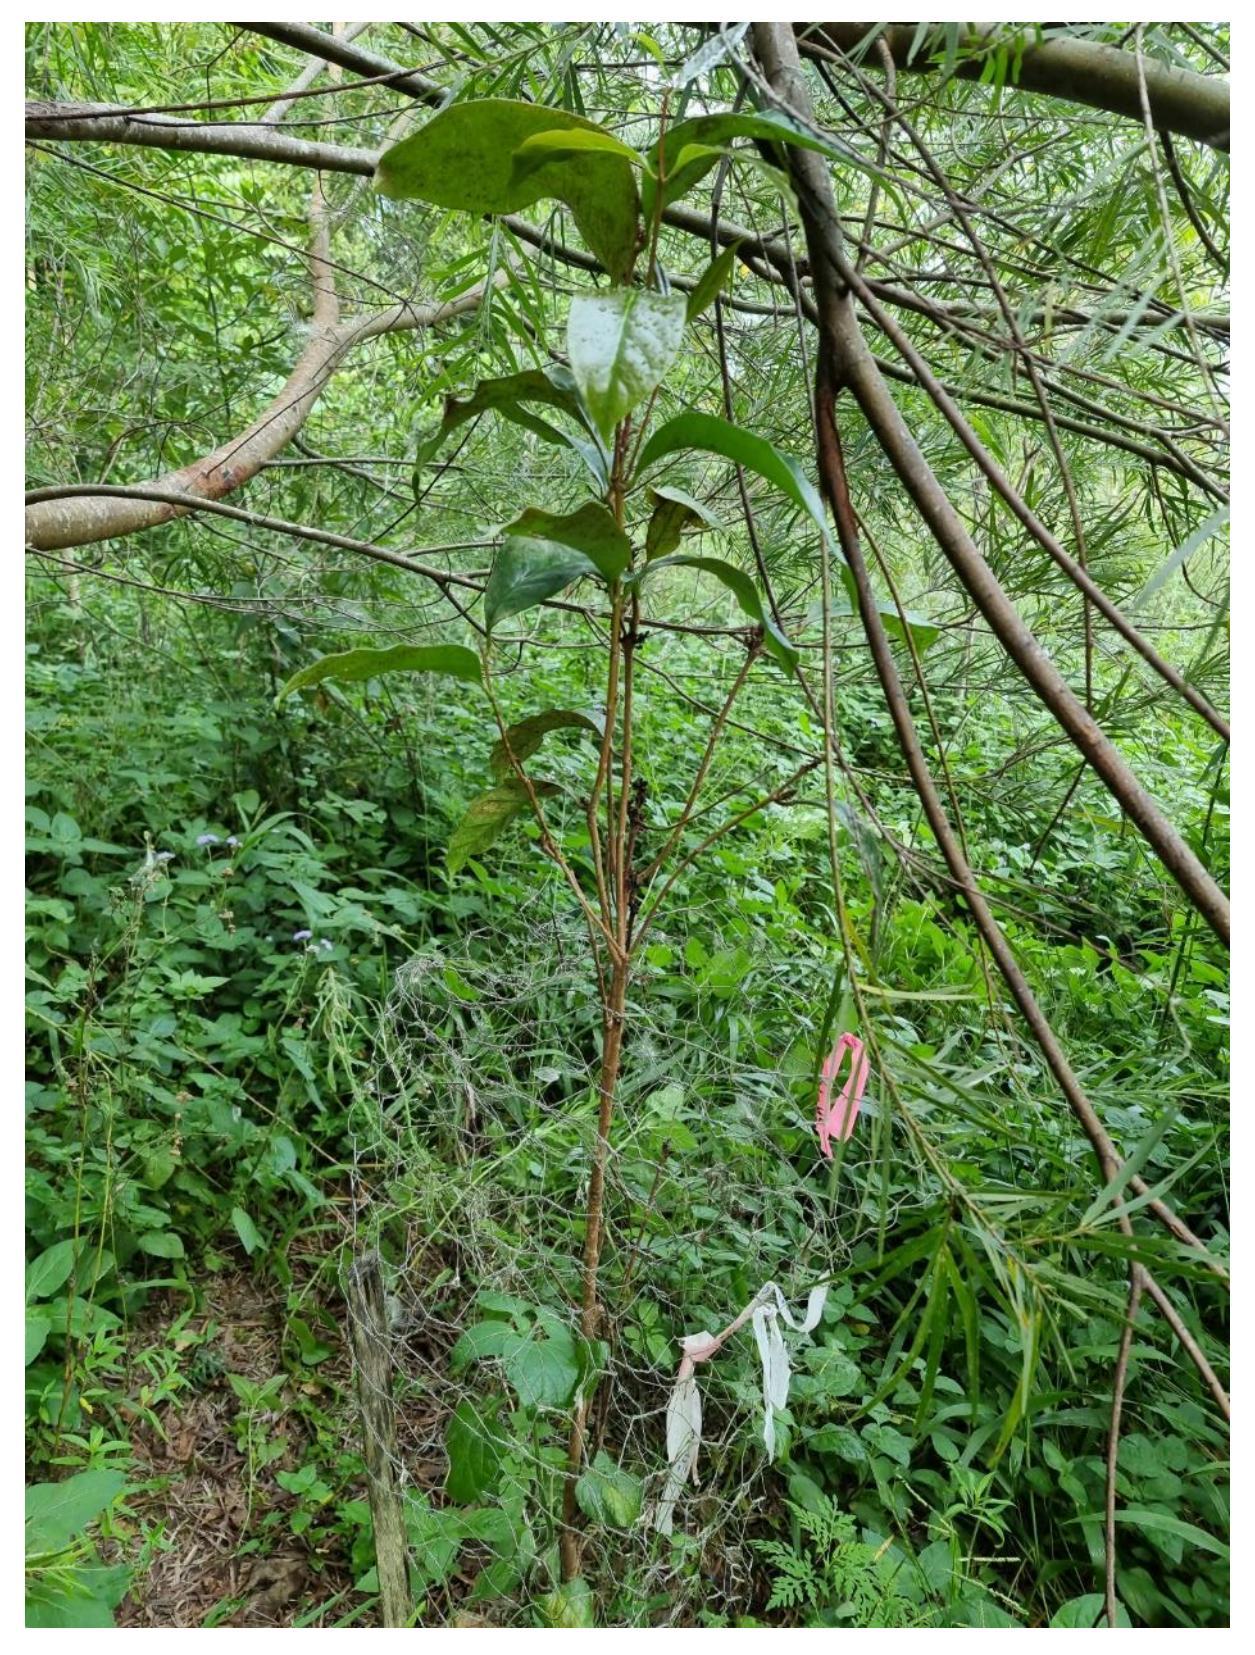
Plate 19: Red Lilly Pilly at Lumleys Lane recipient site. This leggy plant is about 1.4 m high after 5 years but has few leaves. It looks healthy enough and may survive and grow on into a mature tree, a first for translocation of this species in my experience.

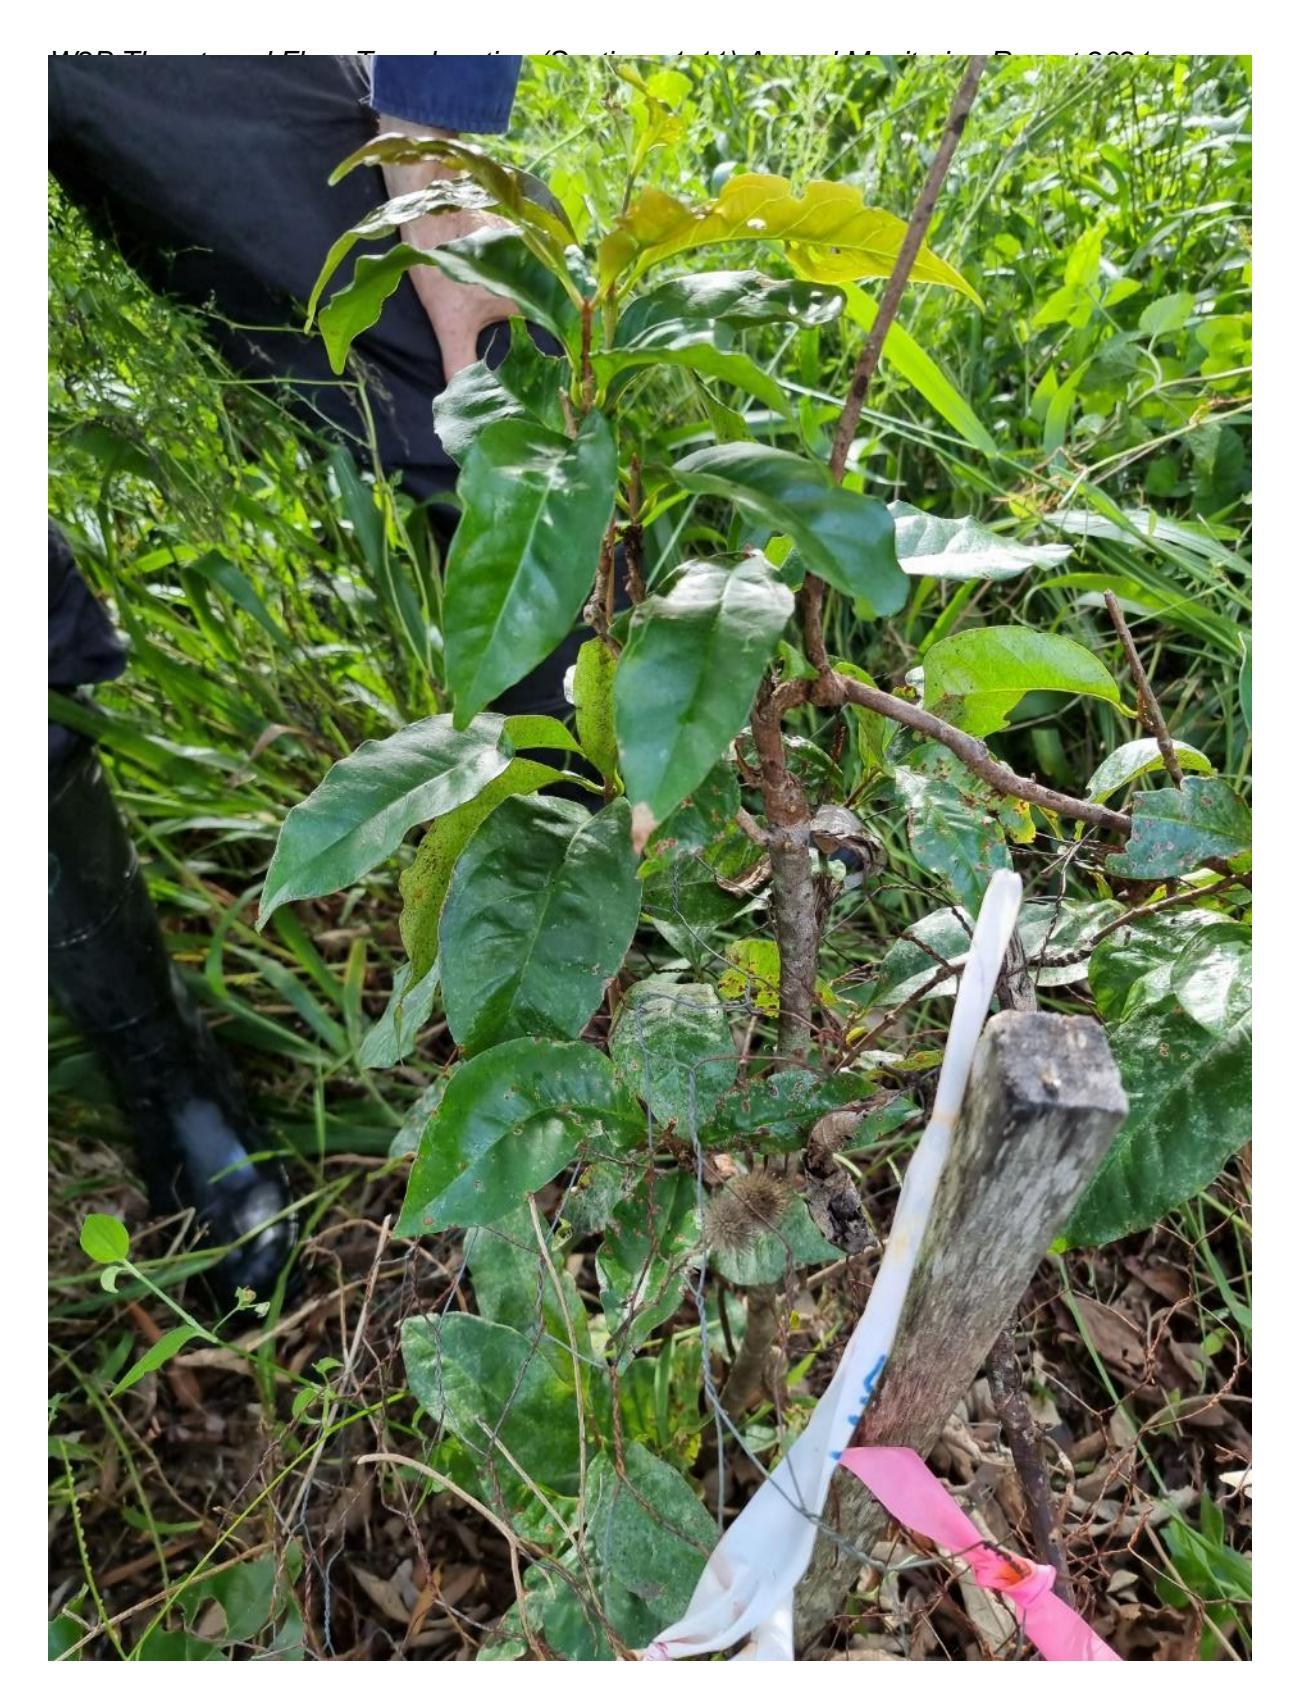
Plate 20: Red Lilly Pilly at Lumleys Lane recipient site. This plant (no. 10) is the healthiest of 13 at the site and about 1 m high. The new leaves are healthy in contrast to leaves lower down. New leaves have grown out of the top of the red tip 'cap', which was left in place rather than picking it off. This growth that looks like a disease may actually provide a protective shield against insects. Picking it off removes apical buds as well, so no new leaf is produced, and plant condition declines.

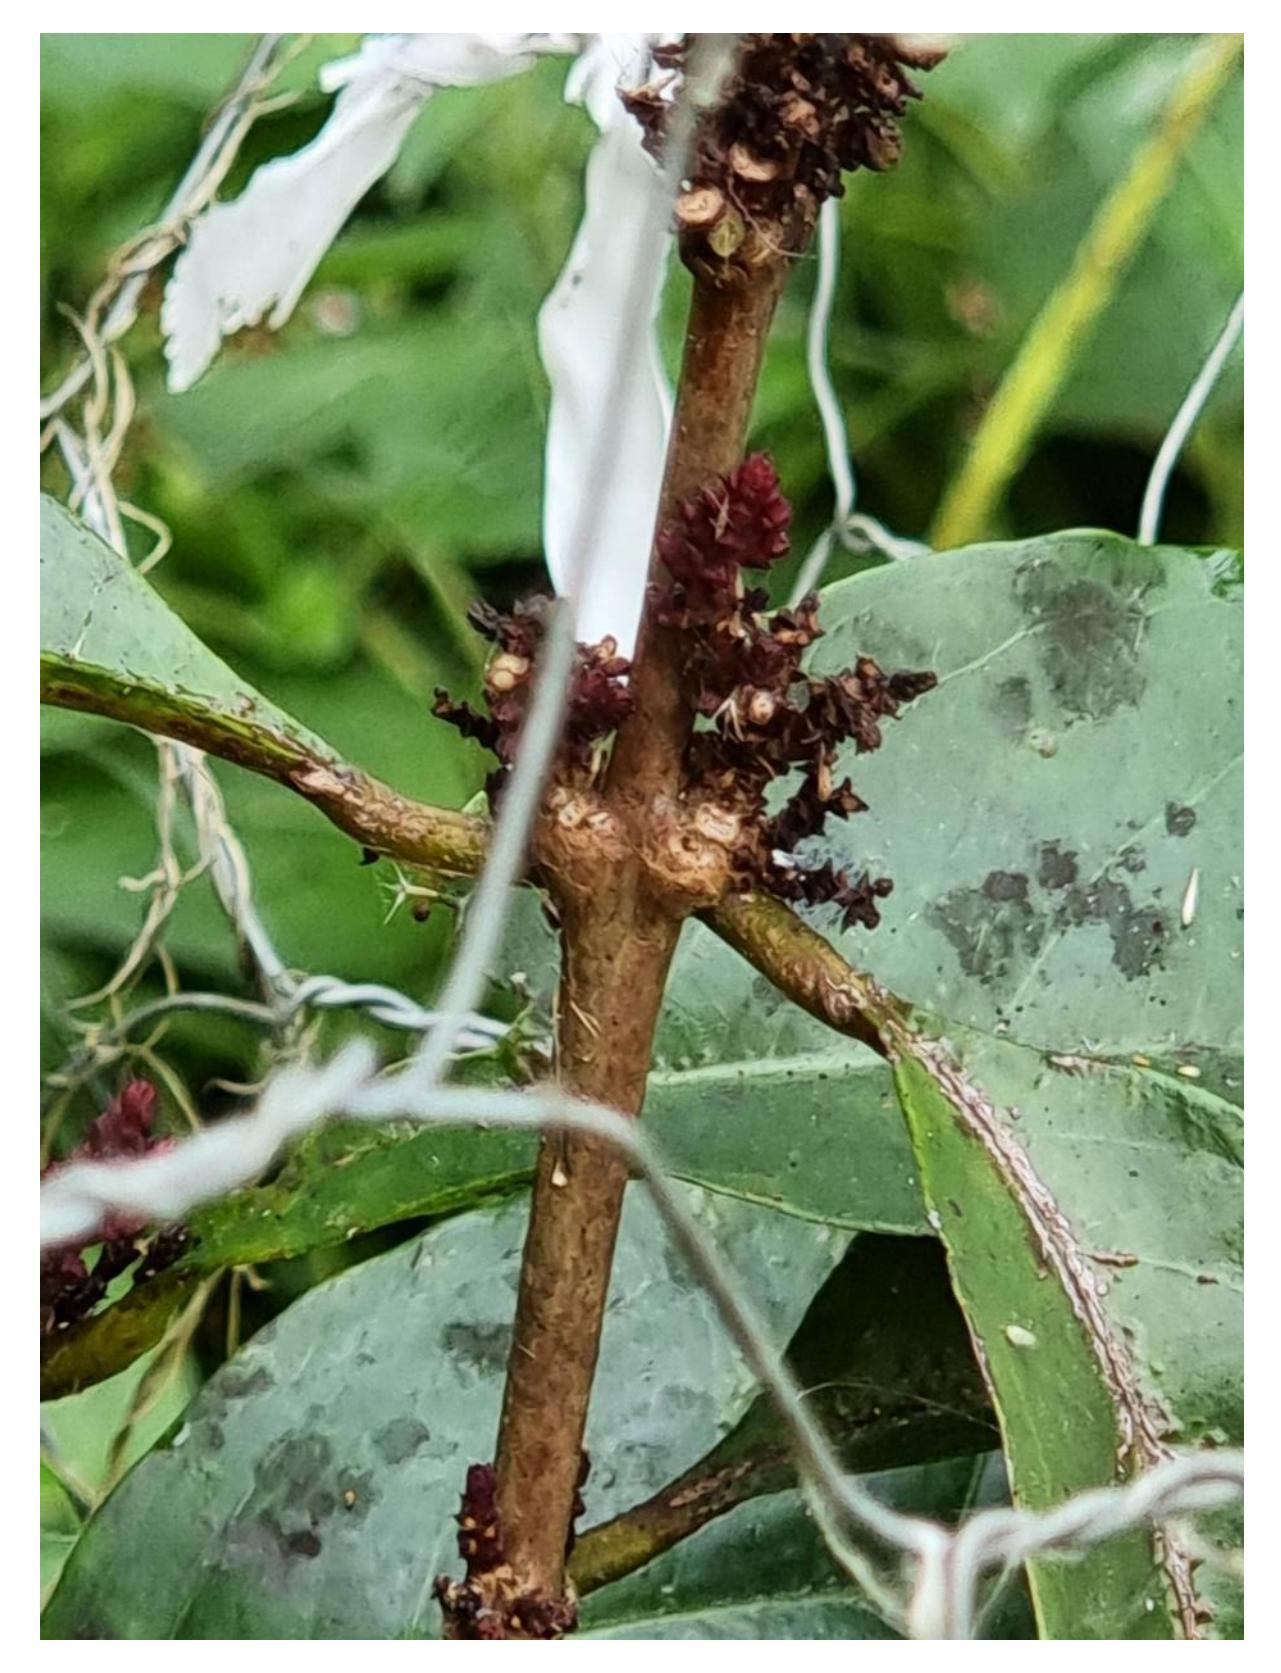
Plate 21: Close up of red tip 'disease' on Red Lilly Pilly. Several infected shoots can be seen in one leaf axil and scars where previous red tip shoots were picked off during maintenance. They are brittle and easily break off. New shoots grew from below the break and a new hardened red tip formed. The red tip appears to require several months or a year before leaves are produced out of the top of the hardened cap. The poor condition of old leaves, possibly 3 or 4 years old can be seen.

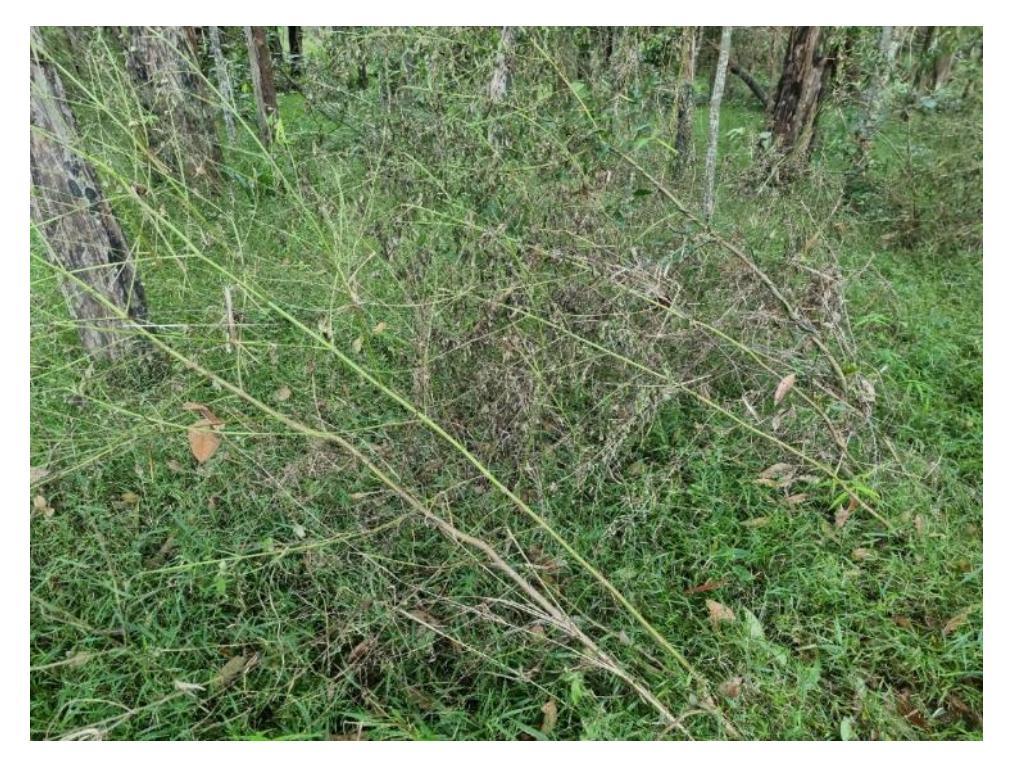
Plate 22: Singleton Mint Bush (SMB) at the recipient site in Tabbimoble Triangle. These translocated plants over 2 m high have been pushed over by a recent flash flood. They survive flood and produce new vertical shoots. The grey leaves are dead and green stems still alive, and can reshot. Most SMB plants at the recipient site were in similar condition, in contrast to the reference site (Plates 25&26).

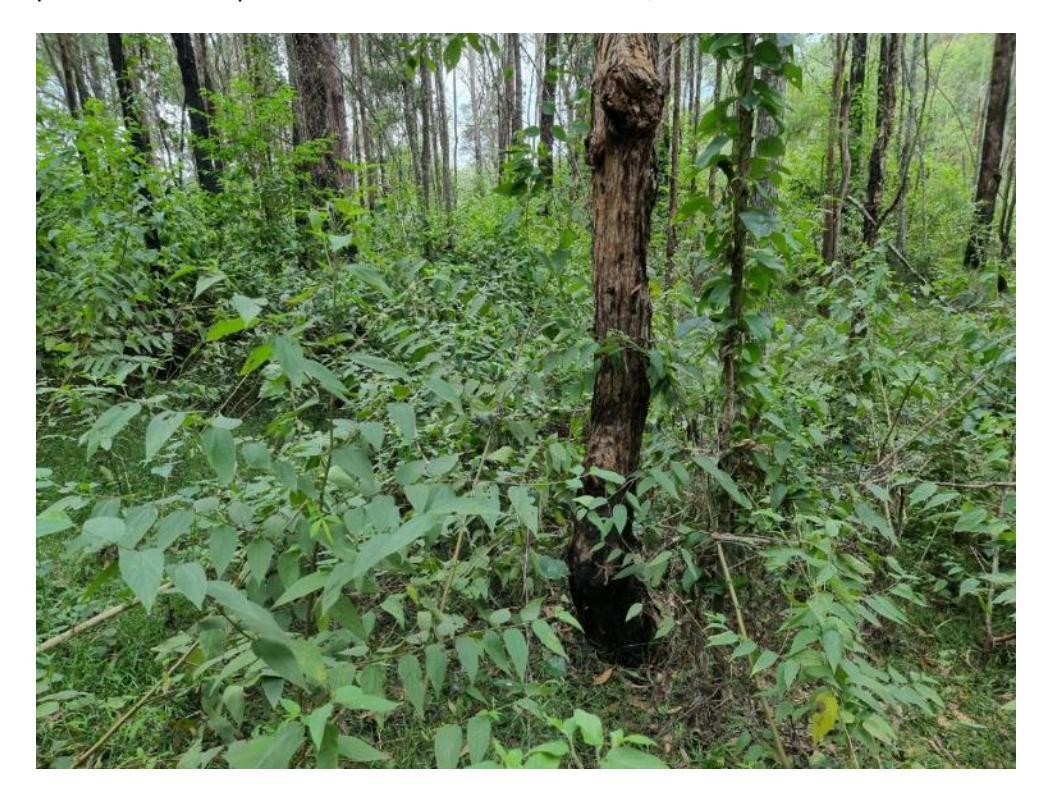
Plate 23: SMB recipient site where Transect C of the experimental plantings is located, showing dense post-fire regrowth dominated by Trema tomentosa. A few SMB survived in these plots by resprouting and the few seedlings that germinated after the fire were dead after two years. The translocated population contracted to the creek levee where soil is sandier. March/2022.

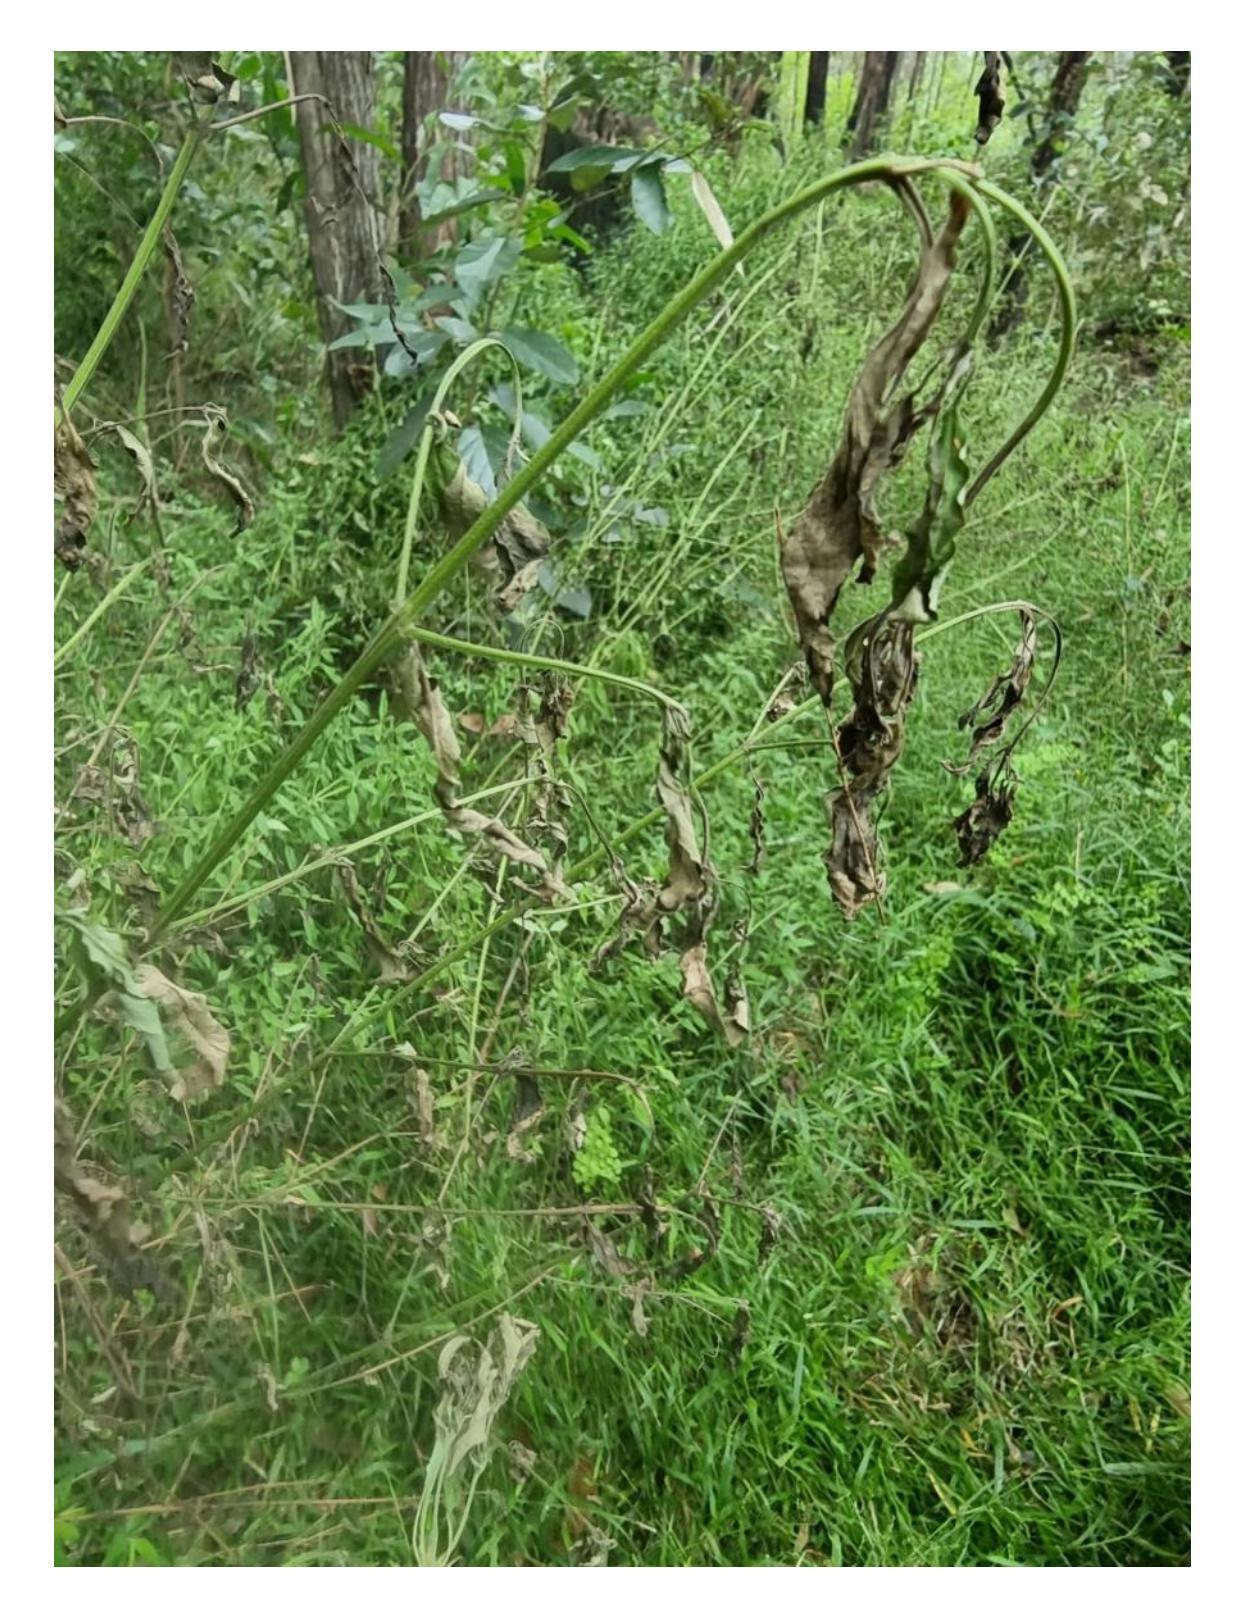
Plate 24: A SMB plant affected by 'grey wilt' after a recent flash flood and period of saturated soil, during the long rainy season of summer-autumn 2021/2022. This condition appears to be related to the disease that killed young seedlings during the first translocation attempt in 2017. The stem has wilted as well as the leaves, which indicates the root system is not taking up water to maintain cell tugor which keeps stems rigid. This may be caused by the soil pathogen *Phytophthora cinnamomii* infecting root hairs and should be flagged for further research, as it could reveal how plants are able to develop resistance to this devastating disease, as appears to happen with SMB. March/2022.

SMB plants have been affected by an apparent disease during translocation that causes foliage and growing tips to wilt (see Plate 24), and death of young seedlings. These symptoms were common in seedlings introduced in autumn 2017, then again after floods in summer 2021/2022, but this time in older plants, up to 2 m high. Some 50-75% of SMB plants in the recipient site were affected in March/2022, and only a small number in the reference area (<5%). The condition was defoliating rather than killing older plants, as stems were still green and likely to resprout.

The wilt symptoms occurred in the wet season during periods of high rainfall and soil saturation, so are different from wilting caused by drought, which is common in SMB in the dry season. The leaves of SMB are soft and wilt easily during hot, dry weather, plants often defoliating to conserve moisture. The wet season wilt symptoms may be caused by *Phytophthora*, a microscopic water mould that infects via root hairs. *P. cinnamomi* is reported to be indigenous to wet forests of the North Coast of NSW but is rarely associated with disease in natural vegetation of the region, unlike southern Australia (Pratt and Heather 1973; Weste 1994).
