Woolgoolga to Ballina Pacific Highway upgrade

Annual Threatened Flora Translocation Monitoring Report 2021

Woolgoolga to Ballina Threatened Flora Translocation Project

Annual Monitoring Report 2021

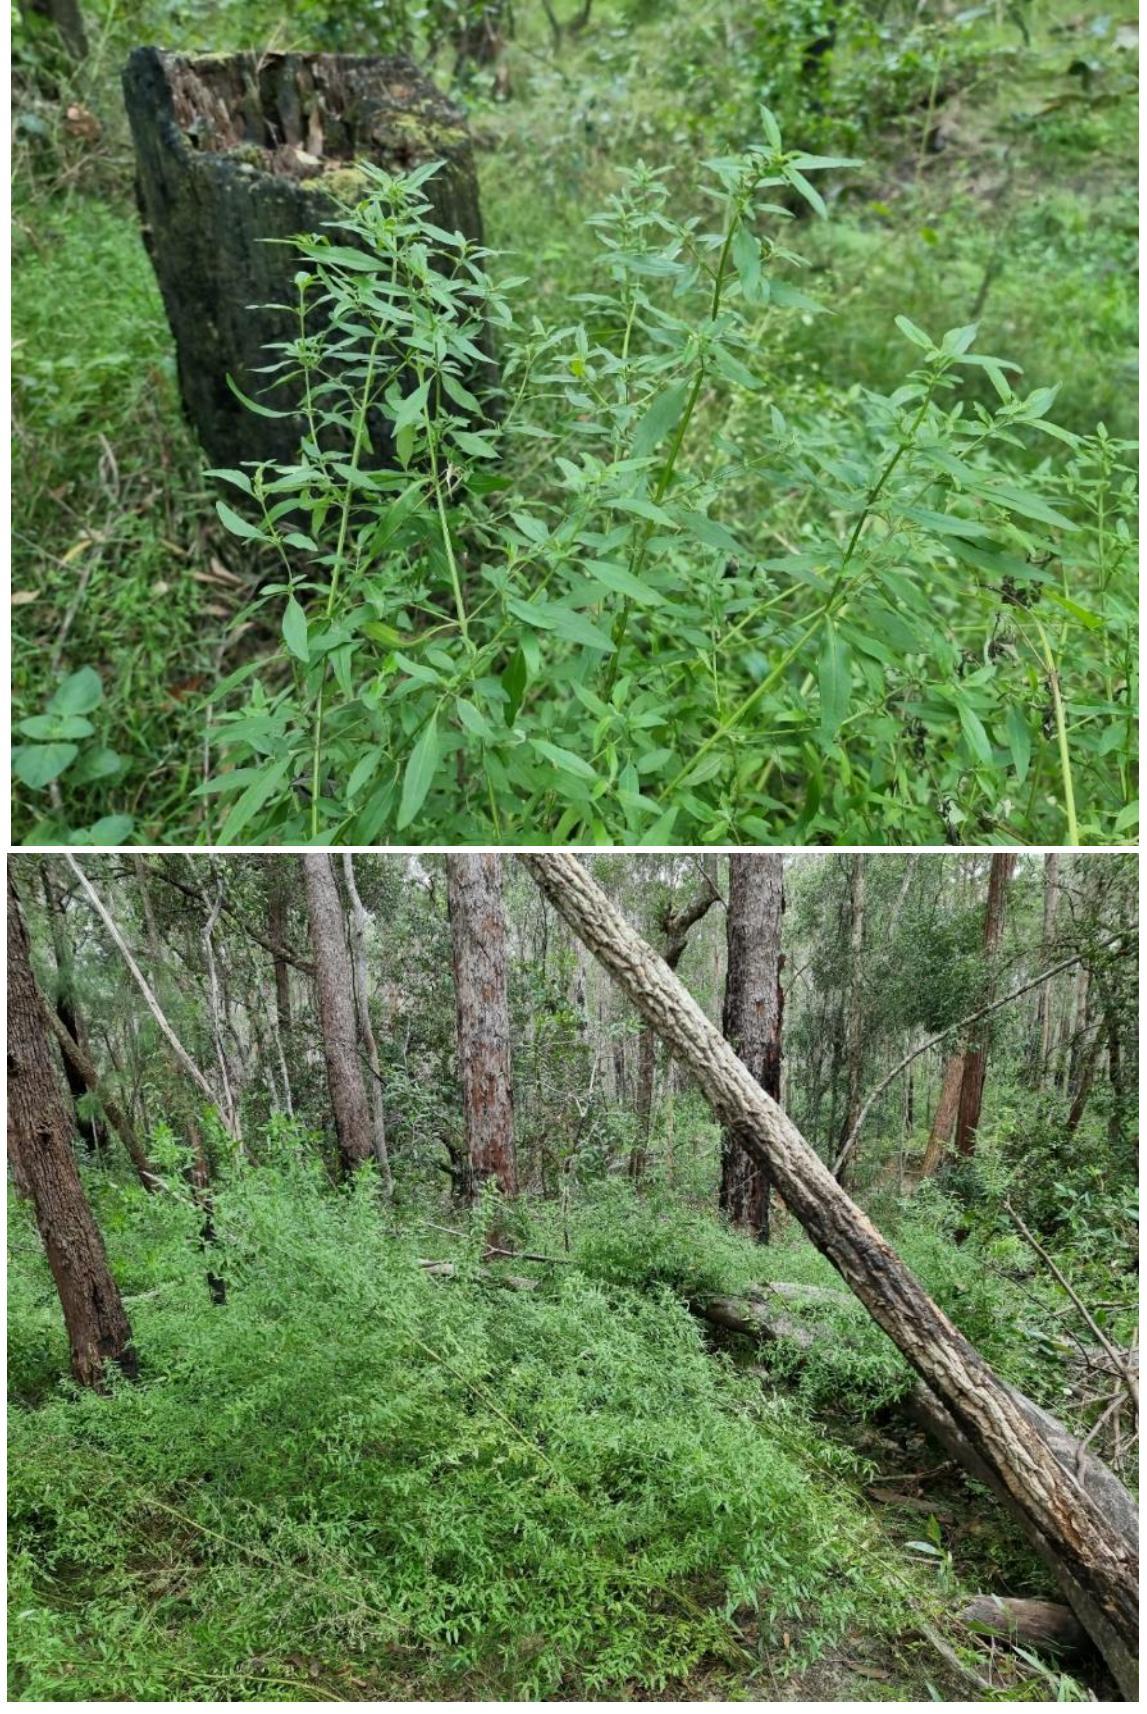
Plates 25&26: SMB in reference area on west side of the highway. A high density of seedlings regrew after the Nov/21 fire and are 1-2+ m high. Grey wilt affects ~10% of plants compared to ~75% of plants at recipient site. Plates shows healthy tips after similar flood depth (stems bent over by force of water). Like the Recipient Site, SMB here prefers sandier soil on the creek levee. March/22.

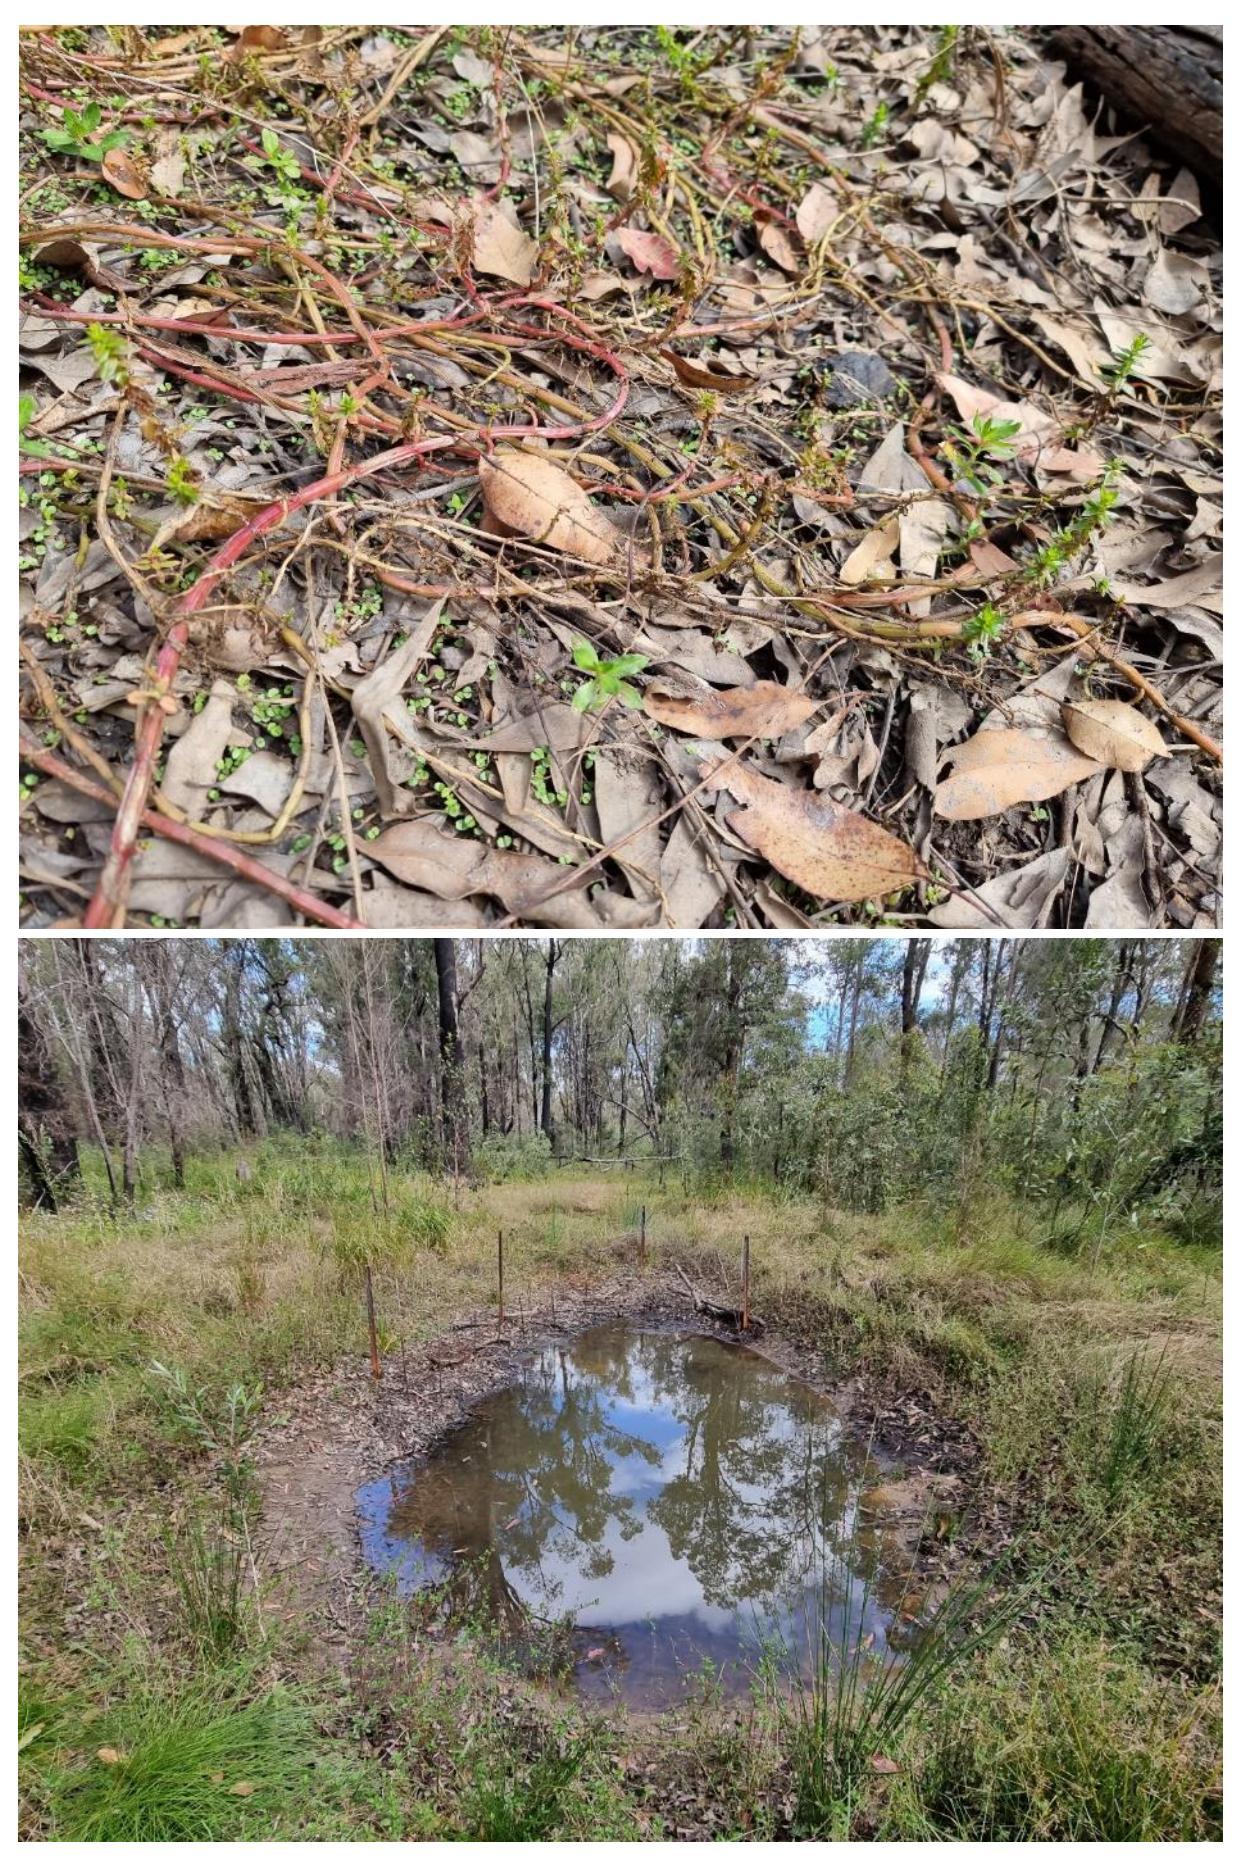
Plates 27&28: Top plate shows creeping reddish stems of *Rotala tripartita* growing along the left hand (east) side of the pond in the lower plate. Rescued in 2017, they were planted in pots in 2018 to allow adjustment in position. Proved to be a hardy species, spreads by stolons. Aug/21

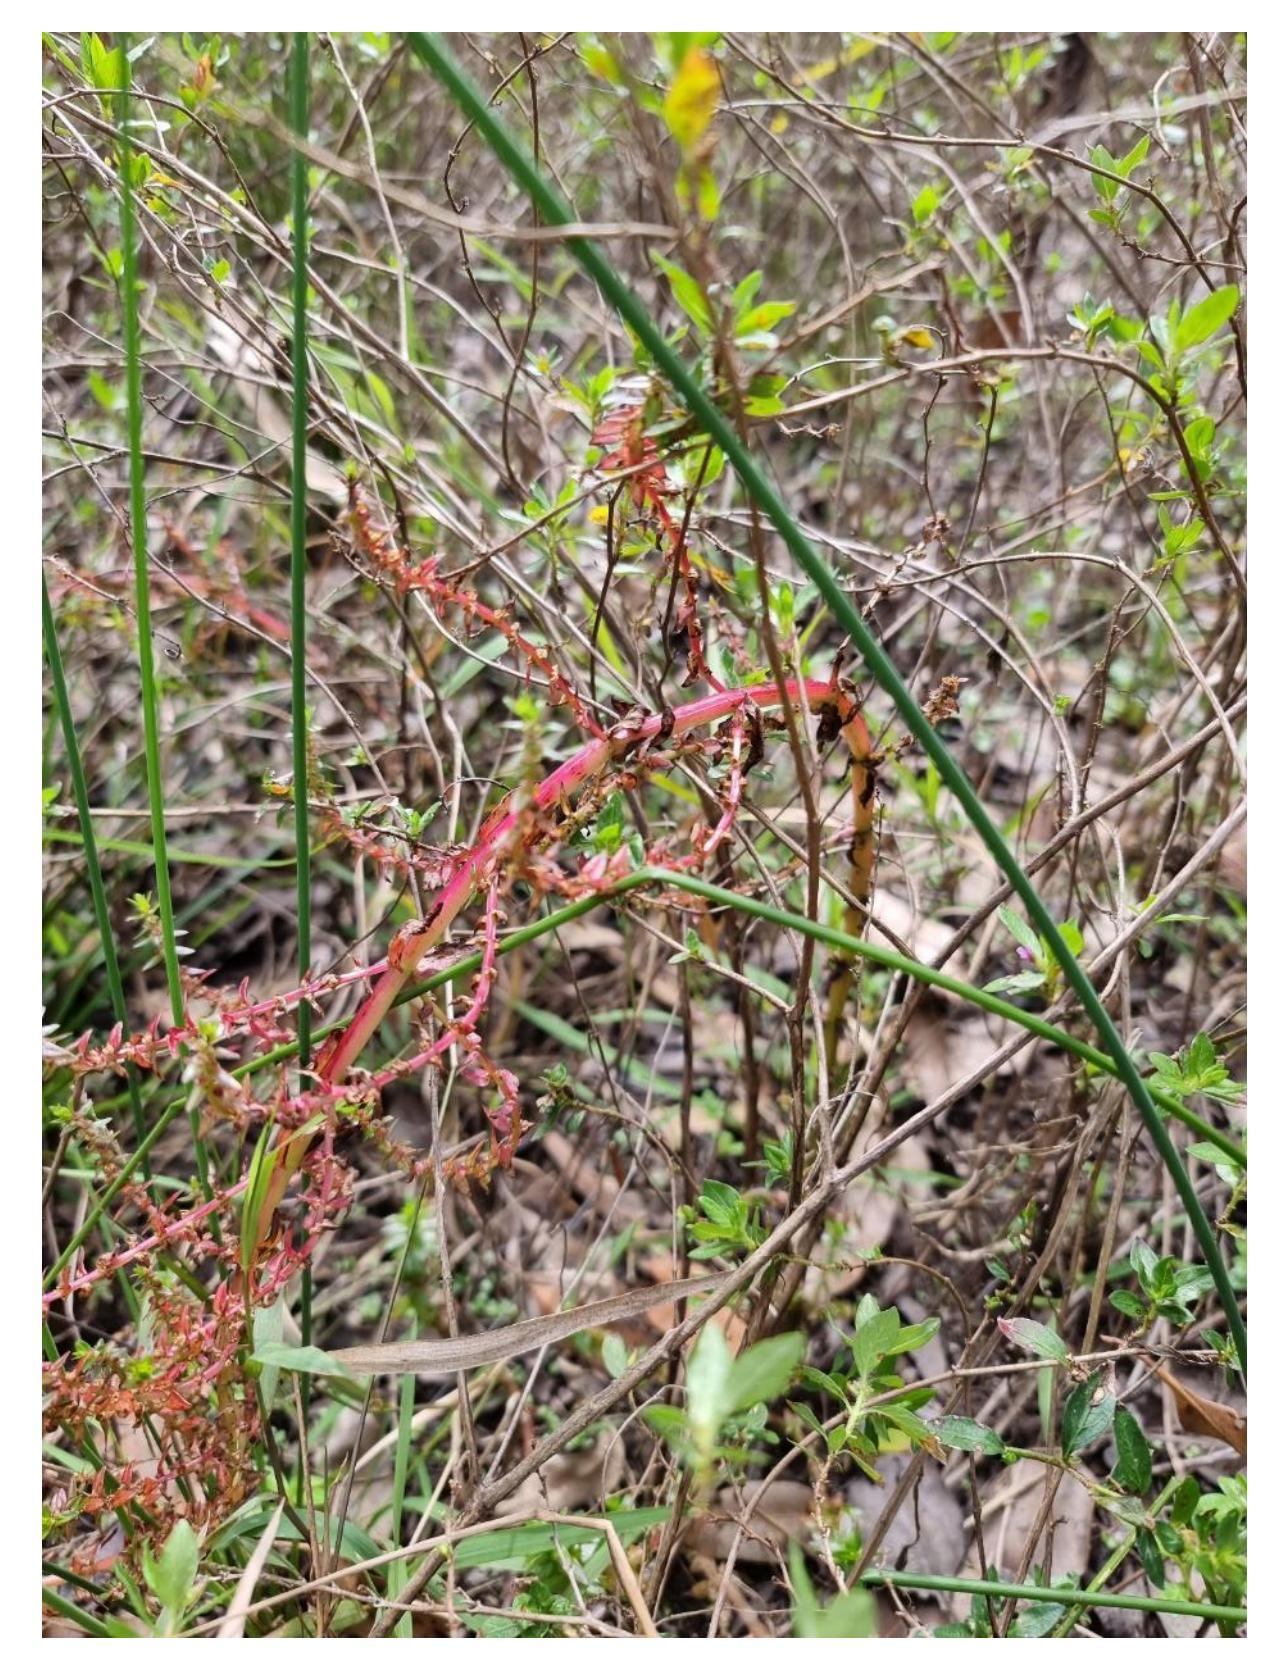
Plates 29: *Rotala tripart*ita had a decumbent to prostrate growth habit at the recipient site on the edge of a pond constructed on the offset land south of Tabbimoble Creek. The plant redness is due to recent soil dryness and frost, which the plant survived. The plants flowered but no seedlings were recorded. Pots were moved up and down as water level in pond changed, but the first position on upper part of bare edge (see Plate 28) proved best. This species appears to die if submerged for more than a week or two and may survive dry seasonal conditions as a dormant stolon. Aug/21.
