Roads and Traffic Authority

Pacific Highway Upgrade -
Oxley Highway to Kempsey
Flora and Fauna Working Paper

Appendix H

Description of vegetation communities in the study area

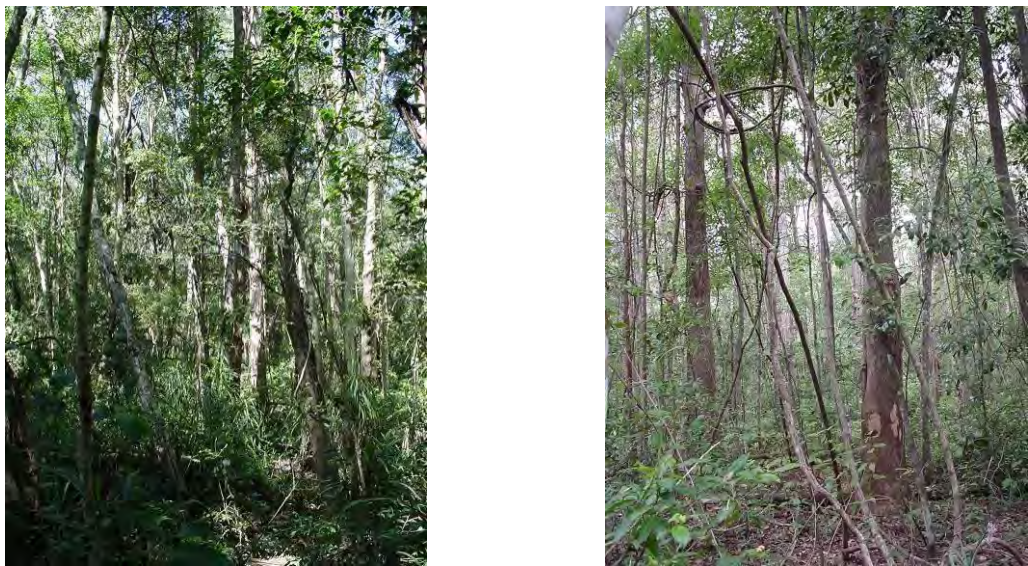
Community 1: Moist Floodplain Closed Forest with Rainforest Elements				
Stratum	Height (m)	% cover*	Dominant species	Description and comments
Tree layer (emergent)	25 - 30	50 - 70	<i>Syncarpia glomulifera</i> , <i>Lophostemon confertus</i> , <i>Eucalyptus propinqua</i> , <i>E. grandis</i> , <i>E. resinifera</i> , <i>E. pilularis</i>	Habitat: Narrow floodplains and lower slopes in gullies by creeks with permanent water, including creek beds; or sheltered moist gullies connecting to creeklines.
Sub-canopy layer	3 - 20	60 - 80	<i>Ficus coronata</i> , <i>Endiandra sieberi</i> , <i>Cryptocarya microneura</i> , <i>Glochidion ferdinandi</i> , <i>Acmena smithii</i> , <i>Melaleuca styphelioides</i> , <i>Acronychia oblongifolia</i> , <i>Callistemon salignus</i> , <i>Trochocarpa laurina</i> , <i>Hibiscus splendens</i> , <i>Backhousia myrtifolia</i> , <i>Hymenosporum flavum</i> , <i>Pittosporum revolutum</i> , <i>Guioa semiglaucula</i> , <i>Psychotria daphnoides</i> , <i>Lantana camara</i> .	Structure/Characteristics: Closed Forest with emergent eucalypts. Lower tree layer and understorey of rainforest species, some paperbarks, vines and epiphytes. Sparse ground layer. Ferns abundant. Distribution within Study Area: Confined to the floodplain of Barrys Creek and its major tributaries, in section 6 of the study area. All patches of the community occur within Ballengarra State Forest.

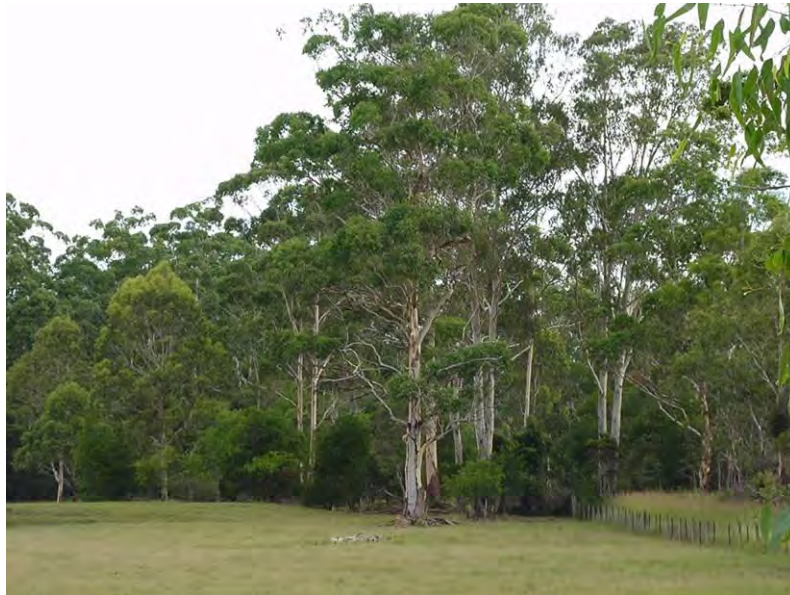
Community 2: Riparian Forest

Stratum	Height (m)	% cover*	Dominant species	Description and comments
Tree layer	20 - 25	20 - 40	<i>Eucalyptus grandis</i> , <i>E. tereticornis</i> , <i>E. microcorys</i> , <i>E. propinqua</i> , <i>Corymbia intermedia</i> , <i>Lophostemon confertus</i>	<p>Habitat: Steeper banks and floodplains immediately adjacent to creeks with permanent water, including creek beds, generally through flat land.</p> <p>Structure/Characteristics: Forest or Open Forest dominated by eucalypt species with rainforest and/or swamp elements in the understorey.</p> <p>Distribution within Study Area: Occurs in small patches associated with creeks and watercourses in 5 areas in the study area. These include Cooperabung Creek, Barrys Creek, Smiths Creek, Pipers Creek and Maria River.</p> <p>Condition & Presence of Weeds: Because of the proximity of the patches to the existing highway and cleared farming land in most of the areas where it occurs, and its characteristic narrowness, the community is generally highly invaded by weeds and in poor condition.</p> <p>Conservation Status: The habitat of the community together with the particular assemblage of species according to the Final Determination (NSW Scientific Committee 2004b) indicates that the community qualifies as the EEC 'Subtropical Coastal Floodplain Forest' under the NSW TSC Act.</p>

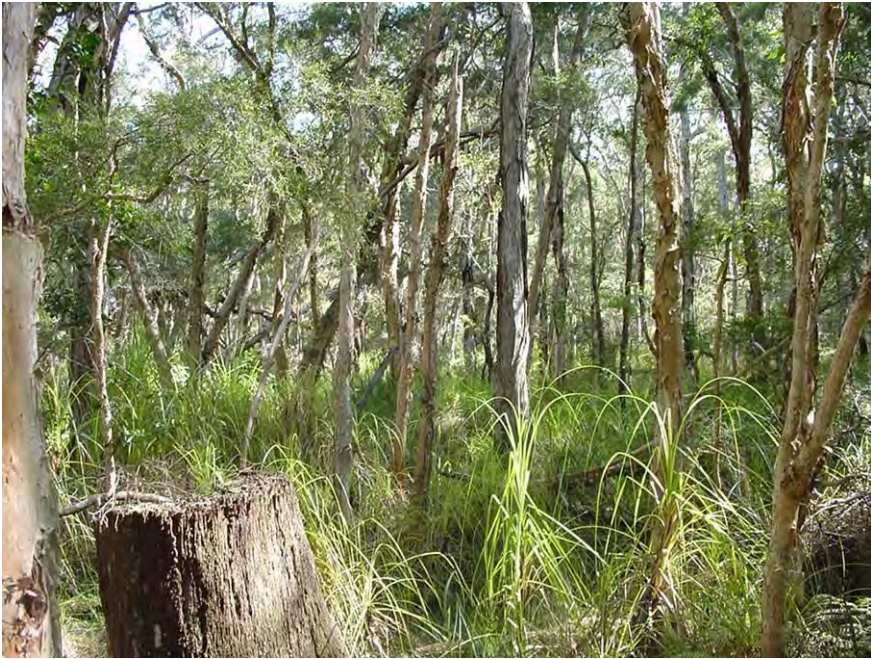
Community 3: Paperbark Swamp Forest				
Stratum	Height (m)	% cover*	Dominant species	Description and comments
Tree layer	18 - 22	40 - 60	<i>Melaleuca quinquenervia</i> plus occasional <i>Eucalyptus tereticornis</i> , <i>E. robusta</i> , <i>E. resinifera</i> . <i>E. pilularis</i> or <i>Syncarpia glomulifera</i>	<p>Habitat: Low-lying permanently wet depressions with poor drainage, associated with floodplains of creeks with permanent water or fringes of dams.</p> <p>Structure/Characteristics: Forest or Open Forest dominated by paperbarks, usually with a sedge understorey with ferns. Eucalypts absent or uncommon.</p> <p>Distribution within Study Area: Occurs in small patches in the vicinity of Fernbank Creek (section 2), immediately north of the Hastings River (section 2), Cairncross State Forest (section 3) and in the floodplain to the north (section 4), and two very minor occurrences in sections 5 and 7.</p> <p>Condition & Presence of Weeds: Most patches of the community are generally in good condition and free of weeds. Patches of weeds, where they do occur in disturbed and edge areas, mainly consist of herbaceous weeds and some Crofton Weed.</p> <p>Conservation Status: The habitat of the community together with the particular assemblage of species according to the Final Determination (NSW Scientific Committee 2004c) indicates that the community qualifies as the EEC 'Swamp Sclerophyll Forest on Coastal Floodplains' under the NSW TSC Act.</p>

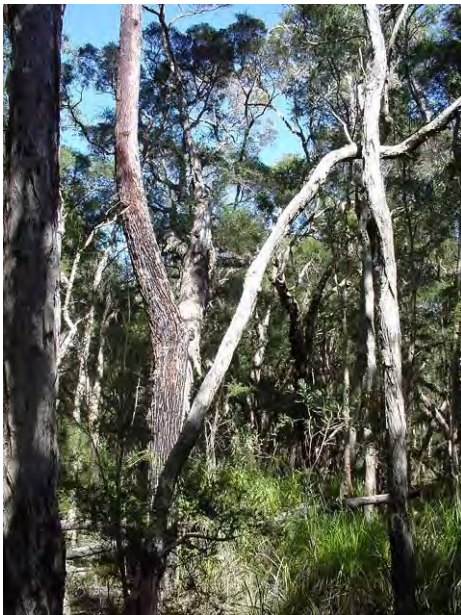
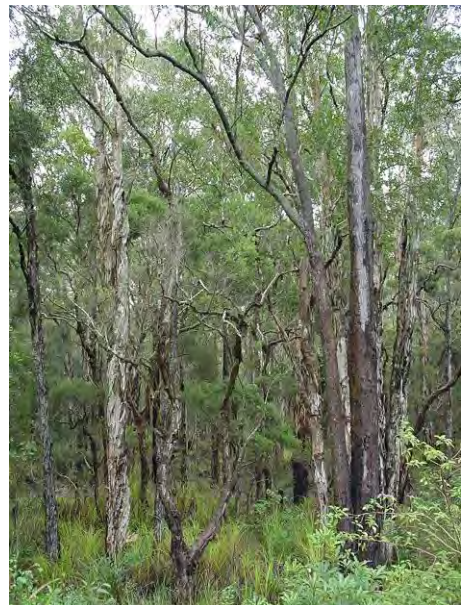
Community 4: Swamp Mahogany / Forest Red Gum Swamp Forest

Stratum	Height (m)	% cover*	Dominant species	Description and comments
Tree layer	25 - 30	30 - 40	<i>Eucalyptus robusta</i> , <i>E. tereticornis</i> , <i>E. amplifolia</i> , <i>E. resinifera</i> , <i>Melaleuca quinquenervia</i> , <i>M. decora</i>	<p><u>Habitat</u>: Low-lying permanently wet flats or depressions with poor drainage on floodplains.</p> <p><u>Structure/Characteristics</u>: Forest or Open Forest dominated by swamp mahogany and/or forest red gum/cabbage gum with larger paperbarks. Usually has a sedge understorey with ferns and/or grasses. Eucalypts uncommon except for swamp mahogany, forest red gum and red mahogany in slightly more elevated drier areas.</p> <p><u>Distribution within Study Area</u>: Restricted to south of the Wilson River. Occupies small to moderate patches associated with creeks and watercourses in the Fernbank Creek area (section 2), Cairncross State Forest (section 3) and in the floodplain to the north (section 4). <u>Condition & Presence of Weeds</u>: Most patches of the community are generally in good condition and free of weeds. In disturbed areas (regularly grazed or subject to runoff from the existing highway), significant infestations of noxious lantana, crofton weed or blackberry occur.</p> <p><u>Conservation Status</u>: The habitat of the community together with the particular assemblage of species according to the Final Determination (NSW Scientific Committee 2004c) indicates that the community qualifies as the EEC 'Swamp Sclerophyll Forest on Coastal Floodplains' under the NSW TSC Act.</p>

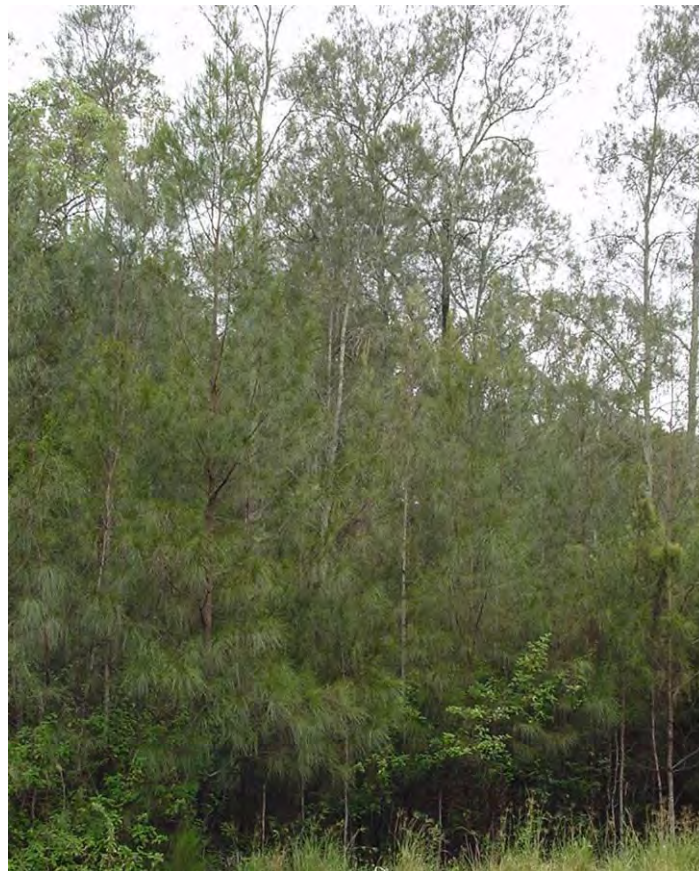
Community 5: Swamp Oak Forest				
Stratum	Height (m)	% cover*	Dominant species	Description and comments
Tree layer	15 - 20	40 - 60	Mainly <i>Casuarina glauca</i> , with some <i>Melaleuca</i> species	<p>Habitat: Low-lying permanently wet depressions with poor drainage on floodplains, with some saline influence.</p> <p>Structure/Characteristics: Forest or Open Forest dominated by swamp oaks, occasional paperbarks and usually with a rush or sedge understorey. Eucalypts absent or uncommon.</p> <p>Distribution within Study Area: Restricted to one small patch in the terrestrial part of the project area, on the floodplain south of the Wilson River (section 4).</p> <p>Condition & Presence of Weeds: The one patch of the community is generally in good condition and free of weeds, although minor herbaceous weeds and exotic pasture grasses have invaded the understorey.</p> <p>Conservation Status: The habitat of the community together with the particular assemblage of species according to the Final Determination (NSW Scientific Committee 2004d) indicates that the community qualifies as the EEC 'Swamp Oak Floodplain Forest' under the NSW TSC Act.</p>

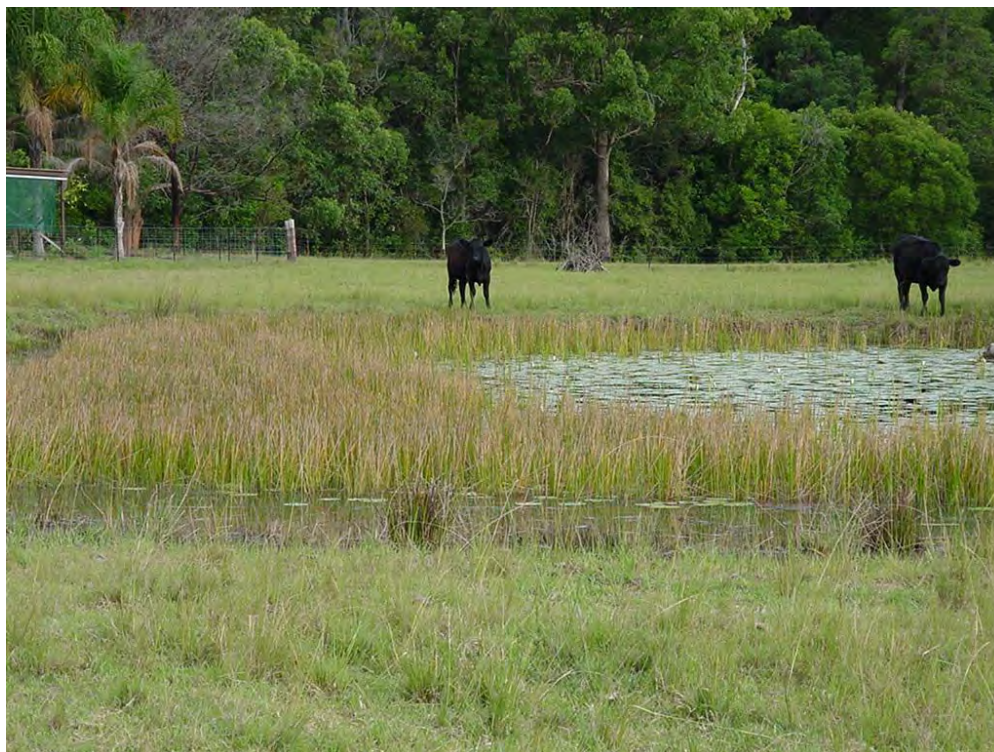
Community 6: Freshwater Wetland				
Stratum	Height (m)	% cover*	Dominant species	Description and comments
Tree layer (fringing)	8 - 15	20 - 40	<i>Melaleuca styphelioides</i> , <i>M. linariifolia</i> , <i>M. quinquenervia</i> , <i>Casuarina glauca</i>	<u>Habitat</u> : Depressions on floodplains associated with or near watercourses. <u>Structure/Characteristics</u> : Shallow fresh water containing or surrounded by macrophytes, sedges, rushes and other aquatic plants, generally less than 1.5 m height. Often fringed by paperbarks and swamp oaks.
Ground layer	<1.5	5 - 90	<i>Juncus kraussii</i> , <i>Philydrum lanuginosum</i> , <i>Cotula coronopifolia</i> , <i>Triglochin procerum</i> , <i>Isolepis inundata</i> , <i>Leptinella longipes</i> , <i>Apium prostratum</i> , <i>Bacopa monnieri</i>	<u>Distribution within Study Area</u> : Restricted to small to medium patches in two broad areas. Small patches occur along Fernbank Creek (section 2), and a series of small to larger patches occur in the floodplain both to the south and north of the Wilson River (section 4). The small patch to the north of the Wilson River is part of a SEPP 14 wetland. <u>Condition & Presence of Weeds</u> : Most occurrences of this community are in good condition and relatively weed-free, but often subject to grazing and therefore trampling by stock. Native species are often consequently replaced by weeds and exotic pasture grasses. <u>Conservation Status</u> : The habitat of the community together with the particular assemblage of species according to the Final Determination (NSW Scientific Committee 2004e) indicates that the community qualifies as the EEC 'Freshwater Wetlands on Coastal Floodplains' under the NSW TSC Act.

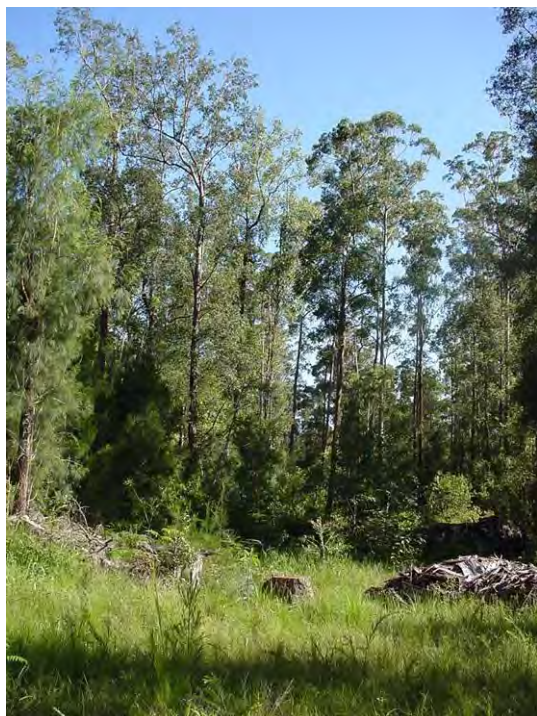
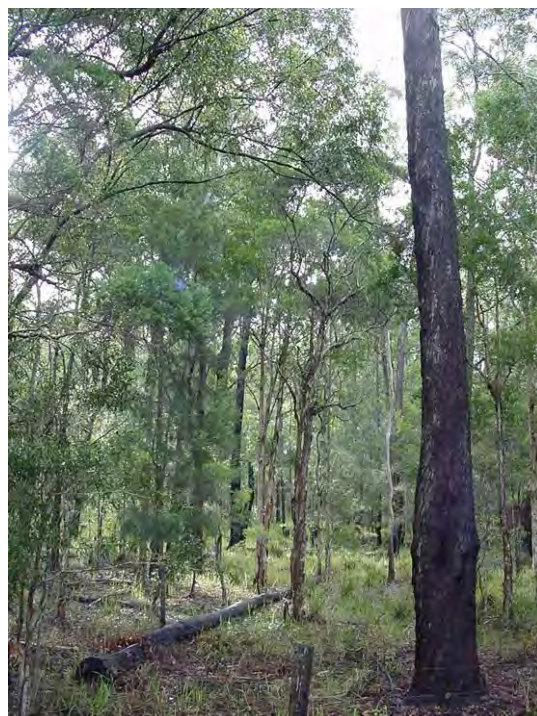
Community 7: Moist Floodplain Forest

Stratum	Height (m)	% cover*	Dominant species	Description and comments
Tree layer	25 - 35	30 - 40	<i>Eucalyptus pilularis</i> , <i>E. microcorys</i> , <i>E. acmenoides</i> , <i>E. siderophloia</i> , <i>E. globoidea</i> , <i>E. resinifera</i> , <i>Corymbia gummifera</i> , <i>C. intermedia</i> , <i>Syncarpia glomulifera</i>	<u>Habitat</u> : Low-lying flat floodplain areas, usually dry but subject to occasional flooding. <u>Structure/Characteristics</u> : Forest or Open Forest dominated by eucalypts, usually with some paperbarks in the sub-canopy layer and an understorey consisting of a mix of dry sclerophyll and moist-tolerant or rainforest elements.
Sub-canopy / shrub layer	2 - 10	10 - 30	<i>Melaleuca quinquenervia</i> , <i>M. sieberi</i> , <i>Allocasuarina littoralis</i> , <i>A. torulosa</i> , <i>Banksia spinulosa</i> var. <i>collina</i> , <i>Melaleuca nodosa</i> , <i>Glochidion ferdinandi</i> , <i>Leptospermum polygalifolium</i> , <i>Persoonia stradbrokeensis</i> , <i>Myrsine howittiana</i> , <i>Pultenaea retusa</i> , <i>Acacia falcata</i> , <i>A. longifolia</i> , <i>A. fimbriata</i> , <i>A. longissima</i>	<u>Distribution within Study Area</u> : Occurs in sections 1, 2, 3, 5 and 7. Most common in sections 2 and 3 (Cairncross State Forest). <u>Condition & Presence of Weeds</u> : Most patches have been heavily logged and there are many areas of logging debris in past logging coupes. Most areas are in an early to advanced state of regrowth. Weeds are generally sparse, and limited to minor herbaceous weeds or exotic grasses in disturbed areas.

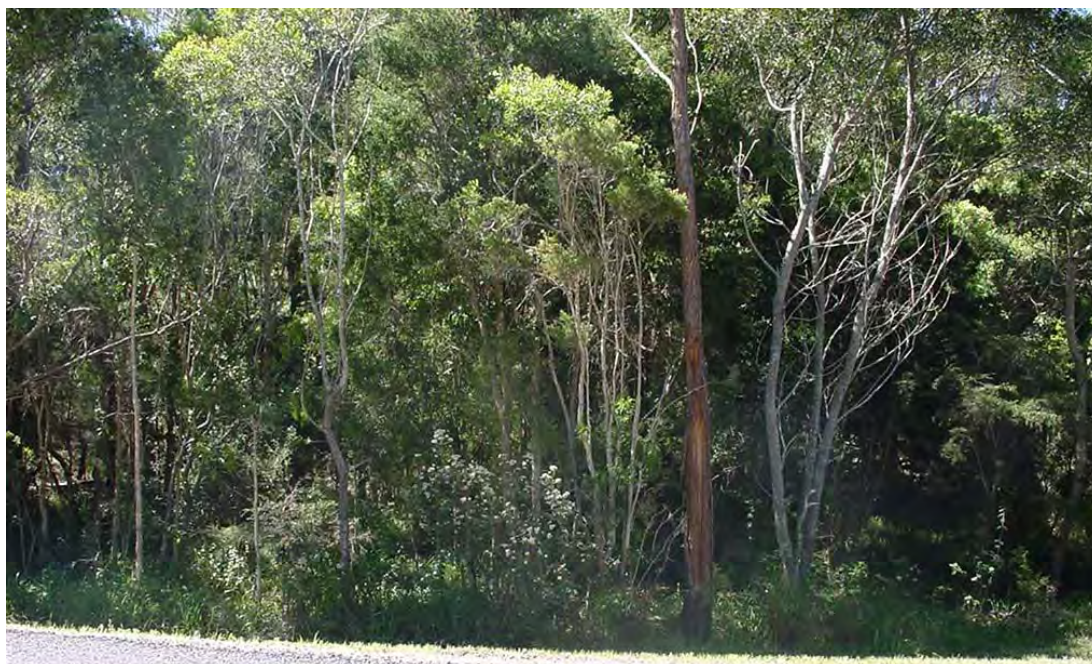
Community 8: Moist Gully Forest				
Stratum	Height (m)	% cover*	Dominant species	Description and comments
Tree layer	25 - 35	40 - 50	<i>Eucalyptus pilularis</i> , <i>E. microcorys</i> , <i>E. propinqua</i> , <i>E. tereticornis</i> , <i>Lophostemon confertus</i> , <i>Syncarpia glomulifera</i>	<p><u>Habitat</u>: Moist, sheltered, gullies in undulating terrain, typically at the base of steeper slopes. Usually abutting/merging into Community 9 at the drier end; and Communities 1, 2 or swamp forest at the wetter end. Generally associated with ephemeral drainage lines or minor creeklines (often without permanent water).</p> <p><u>Structure/Characteristics</u>: Forest or Open Forest dominated by eucalypts and brushbox, with a dense, moist understorey. Some paperbarks in the sub-canopy layer with ferns common in the shrub and ground layers.</p> <p><u>Distribution within Study Area</u>: Most common in Sections 6 & 8 where the topography is more undulating. Small patches also occur in sections 1, 2, 3, 5 and 7.</p> <p><u>Condition & Presence of Weeds</u>: Most patches of the community are generally in good condition and free of weeds, although major infestations of noxious weeds such as Lantana and Crofton Weed occur by streams and adjacent lower slopes in the gullies.</p> <p><u>Conservation Status</u>: No particular conservation significance.</p>

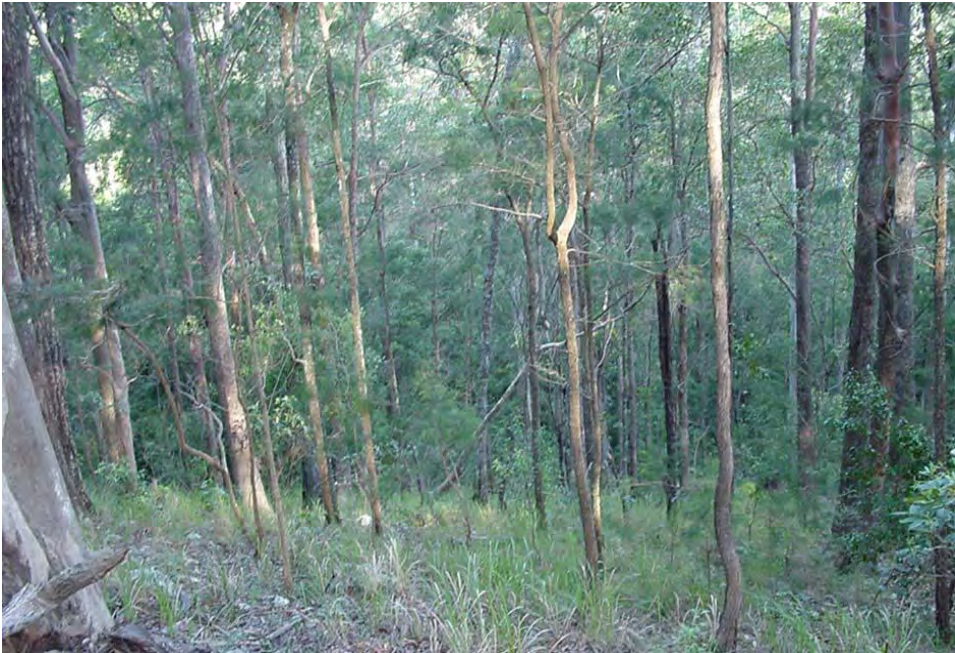
Community 9: Moist Slopes Forest				
Stratum	Height (m)	% cover*	Dominant species	Description and comments
Tree layer	25 - 35	30 - 50	<i>Eucalyptus pilularis</i> , <i>E. microcorys</i> , <i>E. acmenoides</i> , <i>E. propinqua</i> , <i>E. siderophloia</i> , <i>E. globoidea</i> , <i>Lophostemon confertus</i> , <i>Corymbia maculata</i> , <i>C. gummifera</i> , <i>C. intermedia</i> , <i>Syncarpia glomulifera</i>	<p><u>Habitat</u>: Slopes or low ridges with a moist/sheltered aspect and good drainage in undulating terrain. Generally occurs between Dry Ridgetop Forest and Moist Gully Forest, Swamp Forest or Rainforest.</p> <p><u>Structure/Characteristics</u>: Forest or Open Forest dominated by eucalypts and brushbox with a moist, open understorey.</p> <p><u>Distribution within Study Area</u>: The single most abundant natural community in terms of area – widespread in all sections except section 4 (floodplain).</p> <p><u>Condition & Presence of Weeds</u>: Most patches of the community are generally in good condition and free of weeds. Most patches have been subject to past logging. Patches of weeds, where they do occur in disturbed and edge areas, mainly consist of herbaceous weeds. Some patches of lantana occur.</p> <p><u>Conservation Status</u>: No particular conservation significance.</p>

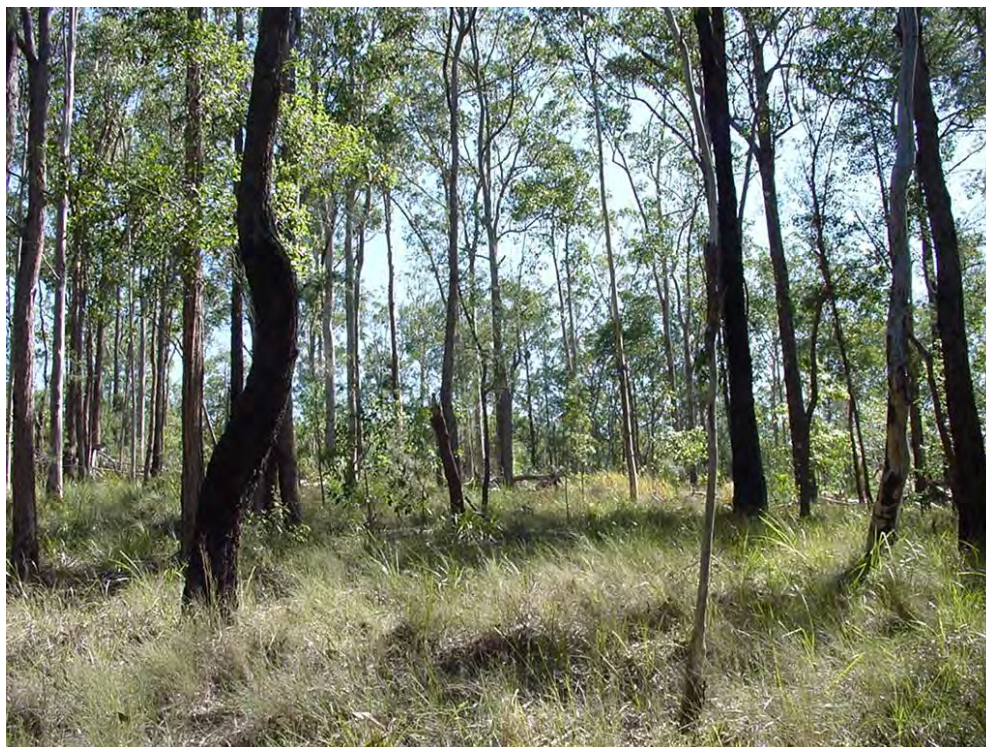
Community 10: Dry Ridgetop Forest

Stratum	Height (m)	% cover*	Dominant species	Description and comments
Tree layer	25 - 30	30 - 40	EITHER <i>Eucalyptus pilularis</i> , <i>E. microcorys</i> , <i>E. acmenoides</i> , <i>E. globoidea</i> , <i>Corymbia gummifera</i> , OR <i>Corymbia maculata</i> , <i>Eucalyptus siderophloia</i> , <i>E. fibrosa</i> , <i>E. acmenoides</i> , <i>E. propinqua</i> , <i>E. globoidea</i> , <i>Syncarpia glomulifera</i>	<u>Habitat</u> : Higher, drier and more exposed Ridgetops and upper slopes in undulating terrain, or more elevated and exposed areas above the floodplain in flatter terrain. <u>Structure/Characteristics</u> : Dry Open Forest dominated either by blackbutt / tallowwood or spotted gum / ironbark. Generally sparse and grassy sclerophyllous understorey
Sub-canopy / shrub layer	2 - 10	20 - 30	<i>Allocasuarina littoralis</i> , <i>Acacia falcata</i> , <i>A. fimbriata</i> , <i>Ozothamnus diosmifolius</i> , <i>Notelaea longifolia</i> , <i>Pultenaea villosa</i> , <i>Breynia oblongifolia</i>	<u>Distribution within Study Area</u> : Moderately common in all sections except 4 and 5 where the topography is more low-lying.

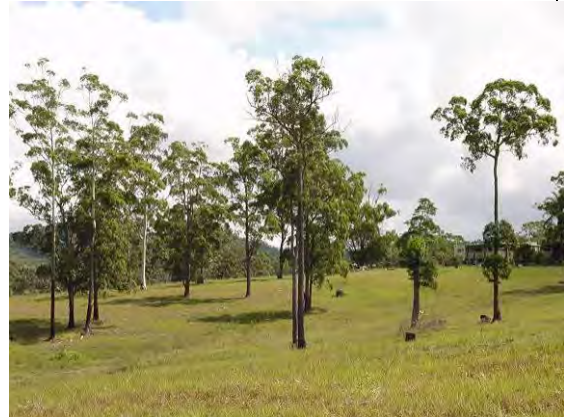
Community 11: Cleared, Open Grassland / Derived Pasture with Scattered Trees

Structure/Characteristics: Scattered mature to regrowth paddock trees, sometimes in clumps, with cleared understorey replaced with pasture – minor clumps of remnant native shrubs at tree bases.

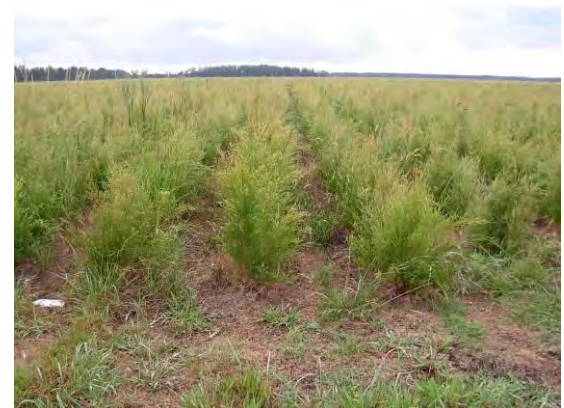
Community 12: Plantation / Cropland / Market Garden etc.

Structure/Characteristics: No particular structure – usually artificially planted in rows and cultivated.

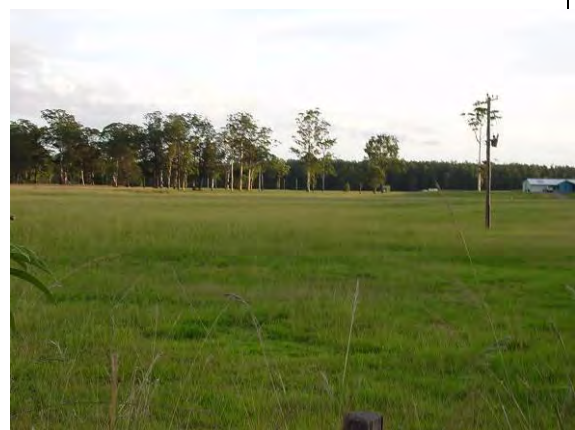
Community 13: Totally Cleared Open Pasture / Weedy Fallow / Roads

Structure/Characteristics: Open grassland; weedy open fallow or bare, hard surfaces (mainly roads).
