Appendix A
Director-General's Requirements
And
Project Description

Director General's Requirements for the Environmental Assessment of Proposed Pacific Highway Upgrade between Tintenbar and Ewingsdale

Director-General's Requirements

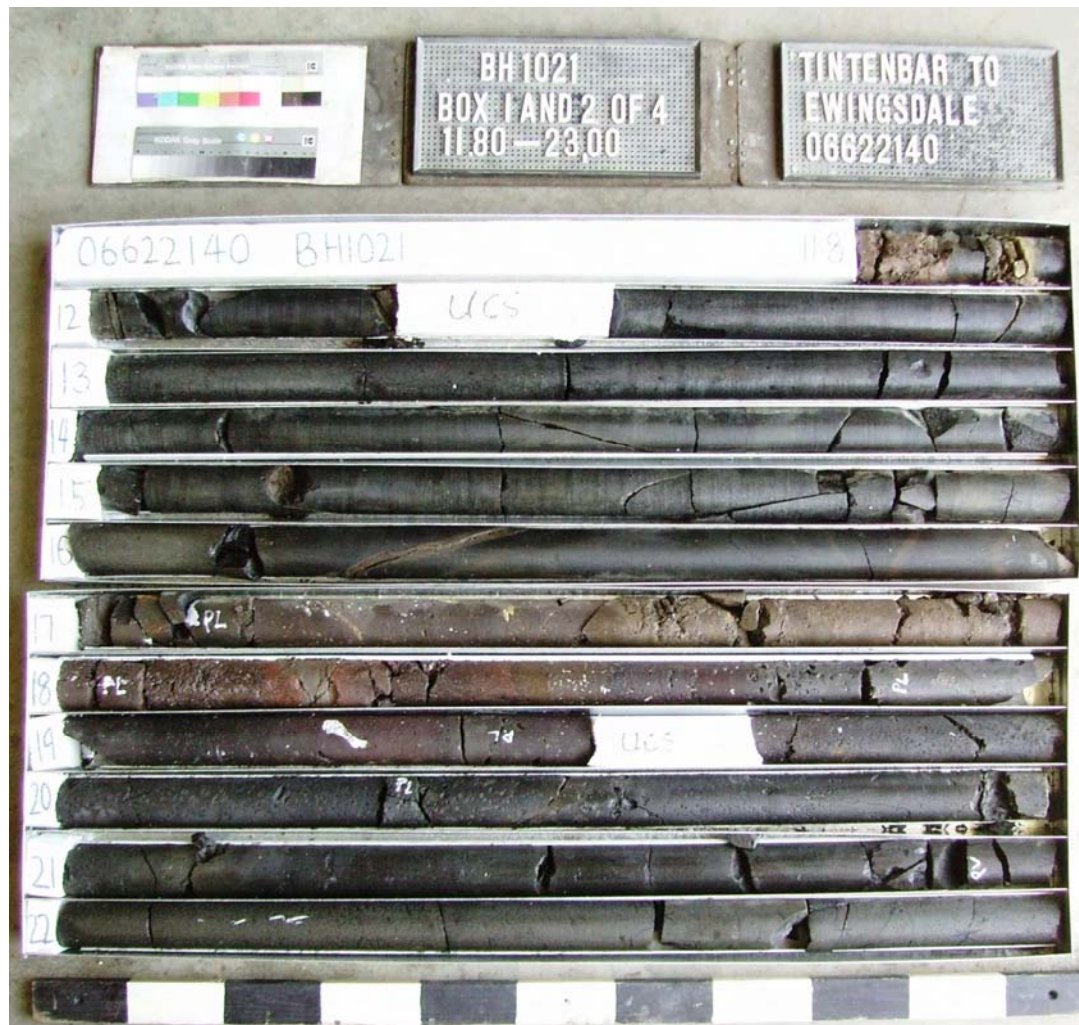
SHEET: 1 OF 3
DRILL RIG: Pioneer 120
DRILLER: North Coast Drilling
LOGGED: BC DATE: 7/11/06
CHECKED: CSC DATE: 6/2/07

COORDS: 552130.1 m E 6820900 m N 56 MGA94
SURFACE RL: 120.20 m DATUM: AHD
INCLINATION: -90°
HOLE DIA: 100/76 mm HOLE DEPTH: 32.00 m

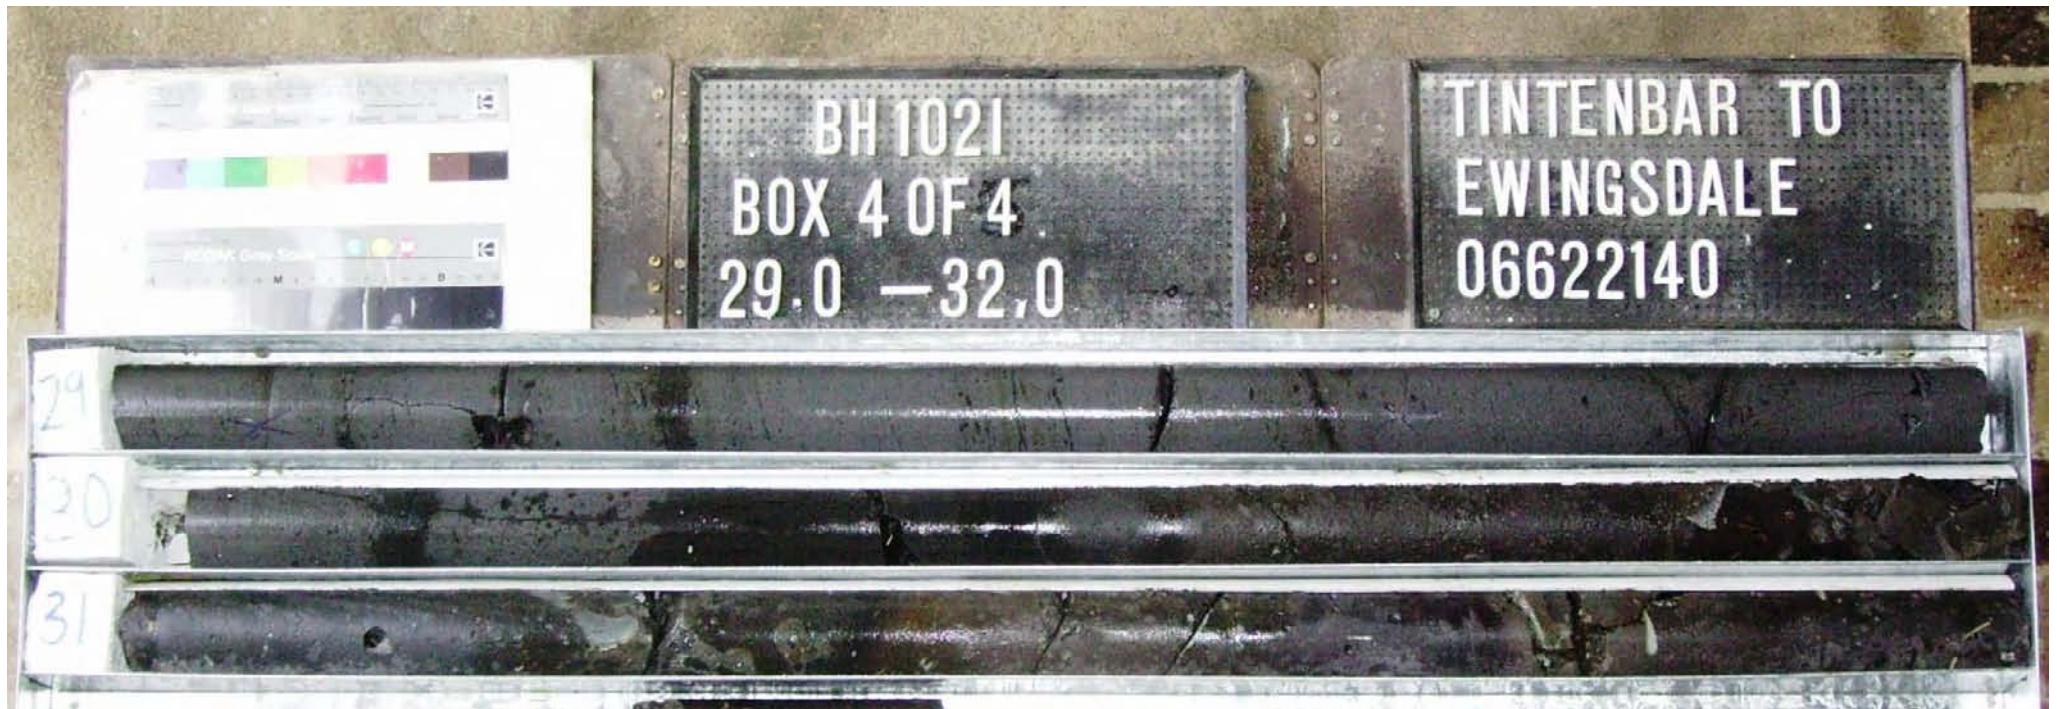
SHEET: 3 OF 3
DRILL RIG: Pioneer 120
DRILLER: North Coast Drilling
LOGGED: BC DATE: 7/11/06
CHECKED: CSC DATE: 6/2/07

COORDS: 552130.1 m E 6820900 m N 56 MGA94
SURFACE RL: 120.20 m DATUM: AHD
INCLINATION: -90°
HOLE DIA: 100/76 mm HOLE DEPTH: 32.00 m

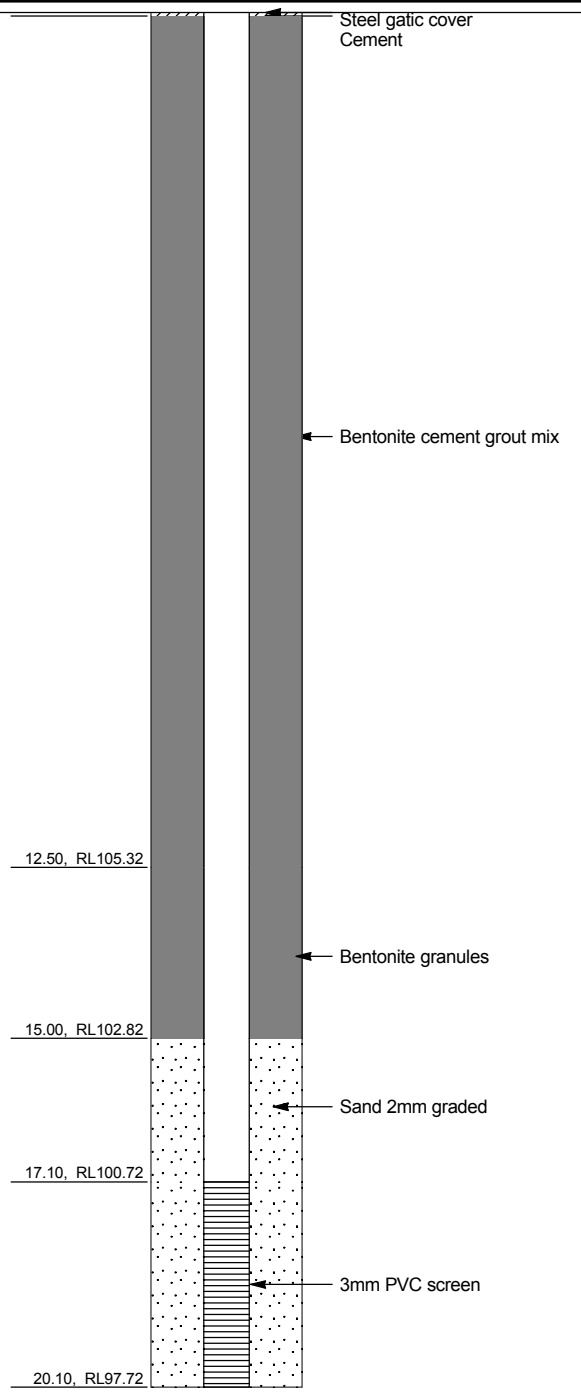
Drilling				Field Material Description		Instrumentation Details	
METHOD	WATER	DRILL FLUID LEVELS	DEPTH (metres)	DEPTH RL	GRAPHIC LOG	ABBREVIATED SOIL / ROCK MATERIAL DESCRIPTION (Refer to Report of Borehole For Details)	
ADT			0	117.82		Sandy CLAY	Steel gatic cover Cement
			2	116.17		BASALT	
			2.30			BASALT	
			4	115.17		BASALT	
			4.20			BASALT	
			4.90	113.62			
			5.60	112.92		BASALT	
			6.10			BASALT	
			6.70	111.72			
			7.30	111.12		BASALT	
			7.65			BASALT	
			8.30			BASALT	
			9.70	109.52		BASALT	
			10.00			BASALT	
			10.72	107.82			
			12				
			14				
			15.20				
			16.00	102.42		NO CORE	
			16.00			BASALT	
			18	101.67		NO CORE	
			18.40			BASALT	
			19.42	99.42			
			20.10	97.72			
			22

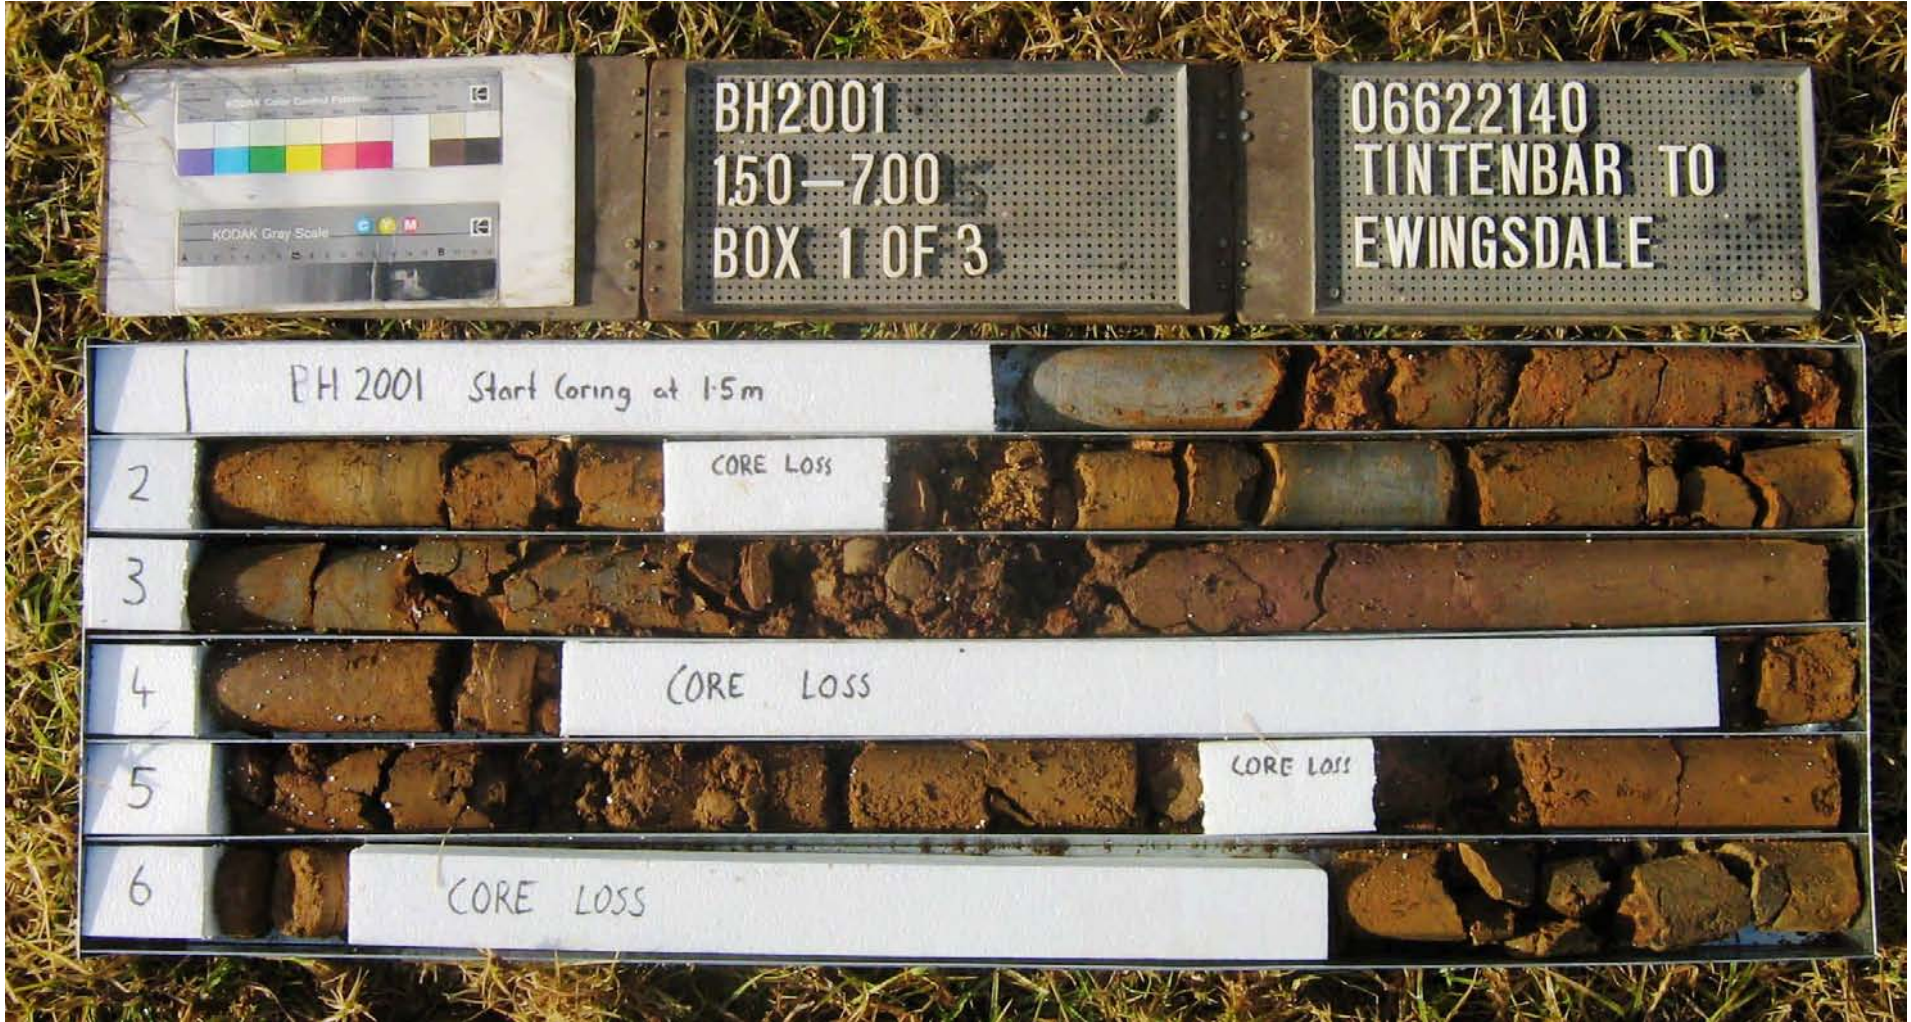
SHEET: 1 OF 3
DRILL RIG: Pioneer 120
DRILLER: North Coast Drilling
LOGGED: AM DATE: 10/7/07
CHECKED: CSC DATE: 10/8/07

COORDS: 552152.5 m E 6820944.8 m N 56 MGA94
SURFACE RL: 117.82 m DATUM: AHD
INCLINATION: -90°
HOLE DIA: 100/76 mm HOLE DEPTH: 20.10 m

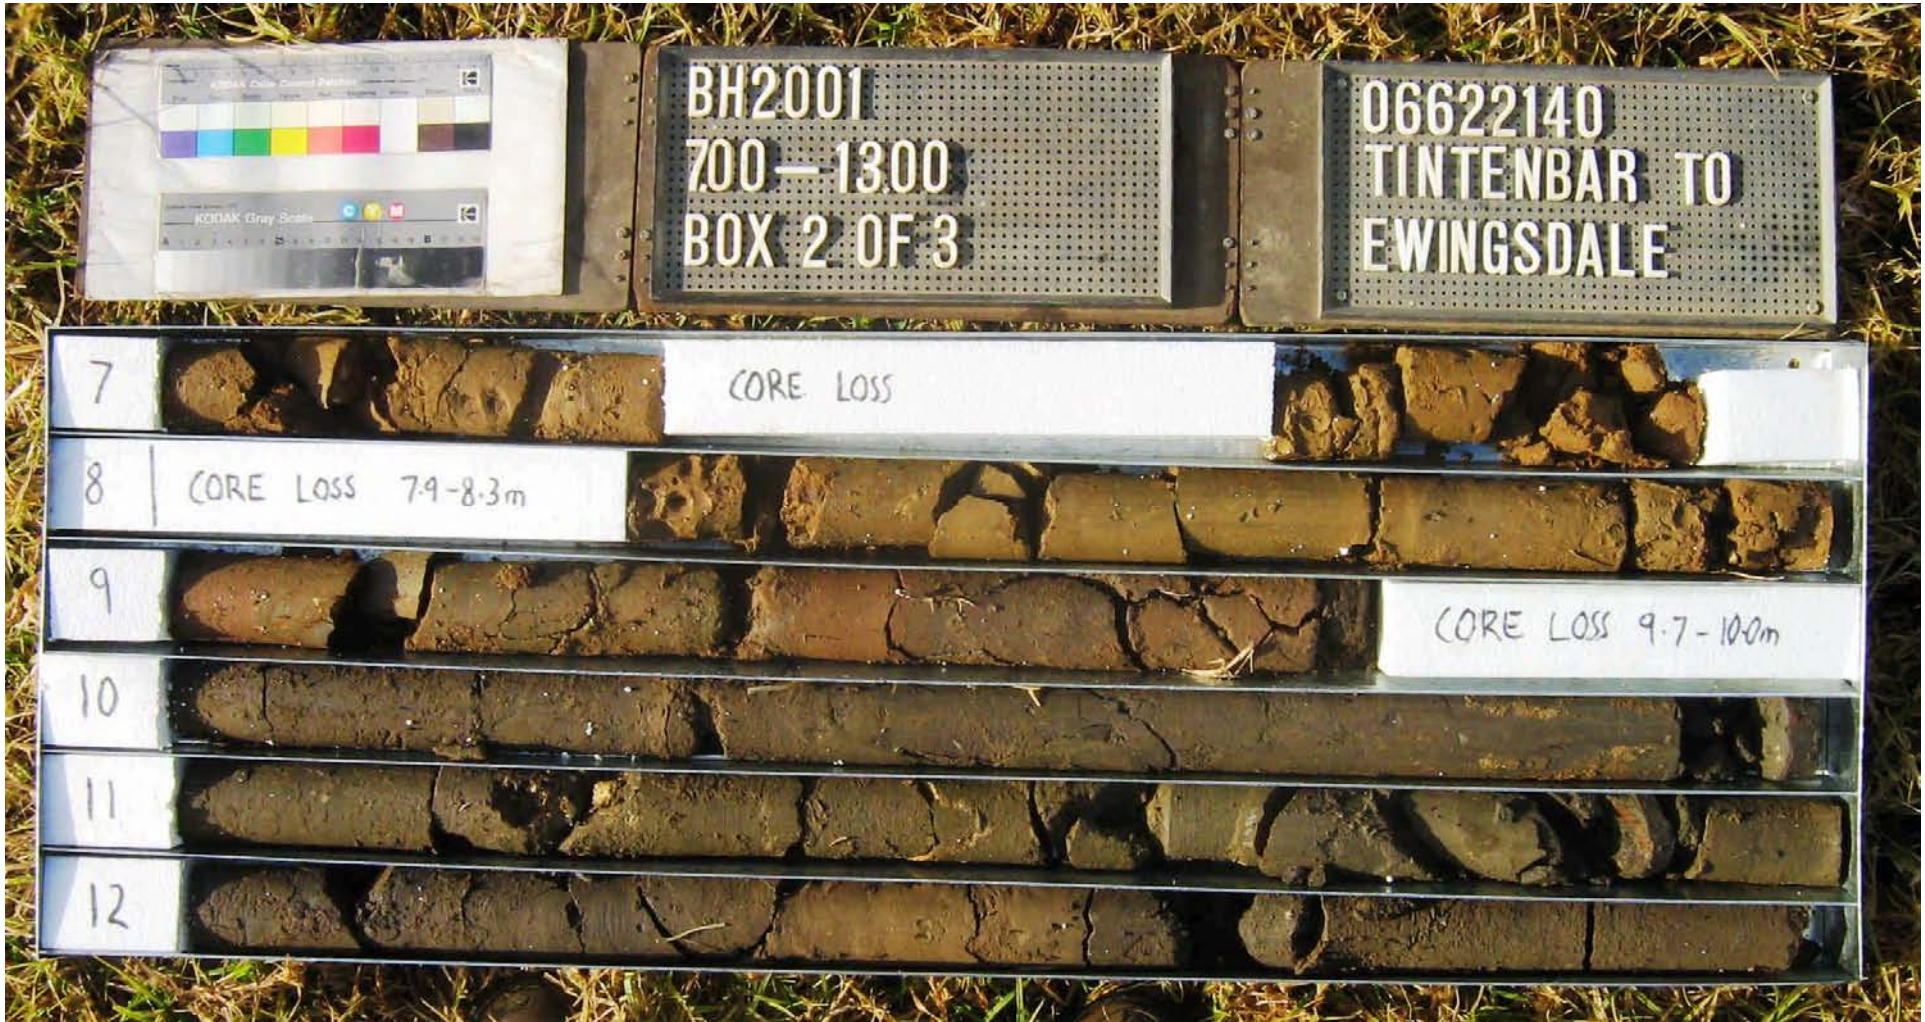
SHEET: 2 OF 3
DRILL RIG: Pioneer 120
DRILLER: North Coast Drilling
LOGGED: AM DATE: 10/7/07
CHECKED: CSC DATE: 10/8/07

COORDS: 552152.5 m E 6820944.8 m N 56 MGA94
SURFACE RL: 117.82 m DATUM: AHD
INCLINATION: -90°
HOLE DIA: 100/76 mm HOLE DEPTH: 20.10 m

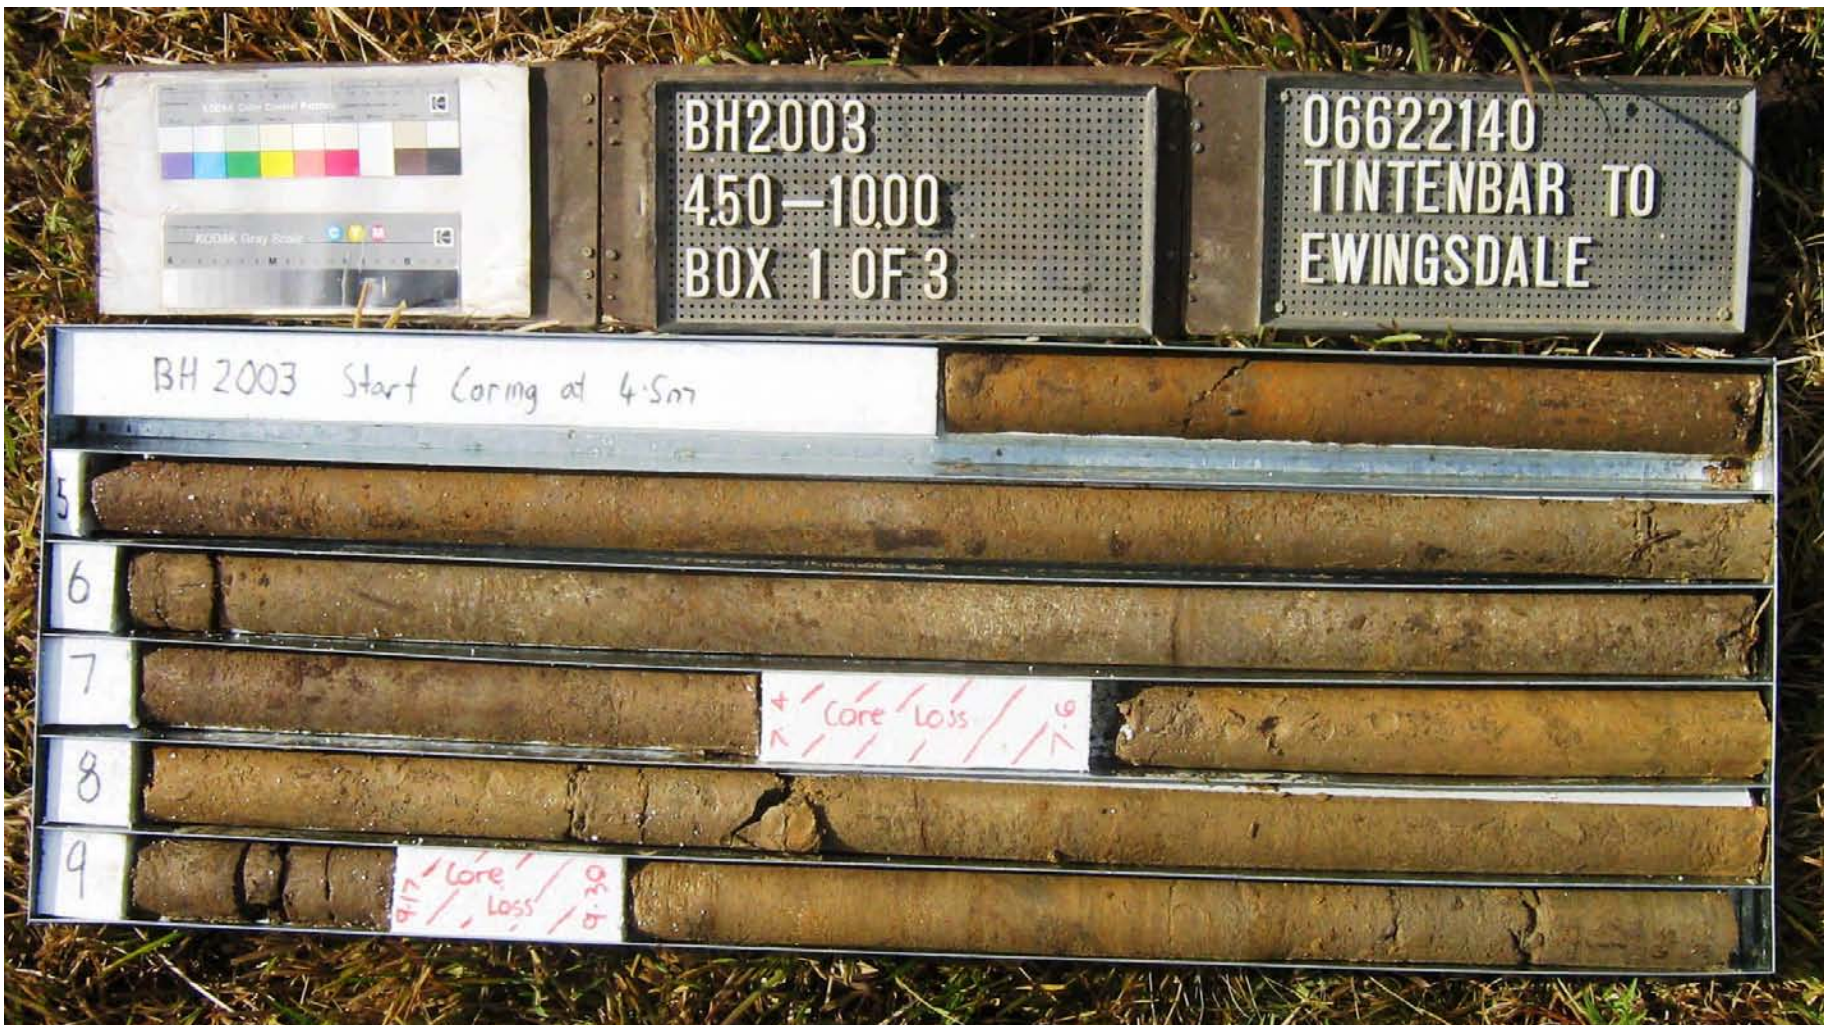
SHEET: 1 OF 3
DRILL RIG: Pioneer 120
DRILLER: North Coast Drilling
LOGGED: AM DATE: 16/7/07
CHECKED: CSC DATE: 10/8/07

COORDS: 552178.1 m E 6821040.2 m N 56 MGA94
SURFACE RL: 96.94 m DATUM: AHD
INCLINATION: -90°
HOLE DIA: 100/76 mm HOLE DEPTH: 19.80 m

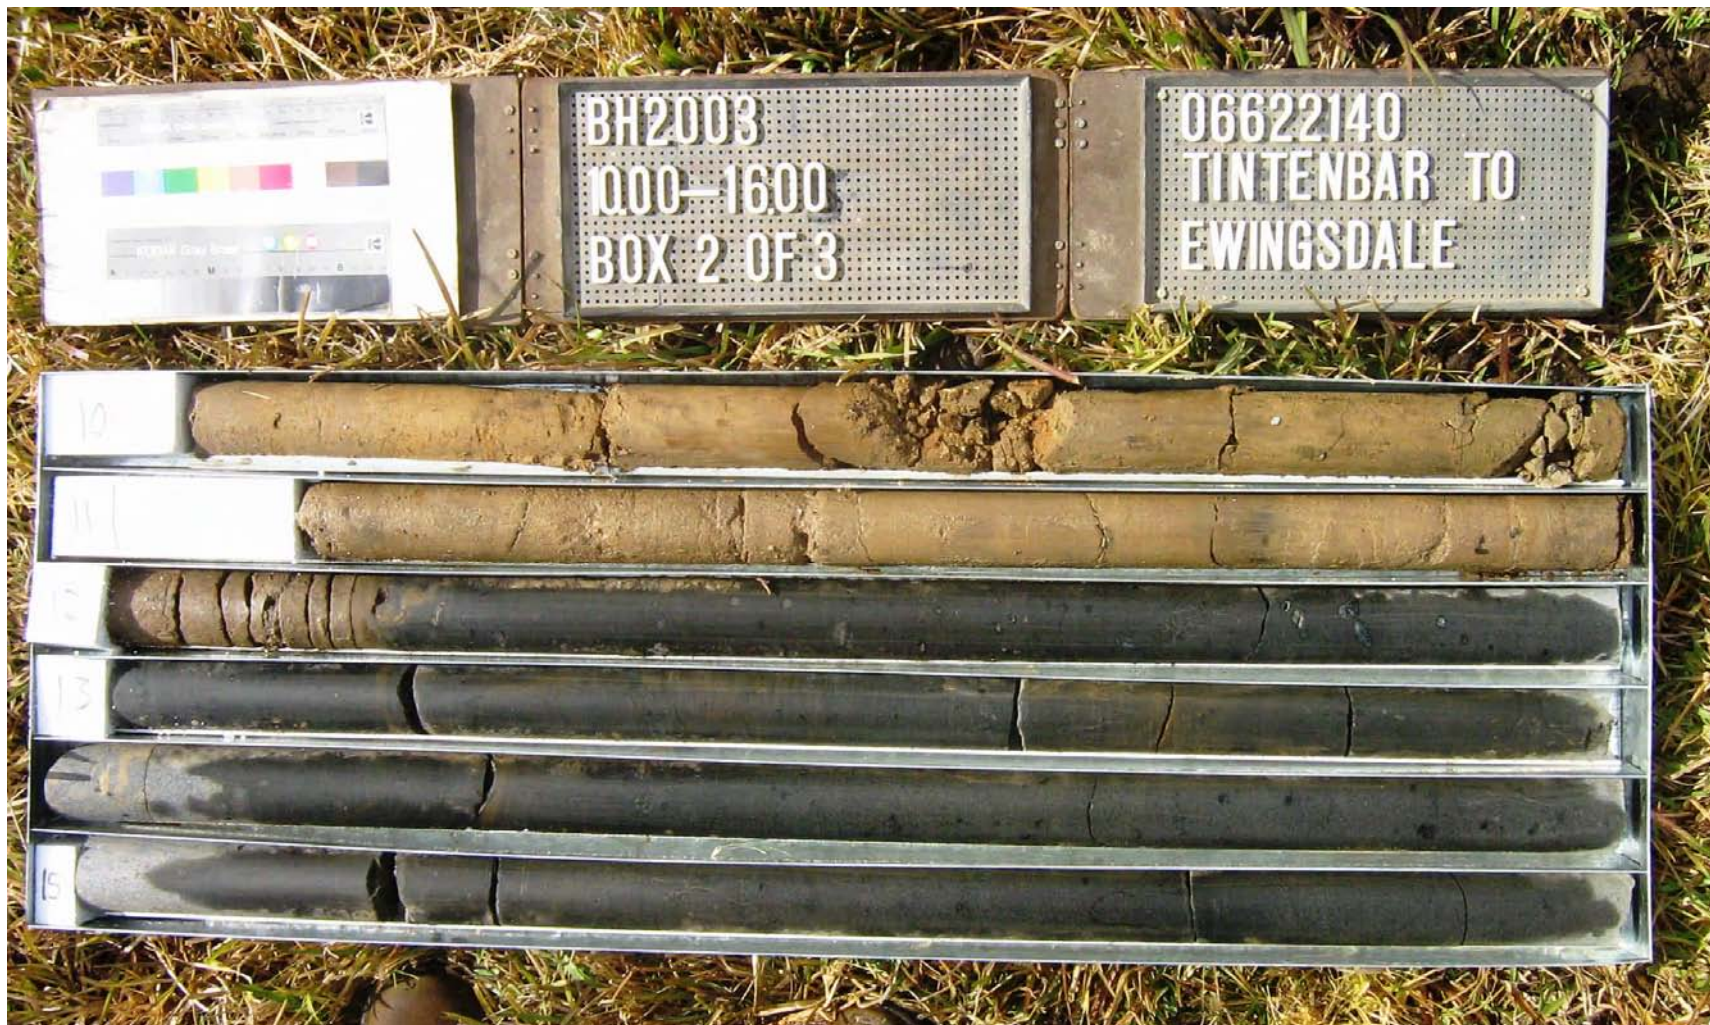
SHEET: 2 OF 3
DRILL RIG: Pioneer 120
DRILLER: North Coast Drilling
LOGGED: AM DATE: 16/7/07
CHECKED: CSC DATE: 10/8/07

COORDS: 552178.1 m E 6821040.2 m N 56 MGA94
SURFACE RL: 96.94 m DATUM: AHD
INCLINATION: -90°
HOLE DIA: 100/76 mm HOLE DEPTH: 19.80 m

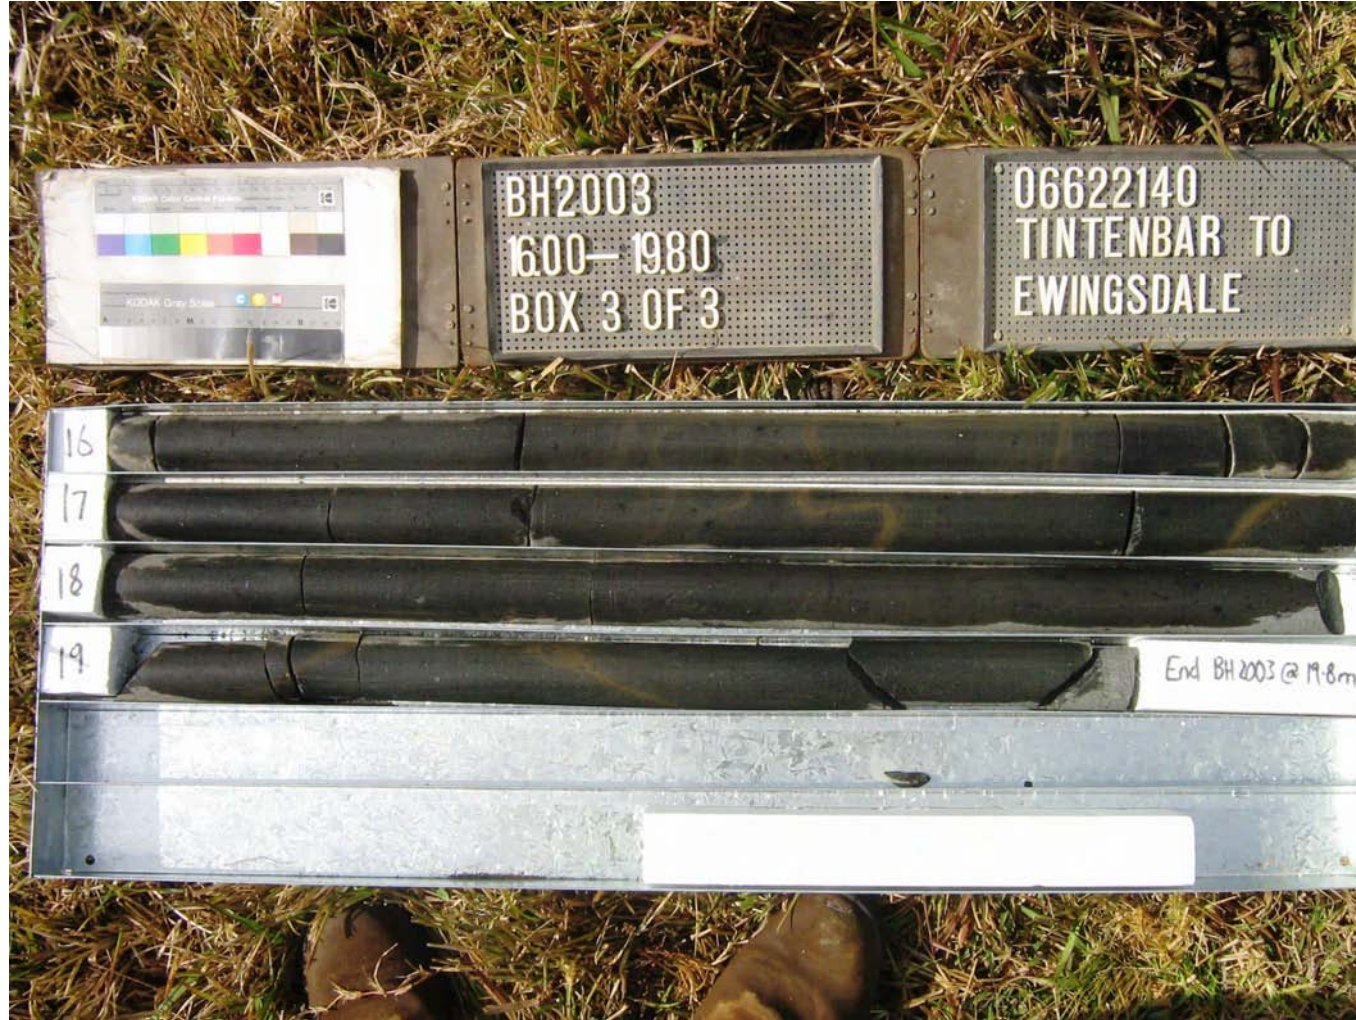
SHEET: 3 OF 3
DRILL RIG: Pioneer 120
DRILLER: North Coast Drilling
LOGGED: AM DATE: 16/7/07
CHECKED: CSC DATE: 10/8/07

COORDS: 552178.1 m E 6821040.2 m N 56 MGA94
SURFACE RL: 96.94 m DATUM: AHD
INCLINATION: -90°
HOLE DIA: 100/76 mm HOLE DEPTH: 19.80 m

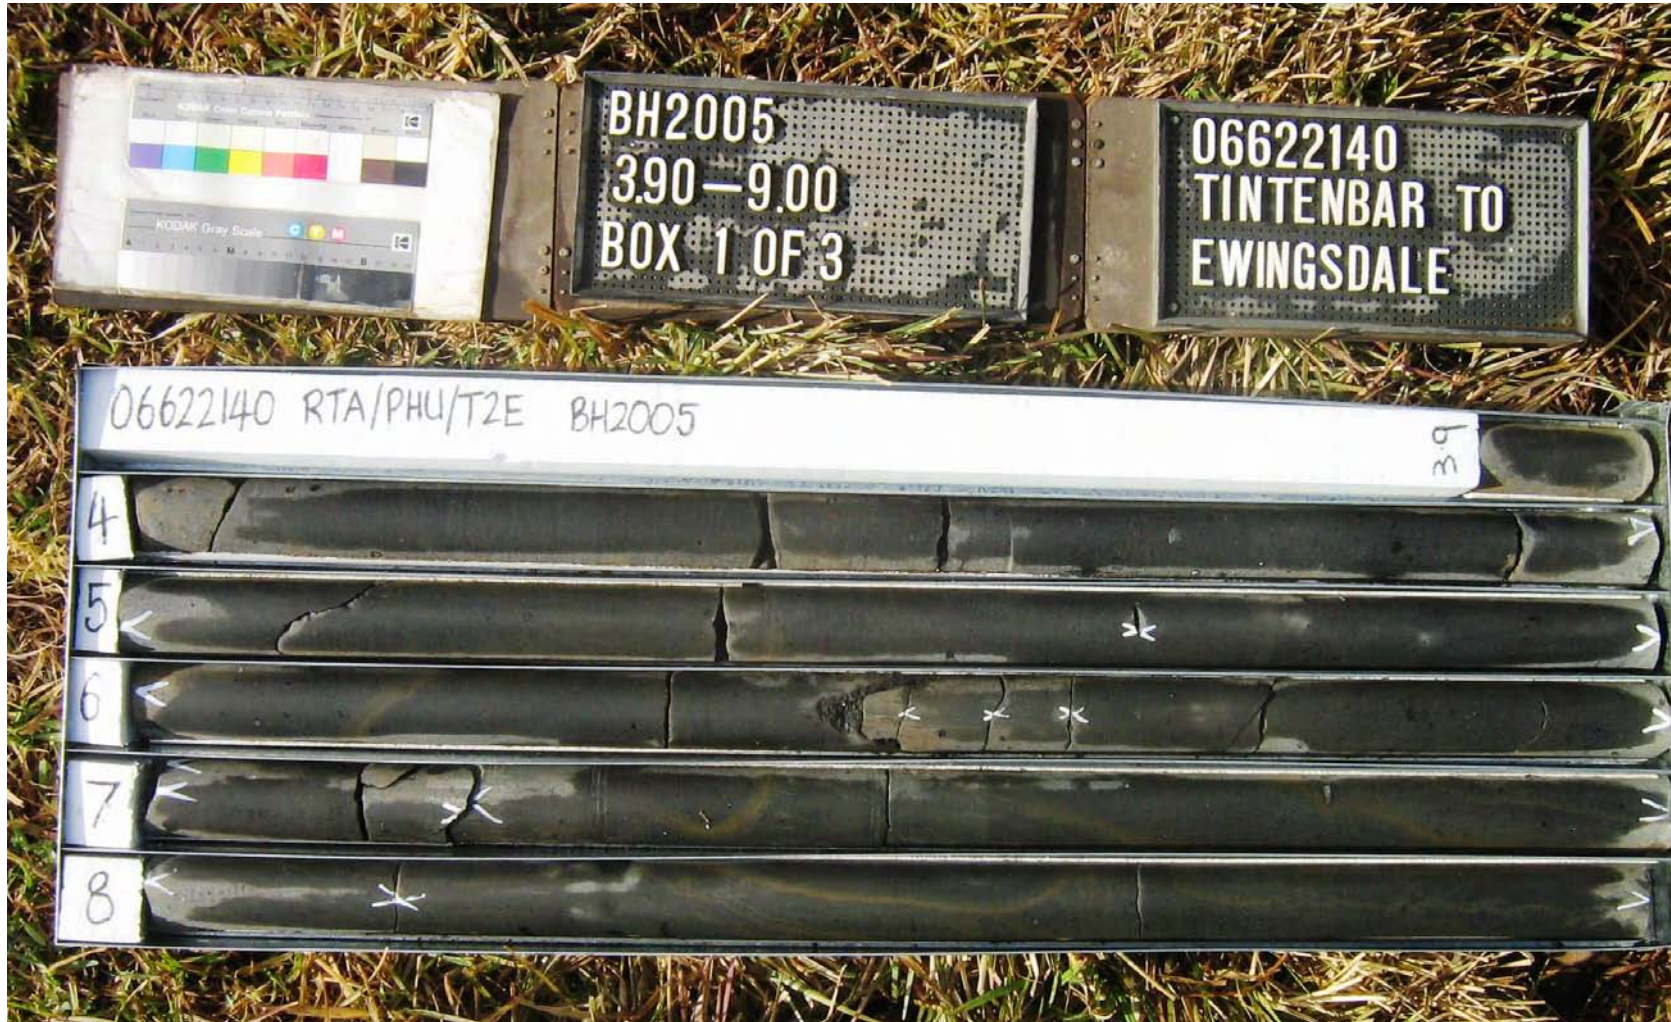
SHEET: 1 OF 3
 DRILL RIG: Pioneer 120
 DRILLER: North Coast Drilling
 LOGGED: BC DATE: 19/7/07
 CHECKED: CSC DATE: 10/8/07

COORDS: 552216.8 m E 6821076.9 m N 56 MGA94
 SURFACE RL: 88.99 m DATUM: AHD
 INCLINATION: -90°
 HOLE DIA: 100/76 mm HOLE DEPTH: 15.40 m

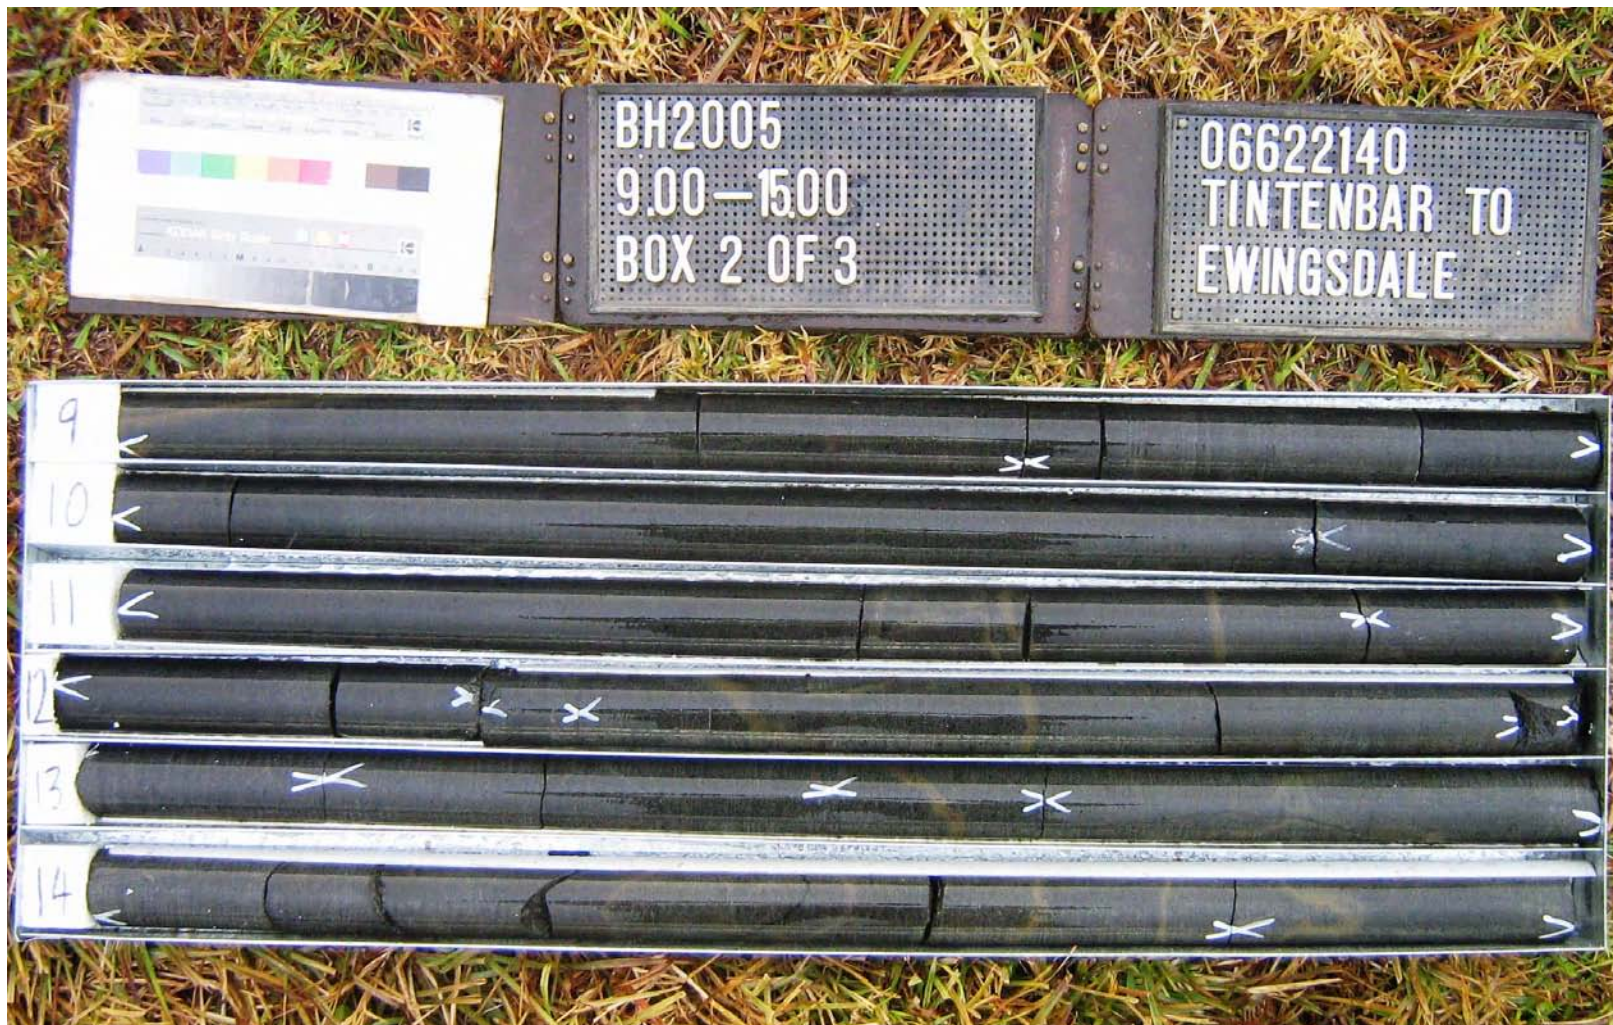
SHEET: 2 OF 3
DRILL RIG: Pioneer 120
DRILLER: North Coast Drilling
LOGGED: BC DATE: 19/7/07
CHECKED: CSC DATE: 10/8/07

COORDS: 552216.8 m E 6821076.9 m N 56 MGA94
SURFACE RL: 88.99 m DATUM: AHD
INCLINATION: -90°
HOLE DIA: 100/76 mm HOLE DEPTH: 15.40 m

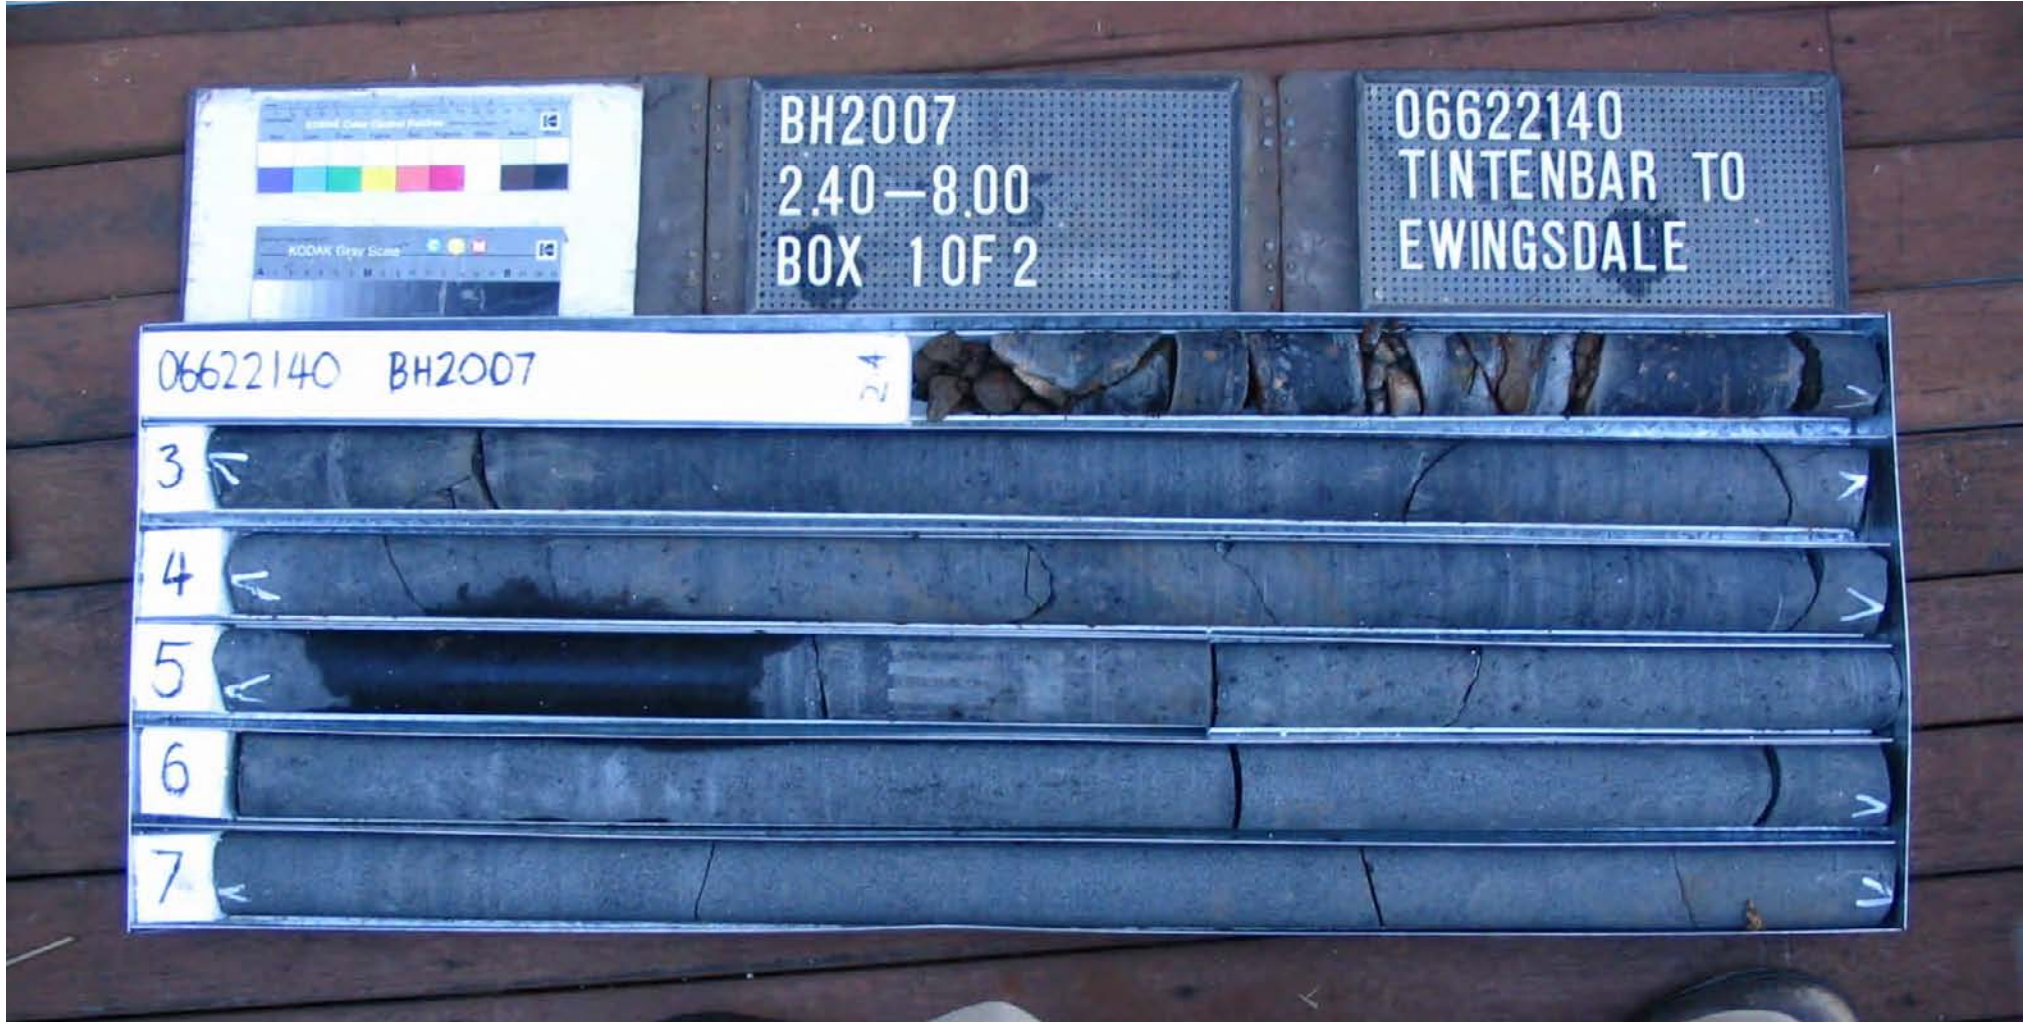
SHEET: 1 OF 2
DRILL RIG: Tracked Scout
DRILLER: Drillsearch
LOGGED: BC DATE: 28/7/07
CHECKED: CSC DATE: 13/8/07

COORDS: 552261.3 m E 6821191.7 m N 56 MGA94
SURFACE RL: 88.62 m DATUM: AHD
INCLINATION: -90°
HOLE DIA: 100/76 mm HOLE DEPTH: 11.60 m

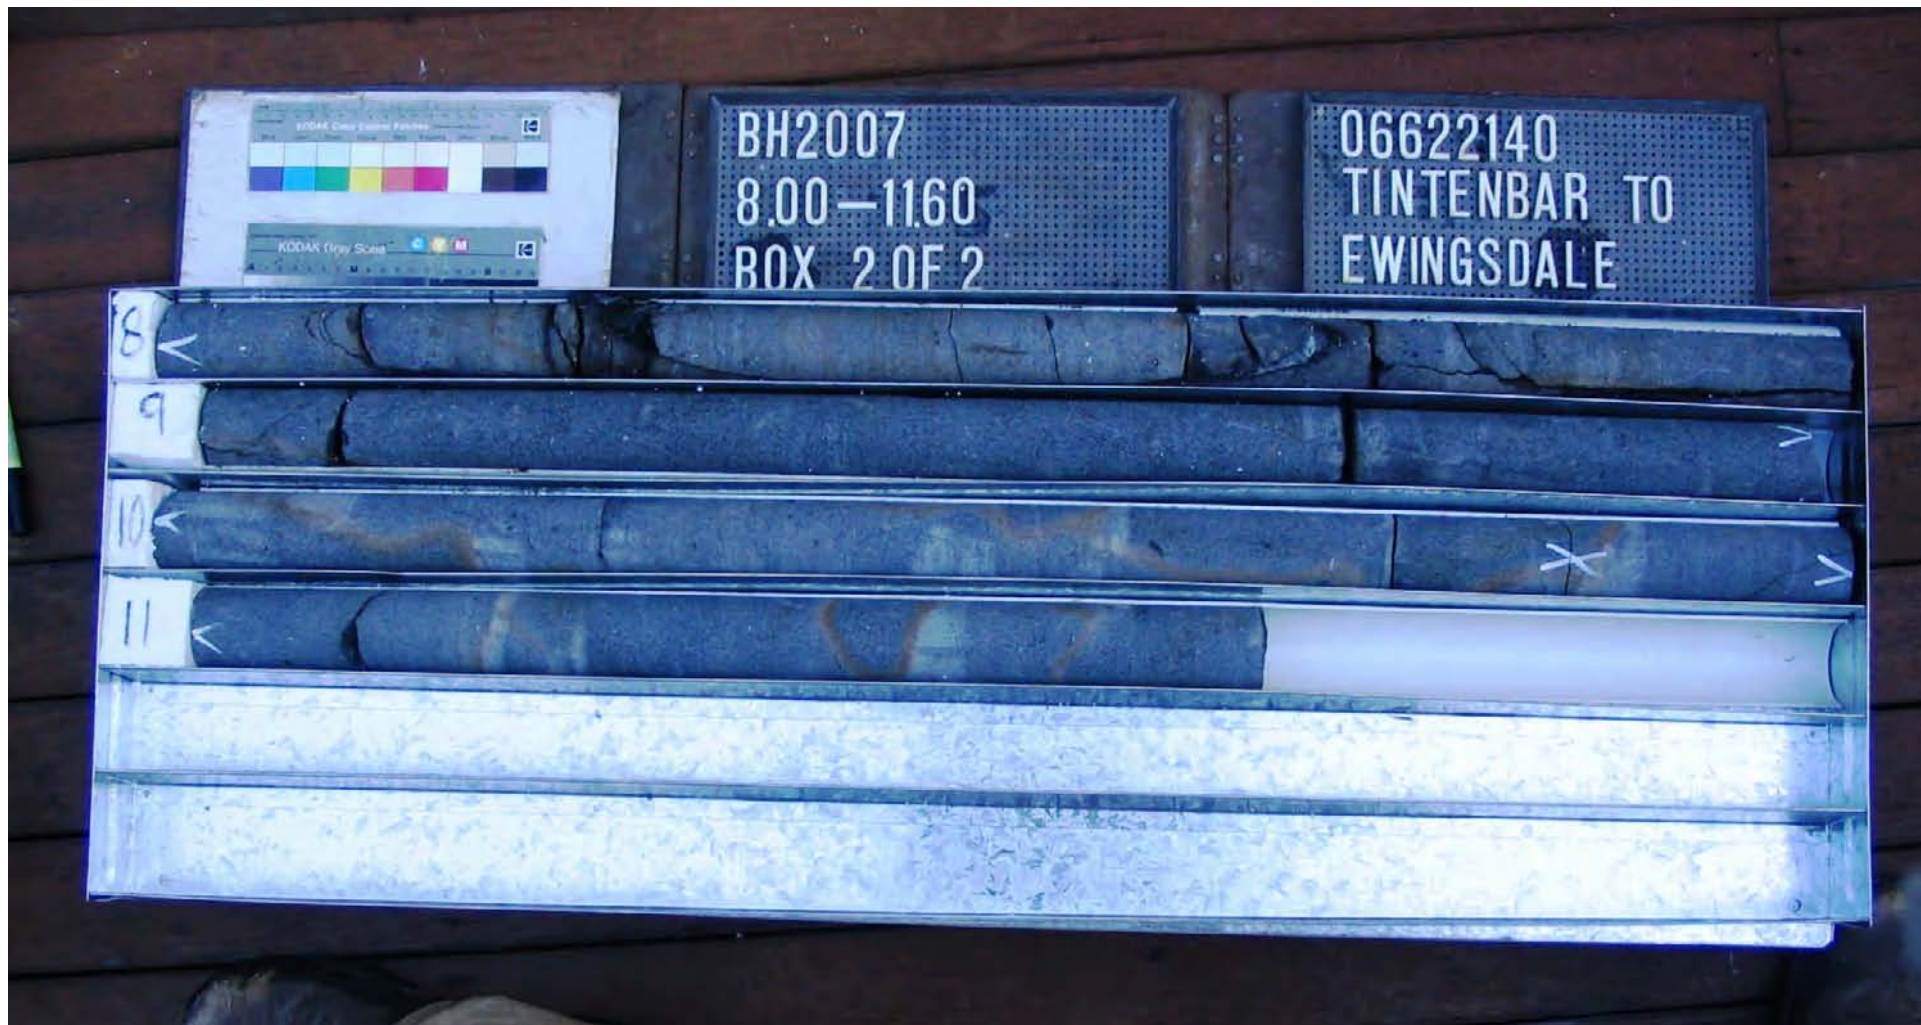
SHEET: 2 OF 2
 DRILL RIG: Tracked Scout
 DRILLER: Drillsearch
 LOGGED: BC DATE: 28/7/07
 CHECKED: CSC DATE: 13/8/07

COORDS: 552261.3 m E 6821191.7 m N 56 MGA94
 SURFACE RL: 88.62 m DATUM: AHD
 INCLINATION: -90°
 HOLE DIA: 100/76 mm HOLE DEPTH: 11.60 m

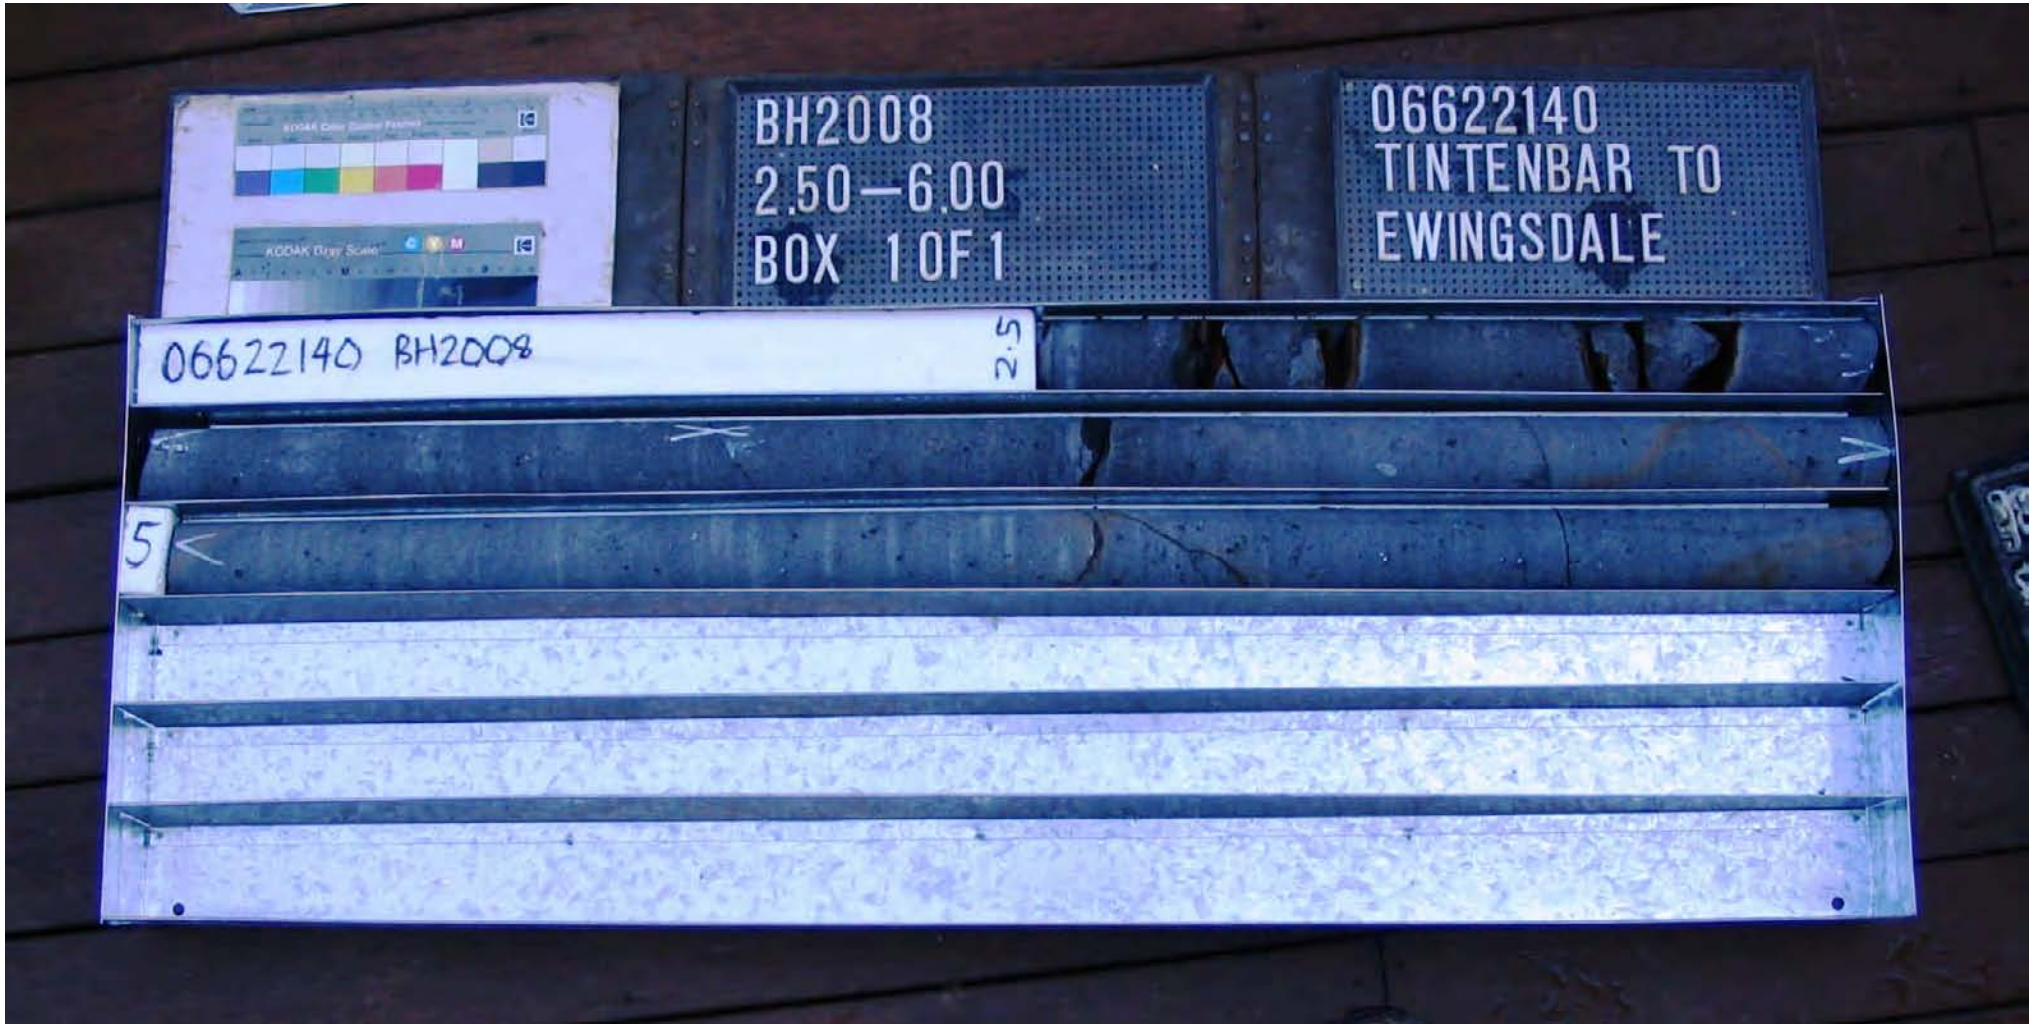
SHEET: 1 OF 1
 DRILL RIG: Tracked Scout
 DRILLER: Drillsearch
 LOGGED: BC DATE: 27/7/07
 CHECKED: CSC DATE: 13/8/07

COORDS: 552262.1 m E 6821190.6 m N 56 MGA94
 SURFACE RL: 88.58 m DATUM: AHD
 INCLINATION: -90°
 HOLE DIA: 100/76 mm HOLE DEPTH: 5.00 m
