Appendix A
Director-General's Requirements
And
Project Description

Director General's Requirements for the Environmental Assessment of Proposed Pacific Highway Upgrade between Tintenbar and Ewingsdale

Director-General's Requirements

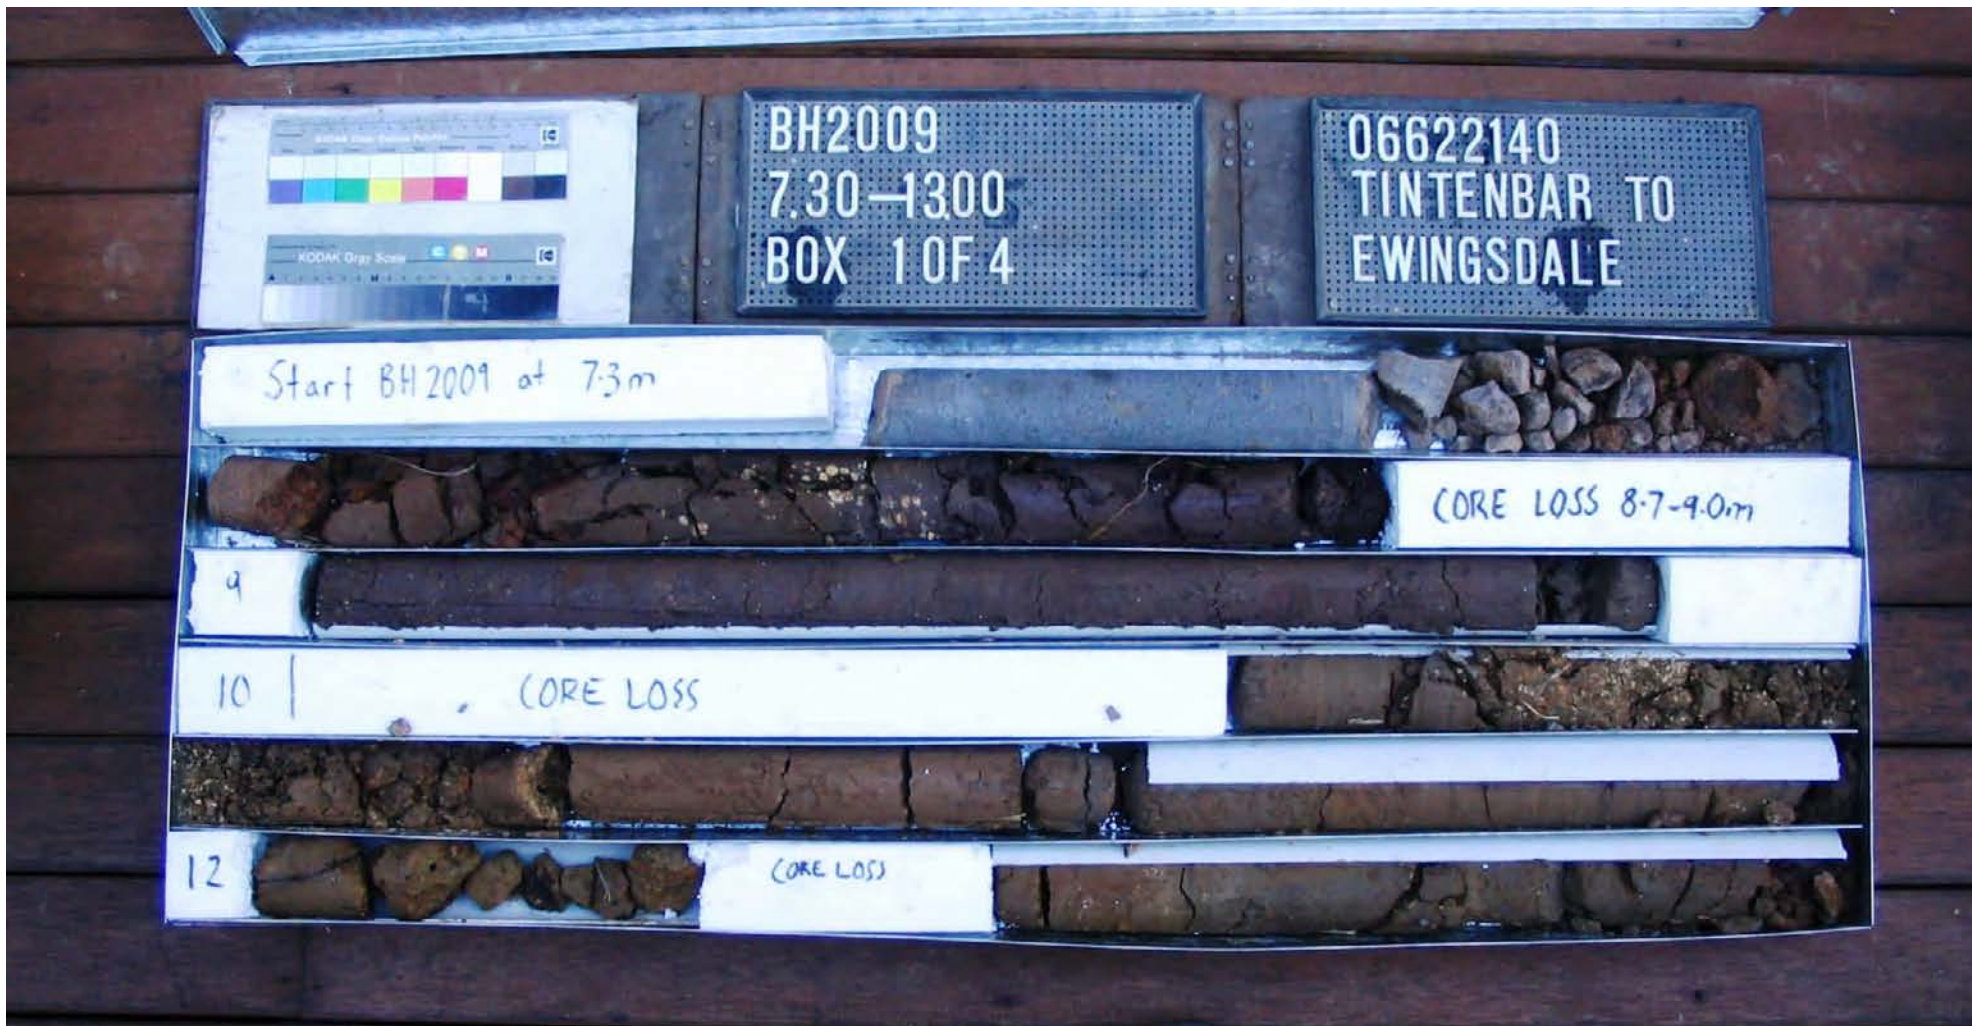
SHEET: 1 OF 4
DRILL RIG: Pioneer 120
DRILLER: North Coast Drilling
LOGGED: AM DATE: 13/7/07
CHECKED: CSC DATE: 13/8/07

COORDS: 552966.8 m E 6828454.4 m N 56 MGA94
SURFACE RL: 94.30 m DATUM: AHD
INCLINATION: -90°
HOLE DIA: 100/76 mm HOLE DEPTH: 30.30 m

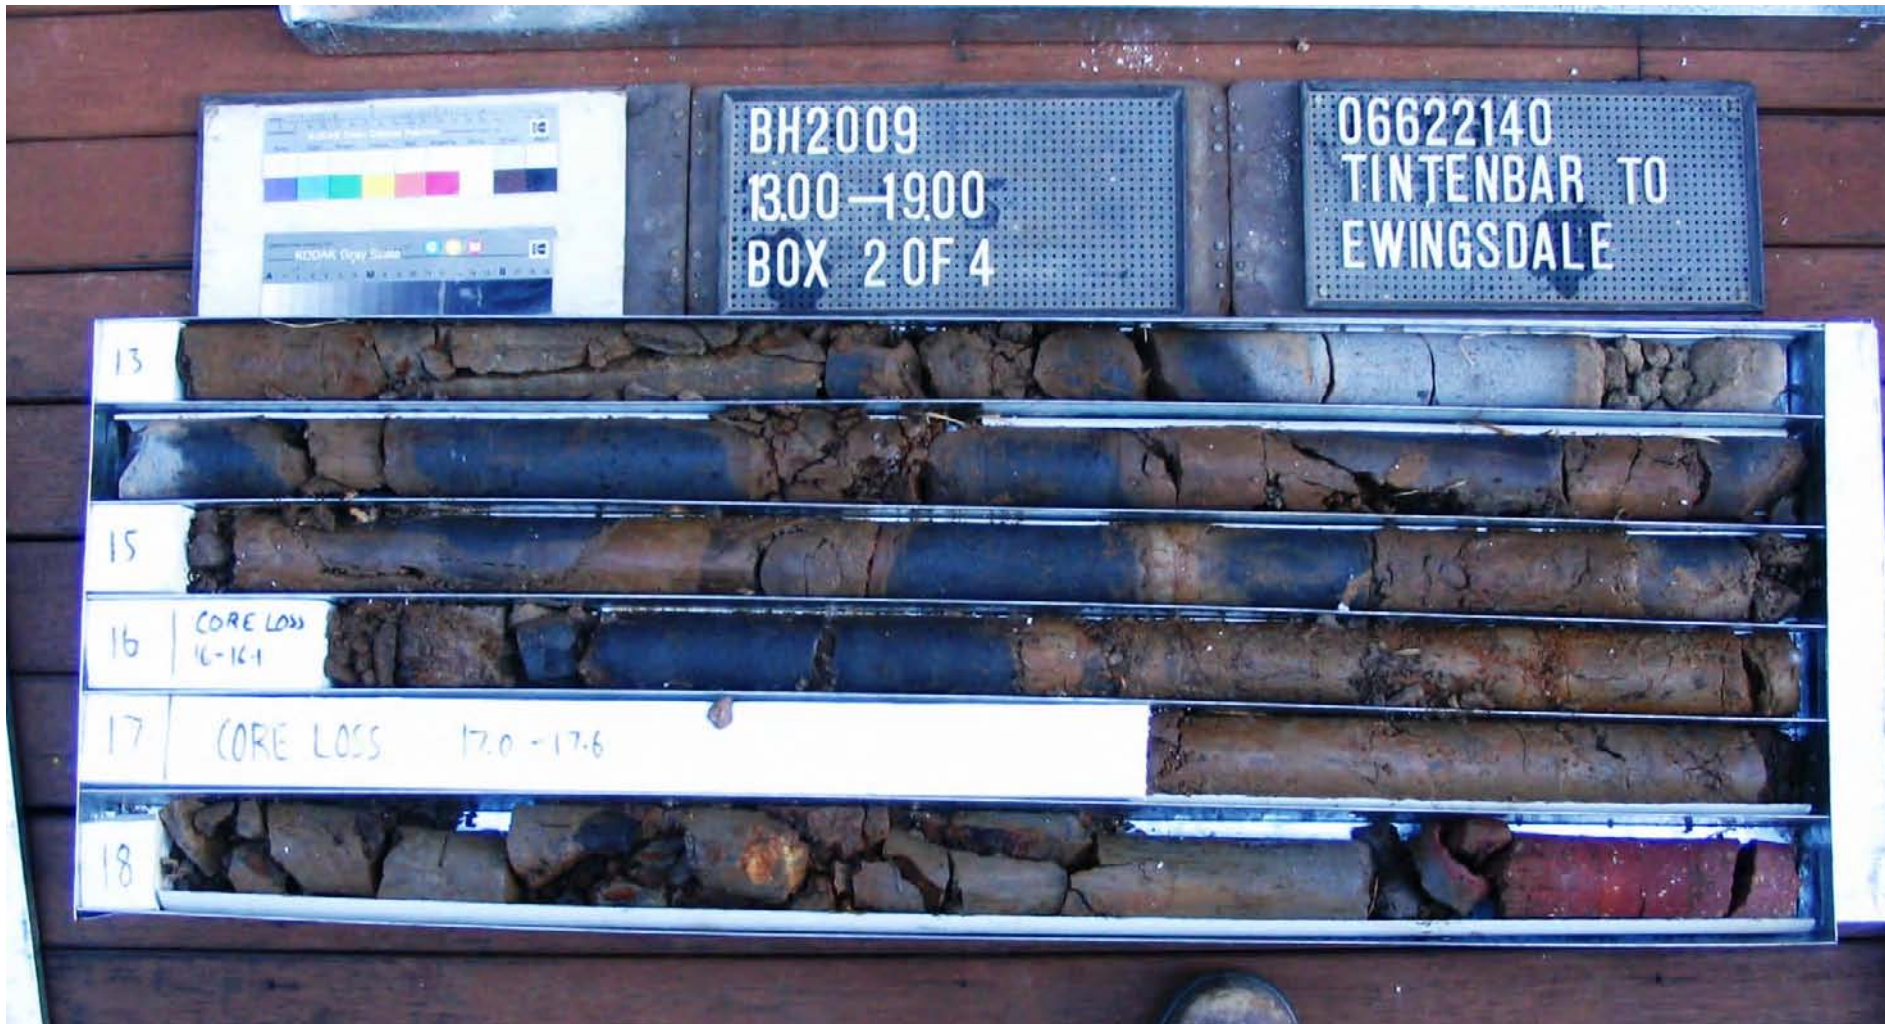
SHEET: 2 OF 4
DRILL RIG: Pioneer 120
DRILLER: North Coast Drilling
LOGGED: AM DATE: 13/7/07
CHECKED: CSC DATE: 13/8/07

COORDS: 552966.8 m E 6828454.4 m N 56 MGA94
SURFACE RL: 94.30 m DATUM: AHD
INCLINATION: -90°
HOLE DIA: 100/76 mm HOLE DEPTH: 30.30 m

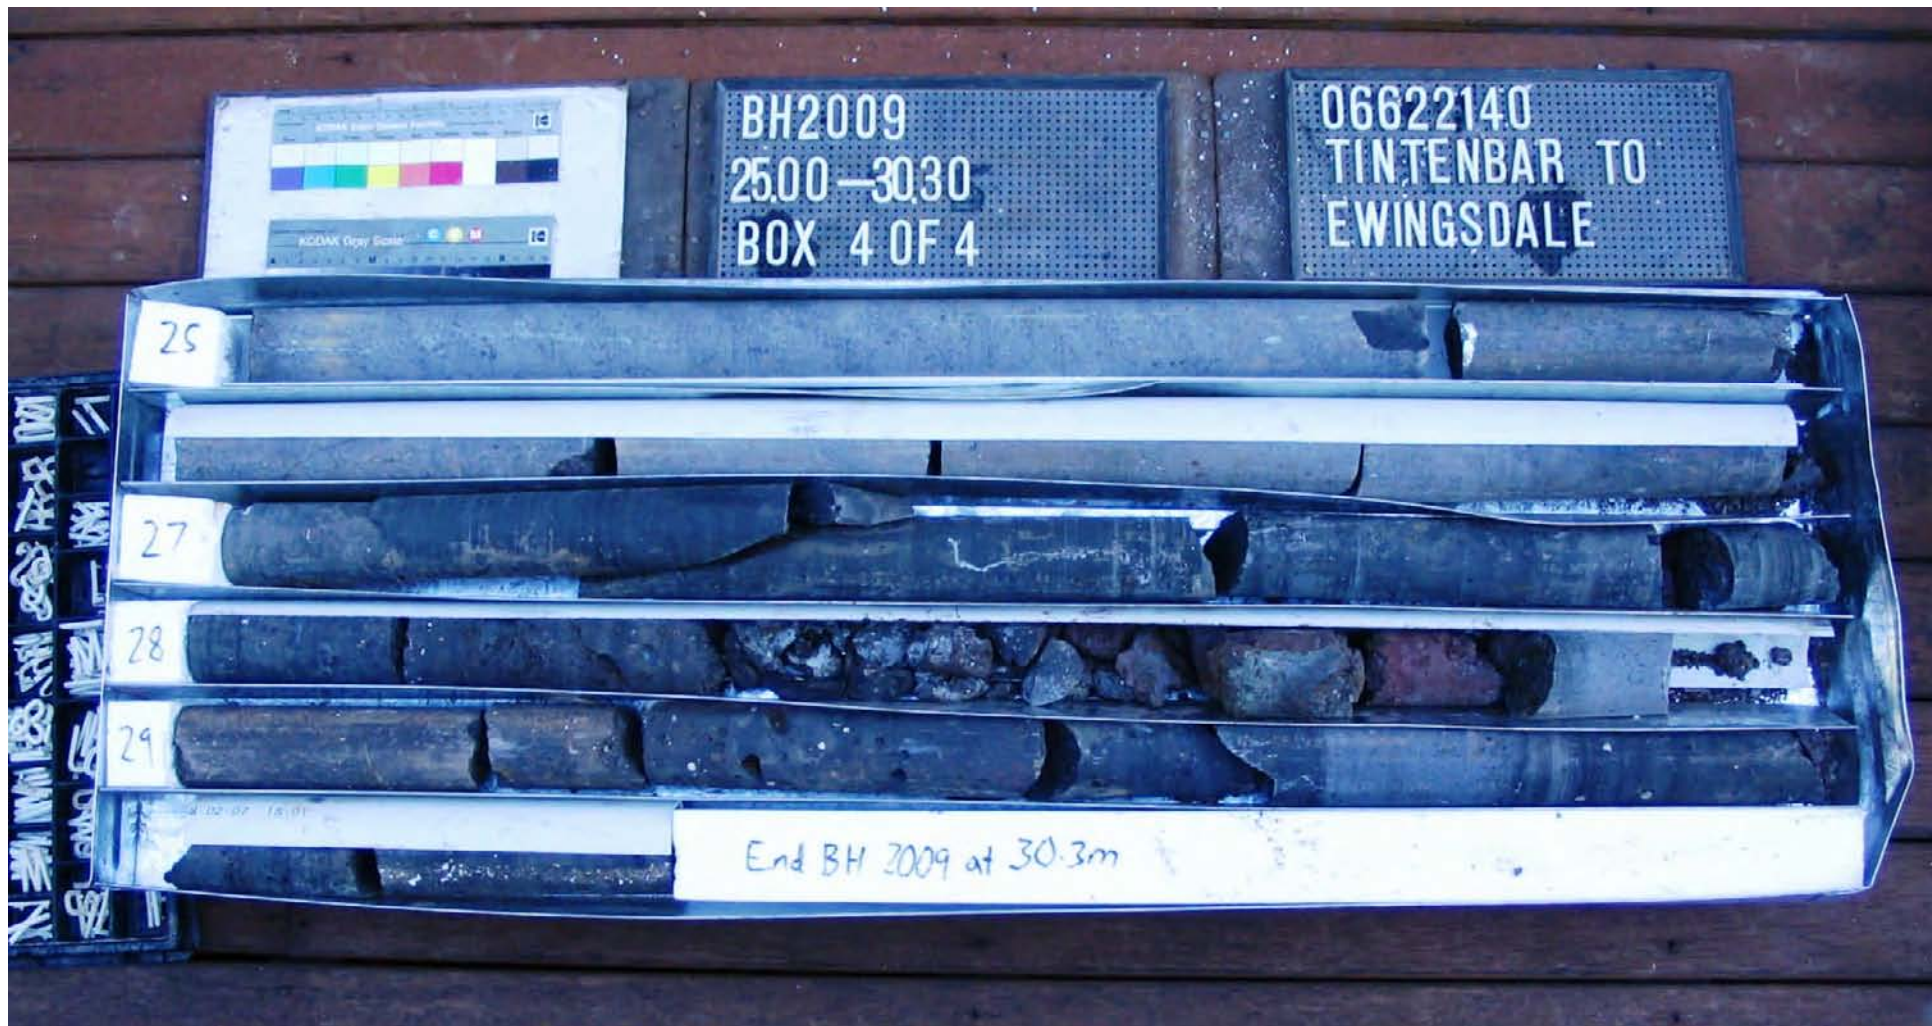
SHEET: 4 OF 4
DRILL RIG: Pioneer 120
DRILLER: North Coast Drilling
LOGGED: AM DATE: 13/7/07
CHECKED: CSC DATE: 13/8/07

COORDS: 552966.8 m E 6828454.4 m N 56 MGA94
SURFACE RL: 94.30 m DATUM: AHD
INCLINATION: -90°
HOLE DIA: 100/76 mm HOLE DEPTH: 30.30 m

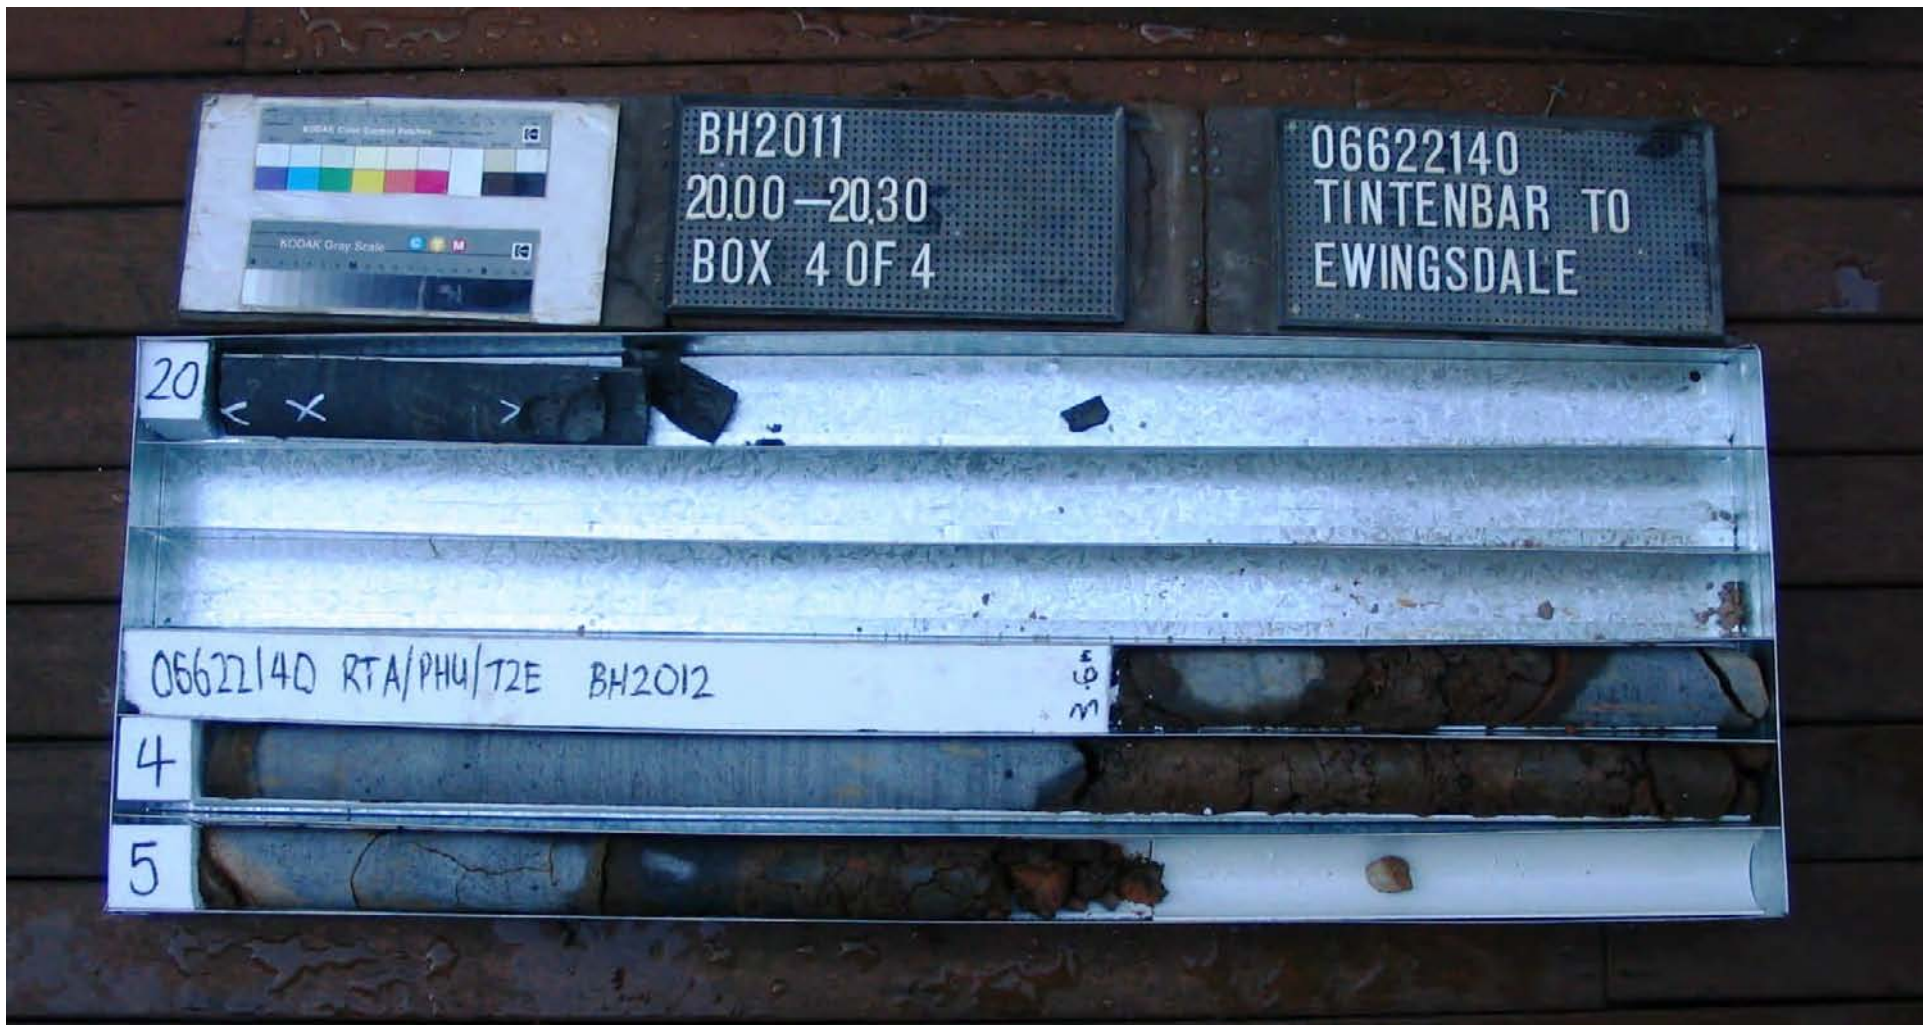
SHEET: 4 OF 4
 DRILL RIG: Pioneer 120
 DRILLER: North Coast Drilling
 LOGGED: BC DATE: 17/7/07
 CHECKED: CSC DATE: 13/8/07

COORDS: 553040.9 m E 6828442.5 m N 56 MGA94
 SURFACE RL: 84.58 m DATUM: AHD
 INCLINATION: -90°
 HOLE DIA: 100/76 mm HOLE DEPTH: 20.30 m

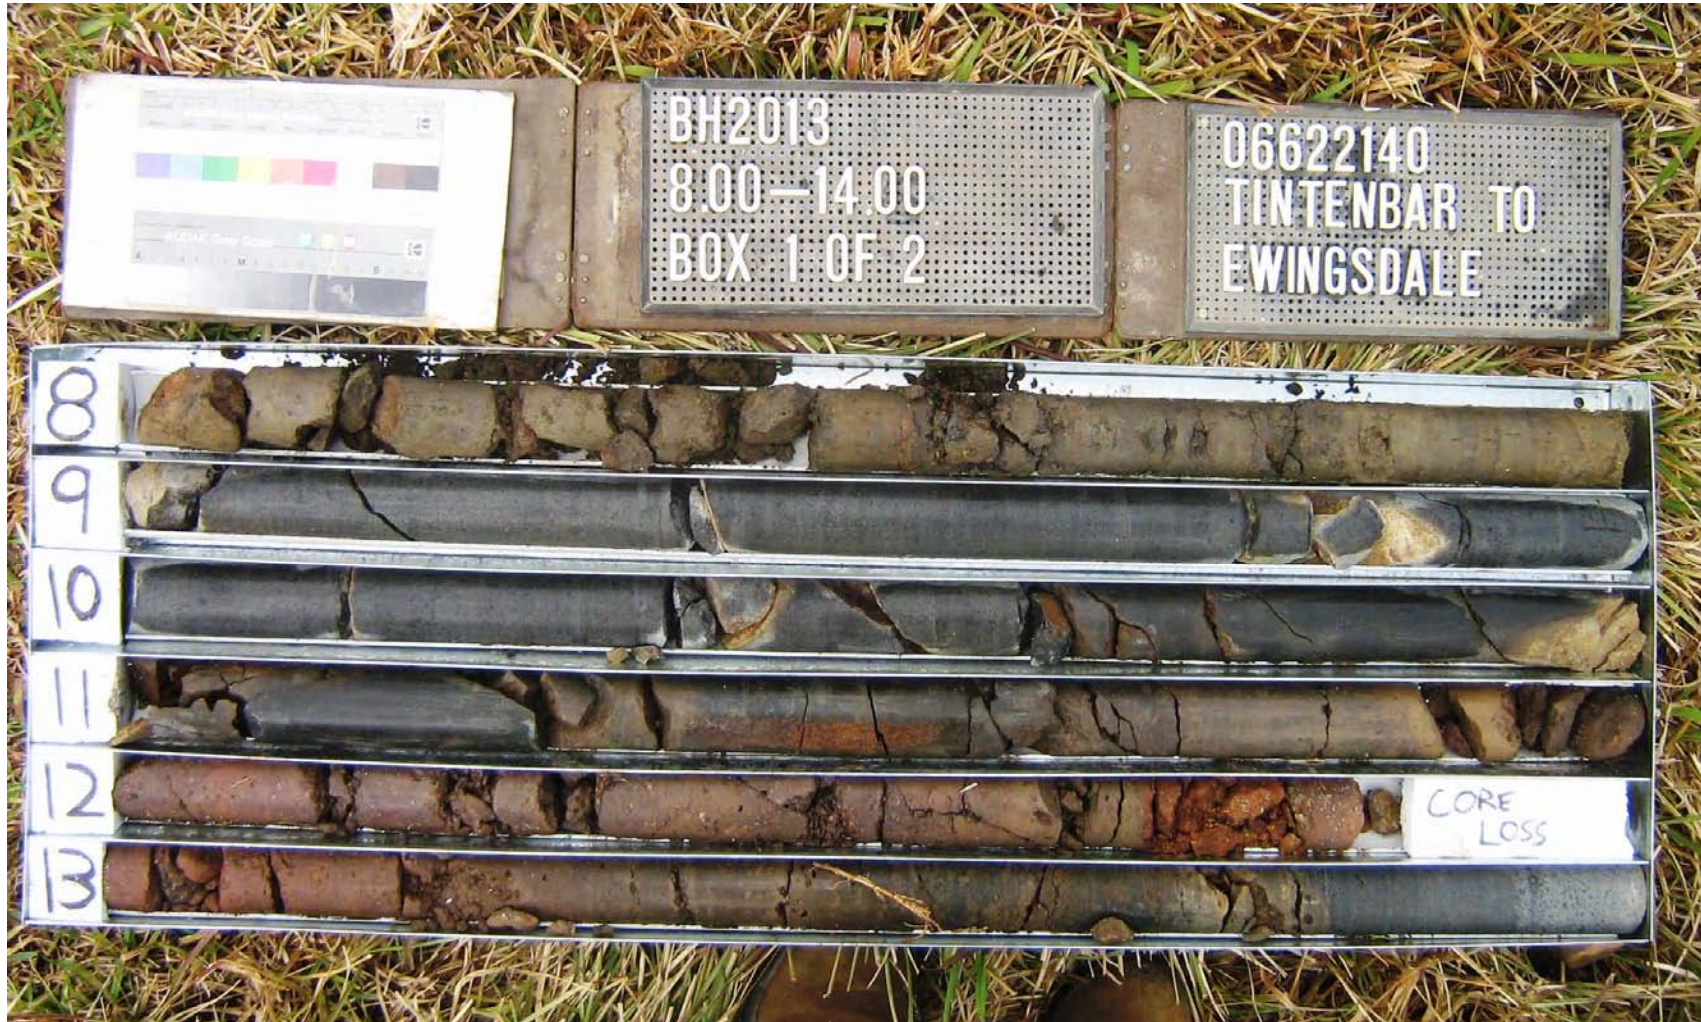
SHEET: 1 OF 2
DRILL RIG: Gemco
DRILLER: Drillsearch
LOGGED: NPP DATE: 21/7/07
CHECKED: CSC DATE: 13/8/07

COORDS: 553097 m E 6828453.7 m N 56 MGA94
SURFACE RL: 75.93 m DATUM: AHD
INCLINATION: -90°
HOLE DIA: 100/76 mm HOLE DEPTH: 18.00 m

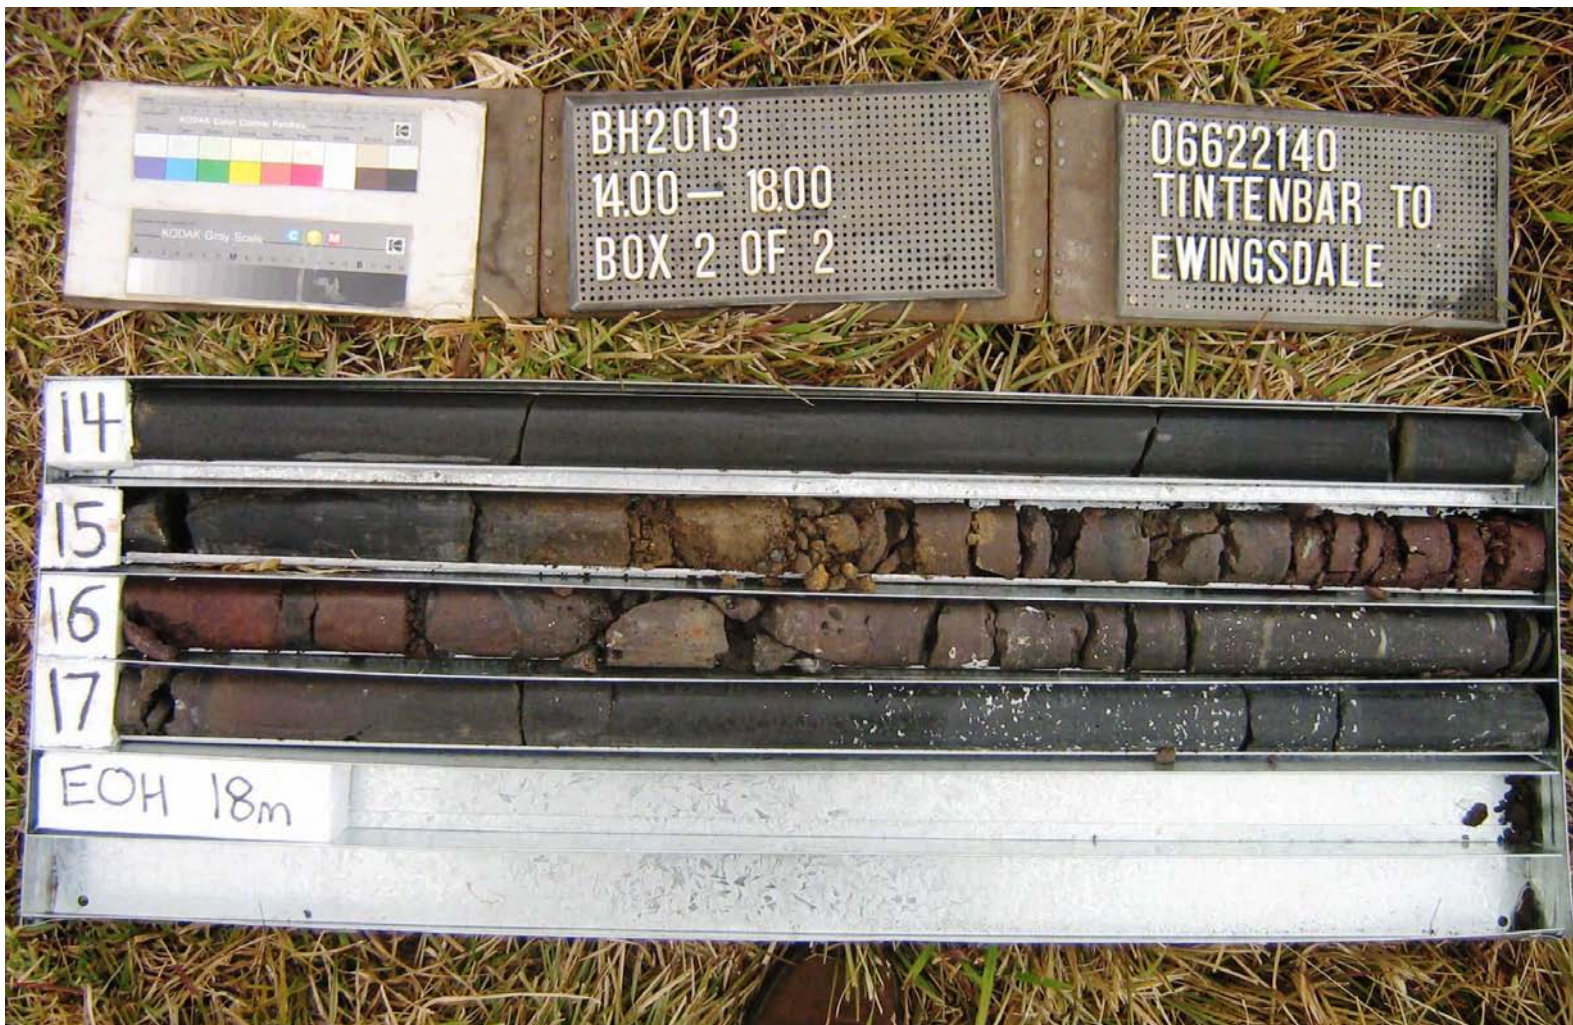
SHEET: 2 OF 2
DRILL RIG: Gemco
DRILLER: Drillsearch
LOGGED: NPP DATE: 21/7/07
CHECKED: CSC DATE: 13/8/07

COORDS: 553097 m E 6828453.7 m N 56 MGA94
SURFACE RL: 75.93 m DATUM: AHD
INCLINATION: -90°
HOLE DIA: 100/76 mm HOLE DEPTH: 18.00 m

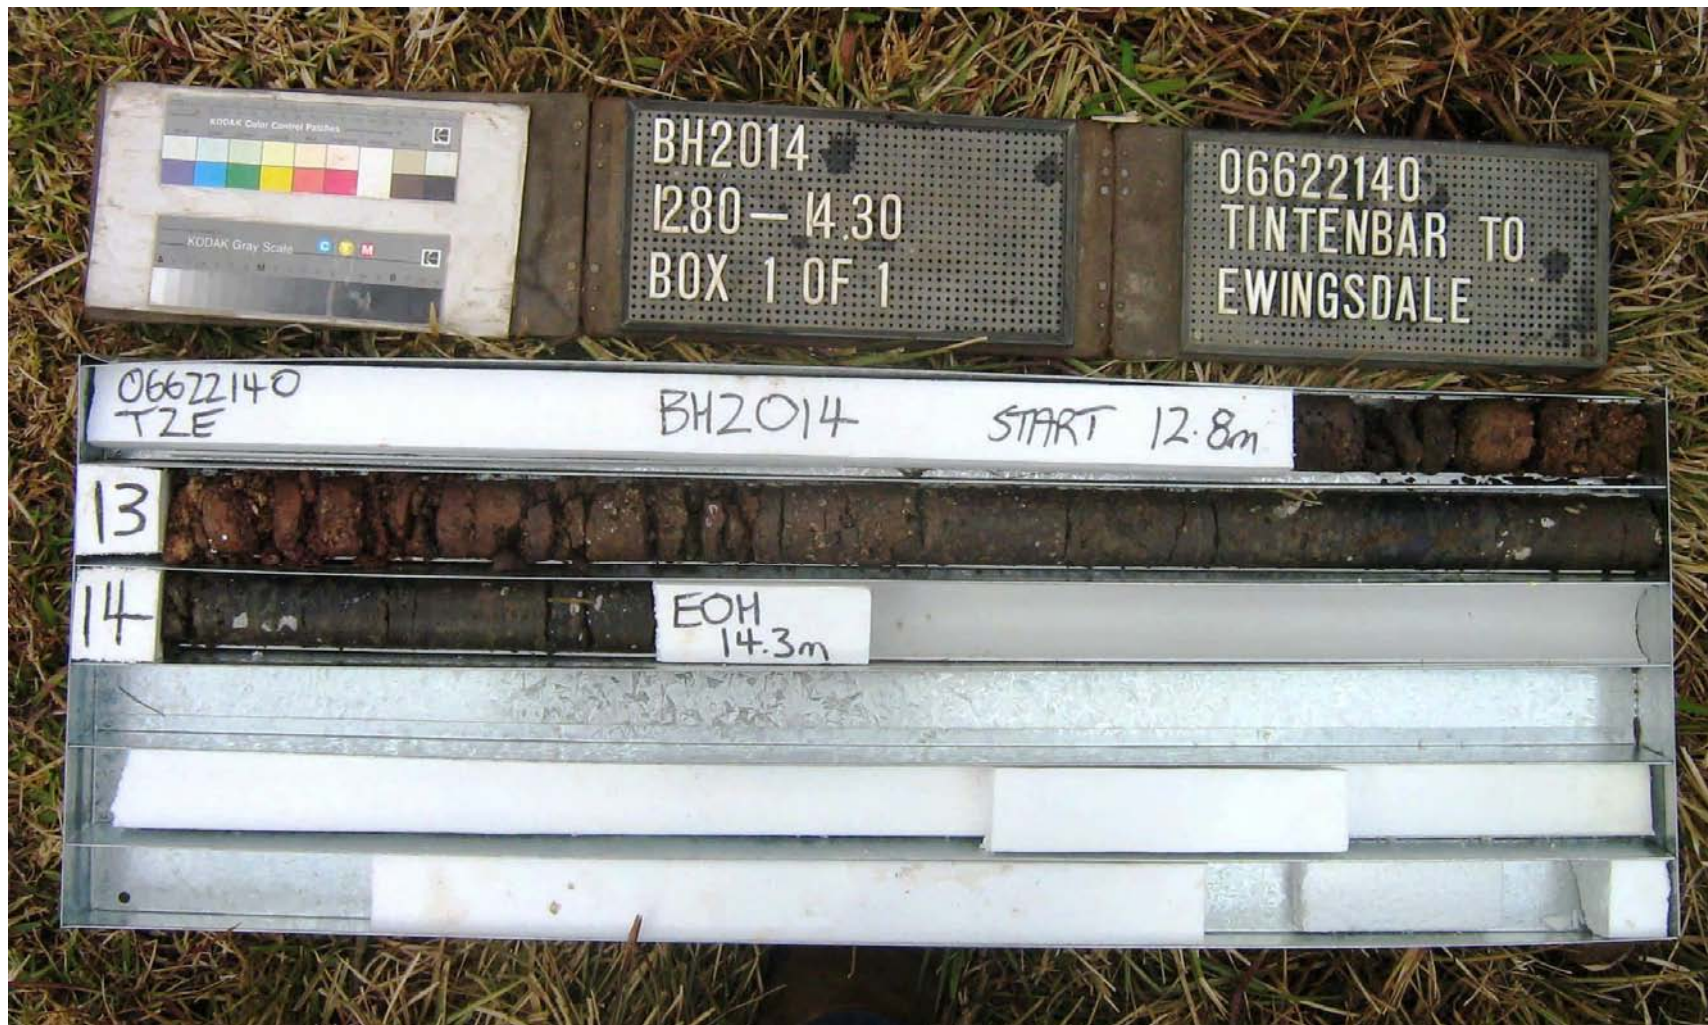
SHEET: 1 OF 1
 DRILL RIG: Gemco
 DRILLER: Drillsearch
 LOGGED: NPP DATE: 21/7/07
 CHECKED: CSC DATE: 13/8/07

COORDS: 553094.4 m E 6828456.5 m N 56 MGA94
 SURFACE RL: 76.03 m DATUM: AHD
 INCLINATION: -90°
 HOLE DIA: 100/76 mm HOLE DEPTH: 14.30 m

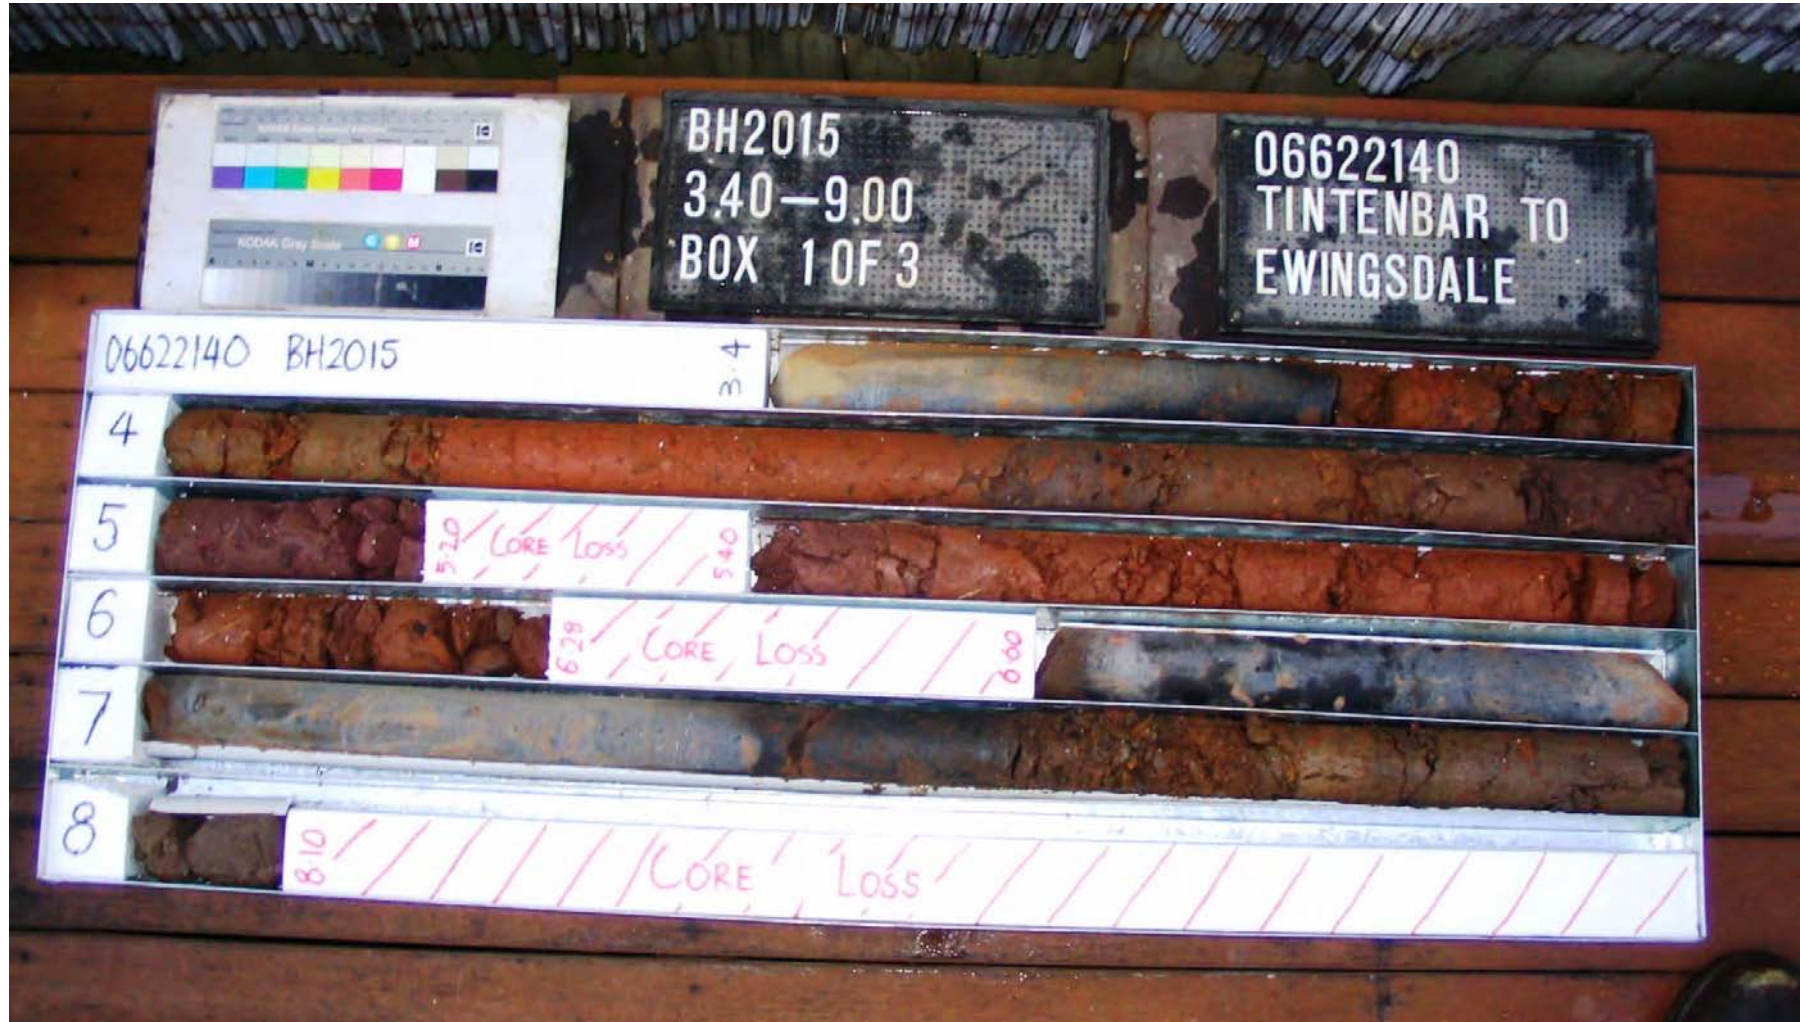
SHEET: 1 OF 3
 DRILL RIG: Tracked Scout
 DRILLER: Drillsearch
 LOGGED: BC DATE: 25/7/07
 CHECKED: CSC DATE: 13/8/07

COORDS: 553127.7 m E 6828430.5 m N 56 MGA94
 SURFACE RL: 69.35 m DATUM: AHD
 INCLINATION: -90°
 HOLE DIA: 100/76 mm HOLE DEPTH: 16.60 m

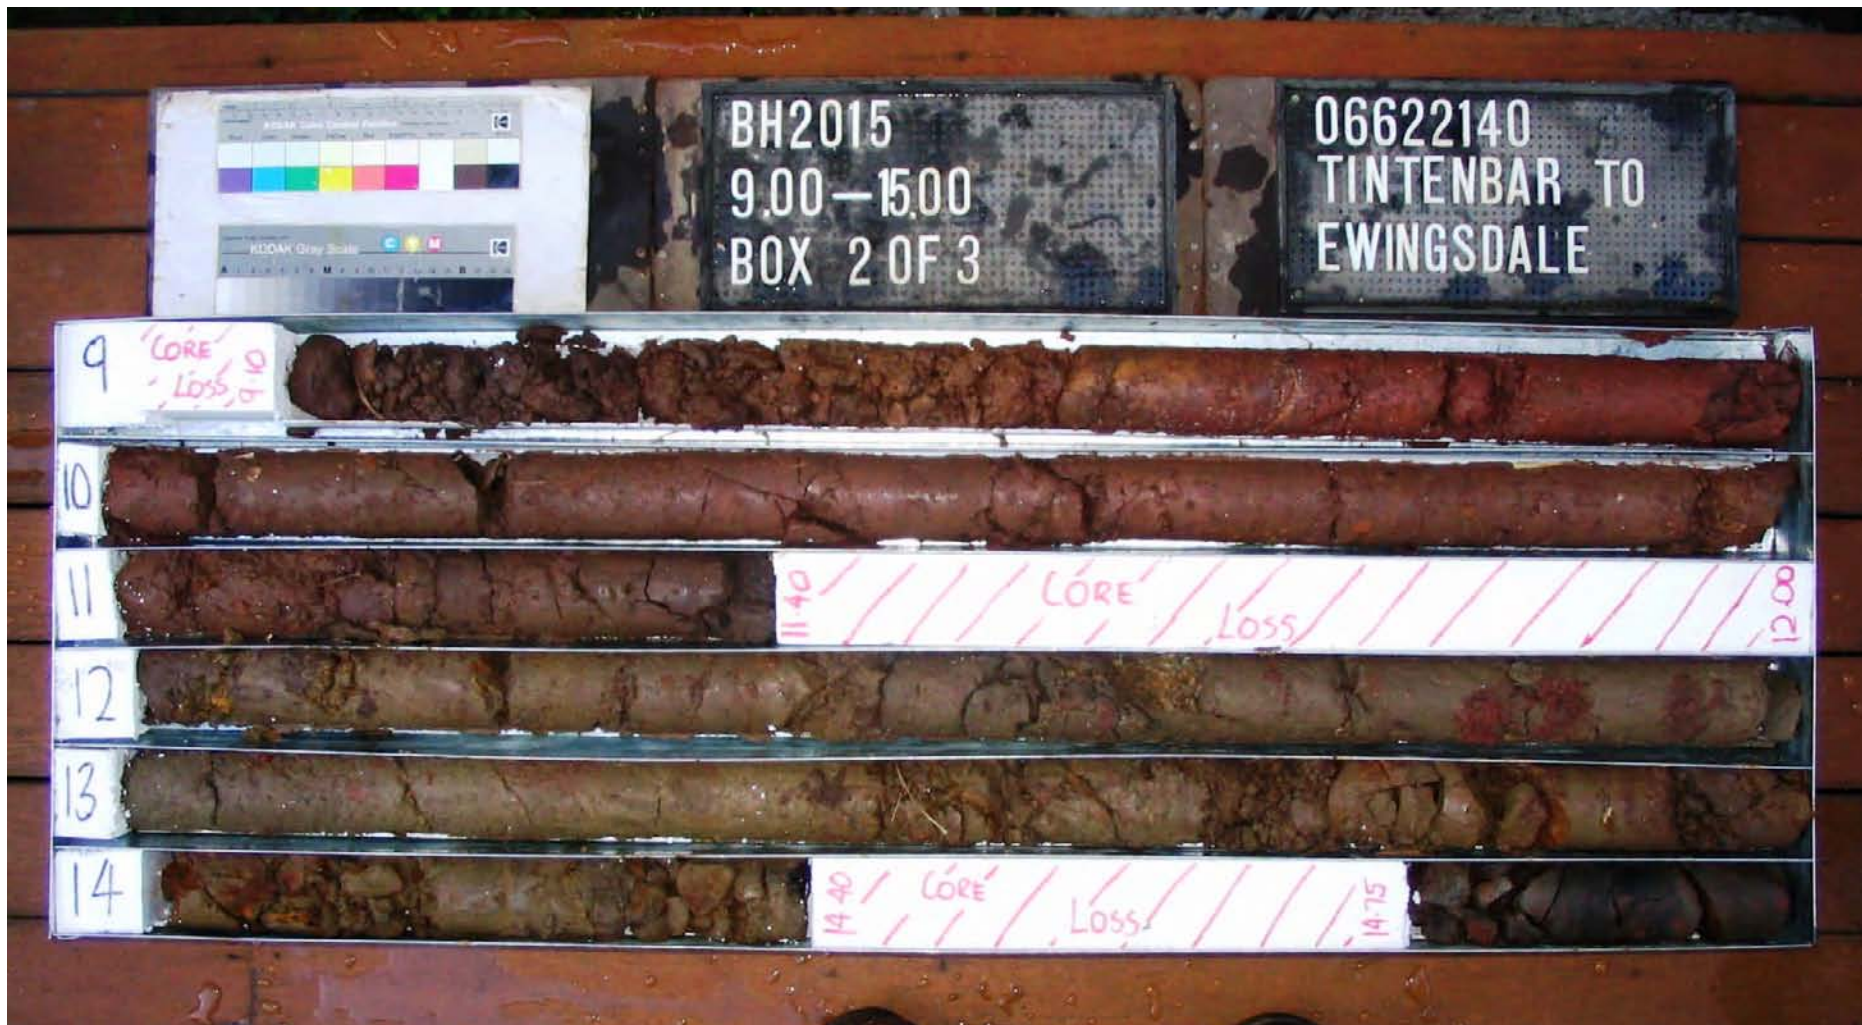
SHEET: 2 OF 3
DRILL RIG: Tracked Scout
DRILLER: Drillsearch
LOGGED: BC DATE: 25/7/07
CHECKED: CSC DATE: 13/8/07

COORDS: 553127.7 m E 6828430.5 m N 56 MGA94
SURFACE RL: 69.35 m DATUM: AHD
INCLINATION: -90°
HOLE DIA: 100/76 mm HOLE DEPTH: 16.60 m

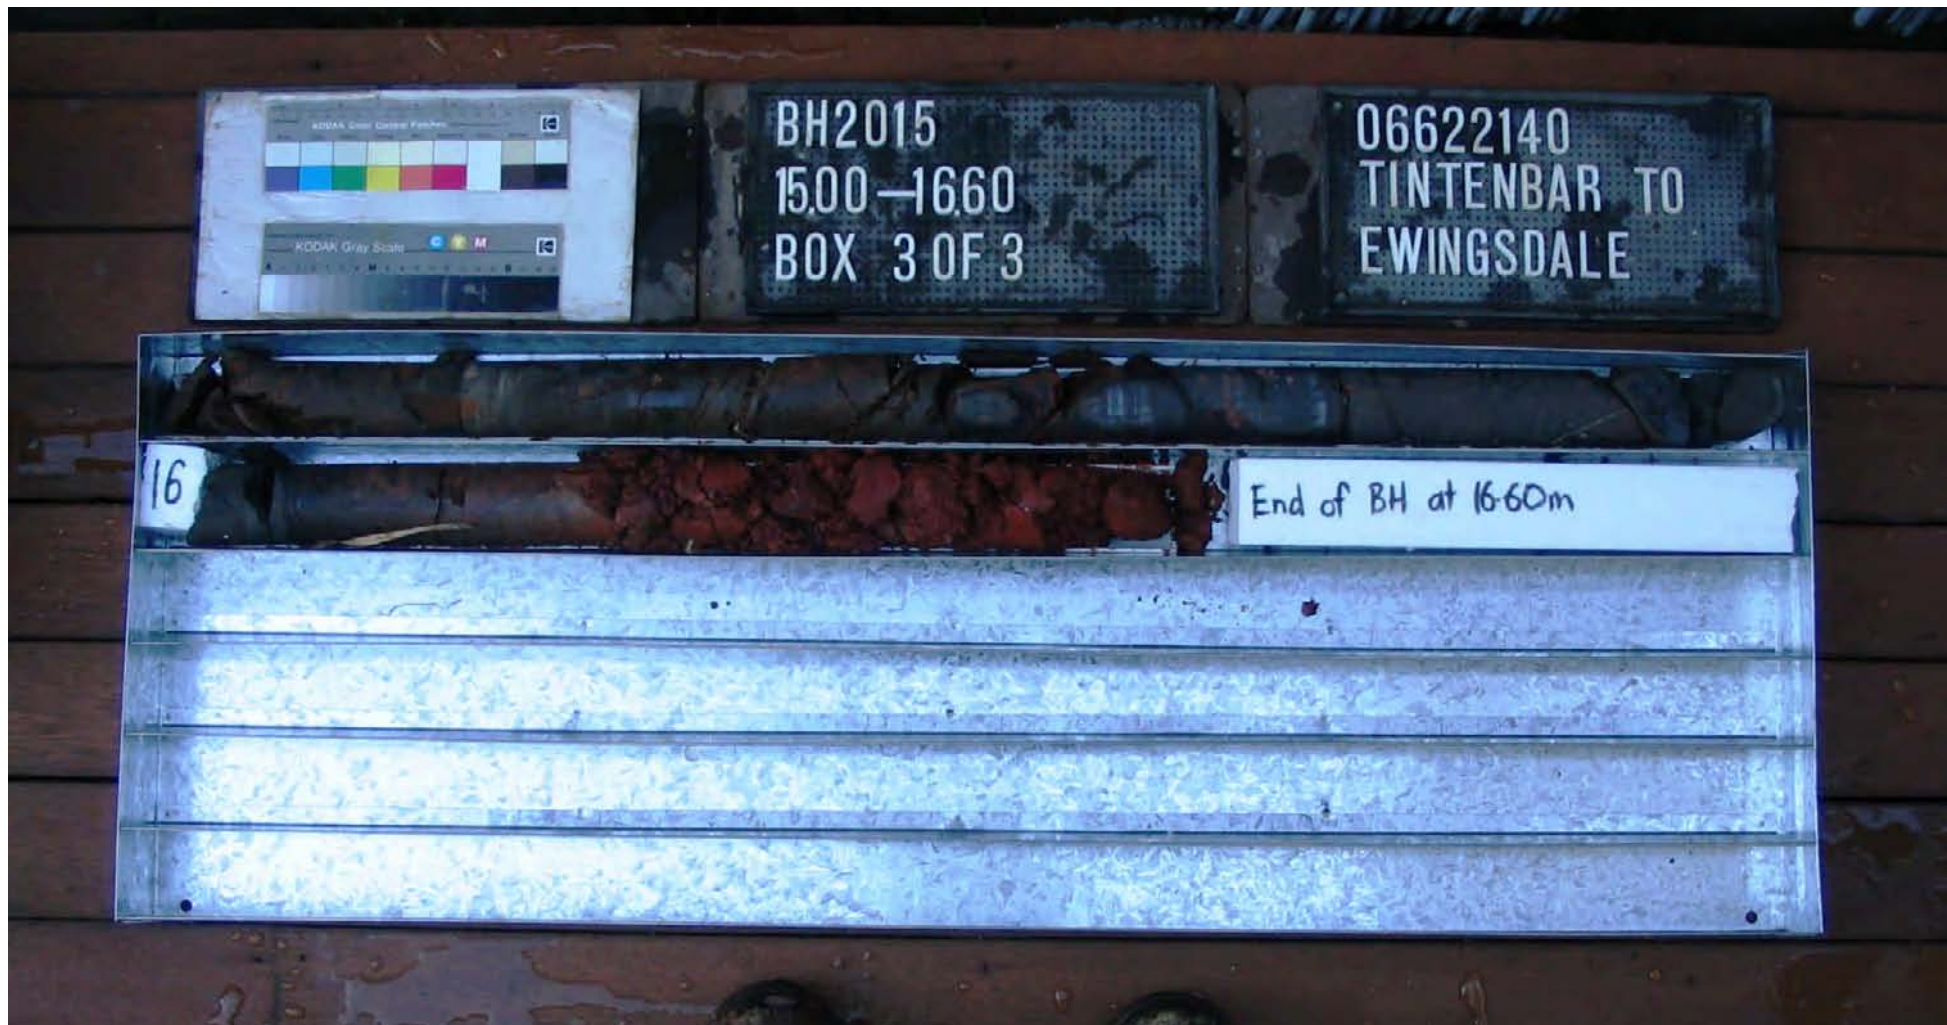
SHEET: 3 OF 3
DRILL RIG: Tracked Scout
DRILLER: Drillsearch
LOGGED: BC DATE: 25/7/07
CHECKED: CSC DATE: 13/8/07

COORDS: 553127.7 m E 6828430.5 m N 56 MGA94
SURFACE RL: 69.35 m DATUM: AHD
INCLINATION: -90°
HOLE DIA: 100/76 mm HOLE DEPTH: 16.60 m

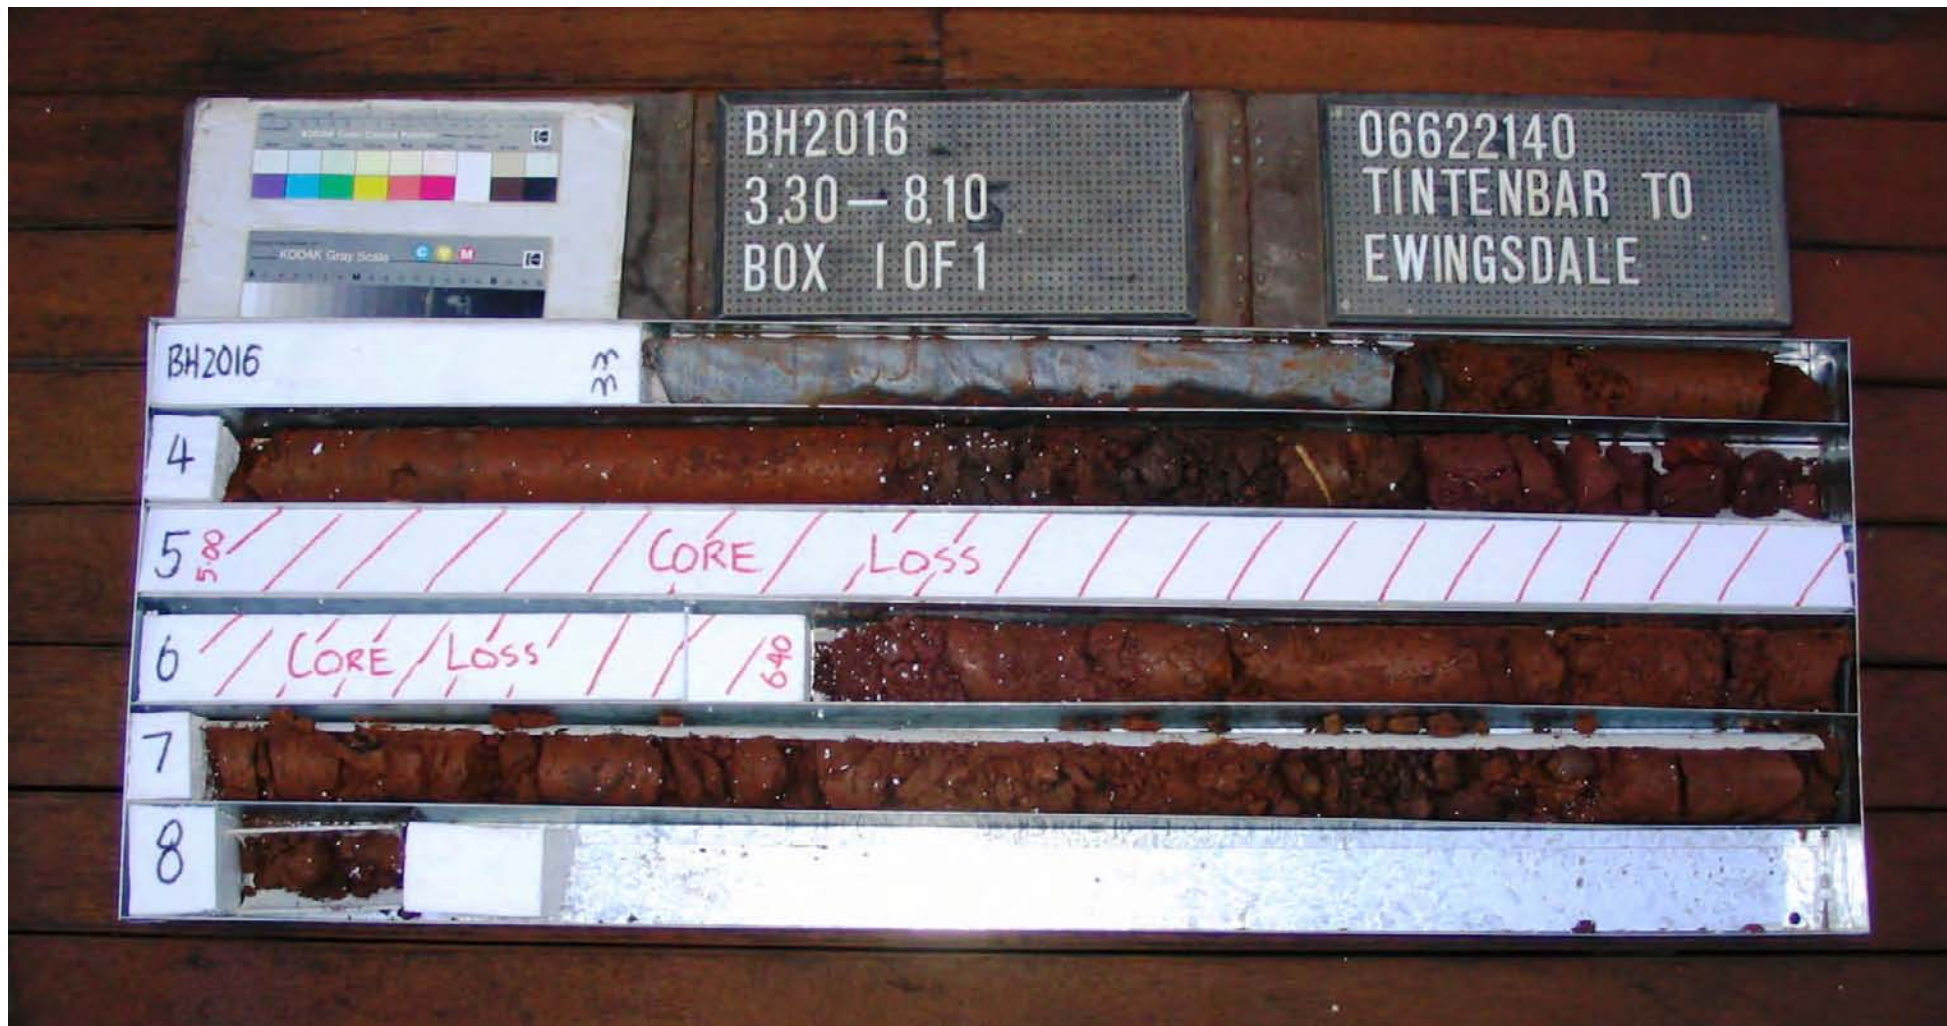
SHEET: 1 OF 1
DRILL RIG: Tracked Scout
DRILLER: Drillsearch
LOGGED: BC DATE: 26/7/07
CHECKED: CSC DATE: 13/8/07

COORDS: 553127.2 m E 6828432 m N 56 MGA94
SURFACE RL: 69.38 m DATUM: AHD
INCLINATION: -90°
HOLE DIA: 100/76 mm HOLE DEPTH: 8.10 m

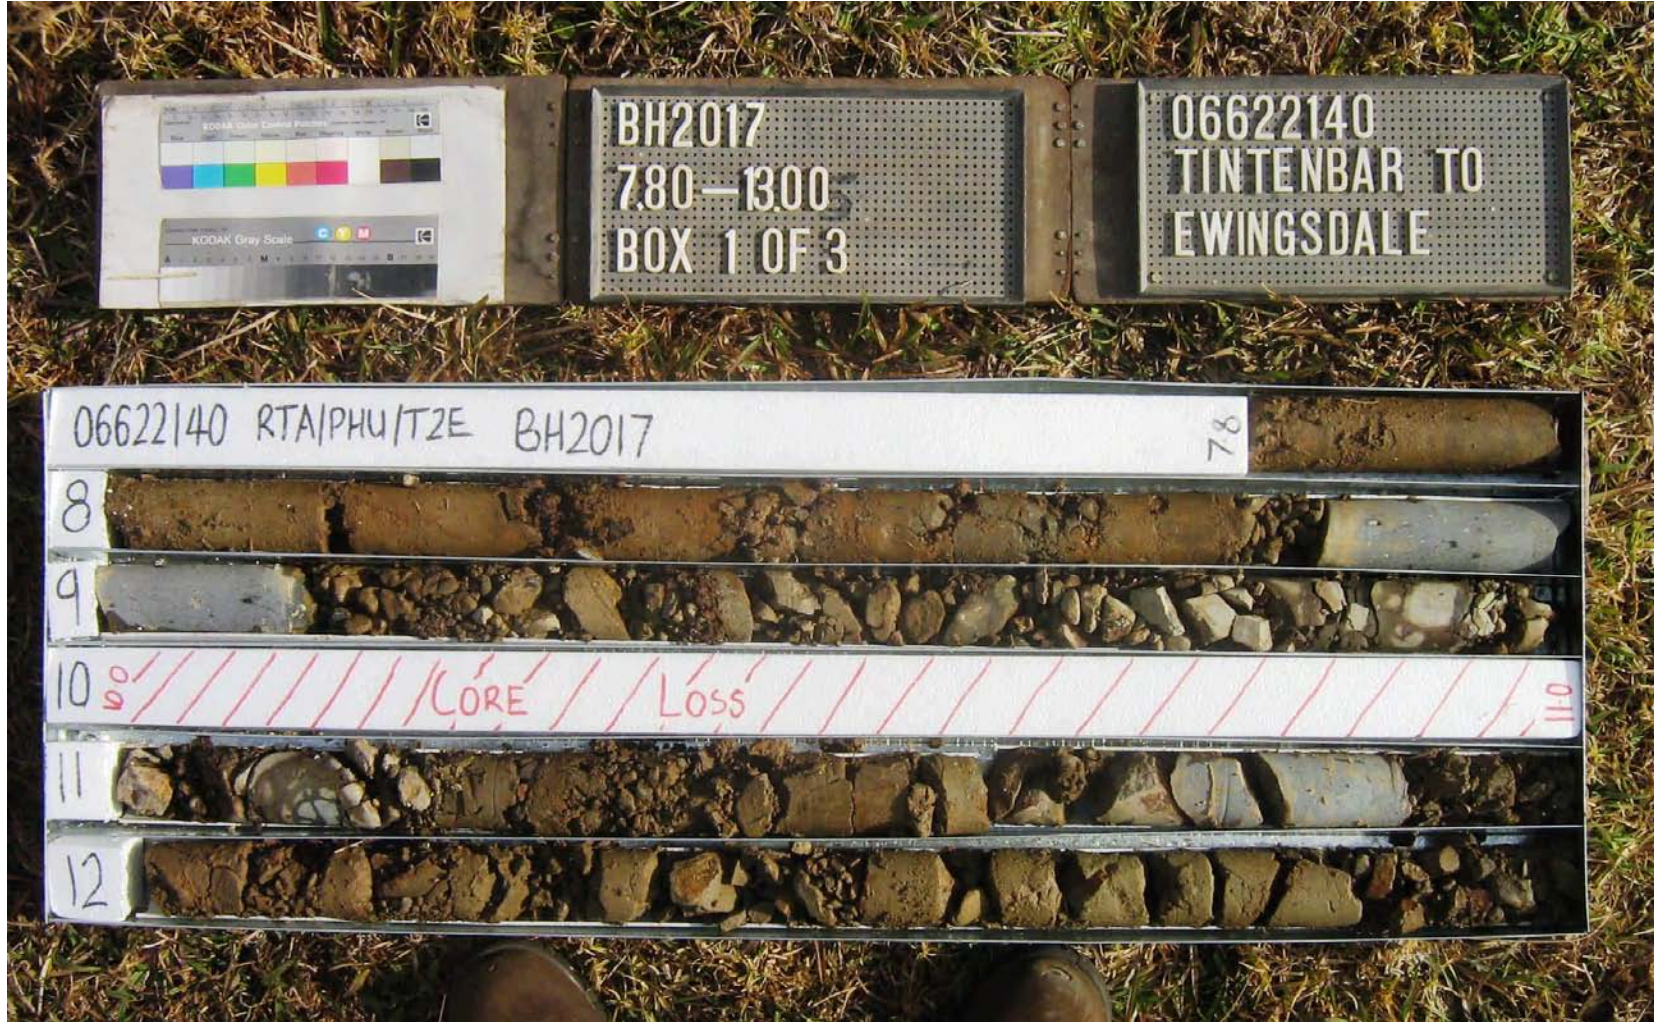
SHEET: 1 OF 3
 DRILL RIG: Gemco
 DRILLER: Drillsearch
 LOGGED: BC DATE: 23/7/07
 CHECKED: CSC DATE: 13/8/07

COORDS: 553228.9 m E 6828420.4 m N 56 MGA94
 SURFACE RL: 54.77 m DATUM: AHD
 INCLINATION: -90°
 HOLE DIA: 100/76 mm HOLE DEPTH: 21.00 m
