Appendix A
Director-General's Requirements
And
Project Description

Director General's Requirements for the Environmental Assessment of Proposed Pacific Highway Upgrade between Tintenbar and Ewingsdale

Director-General's Requirements

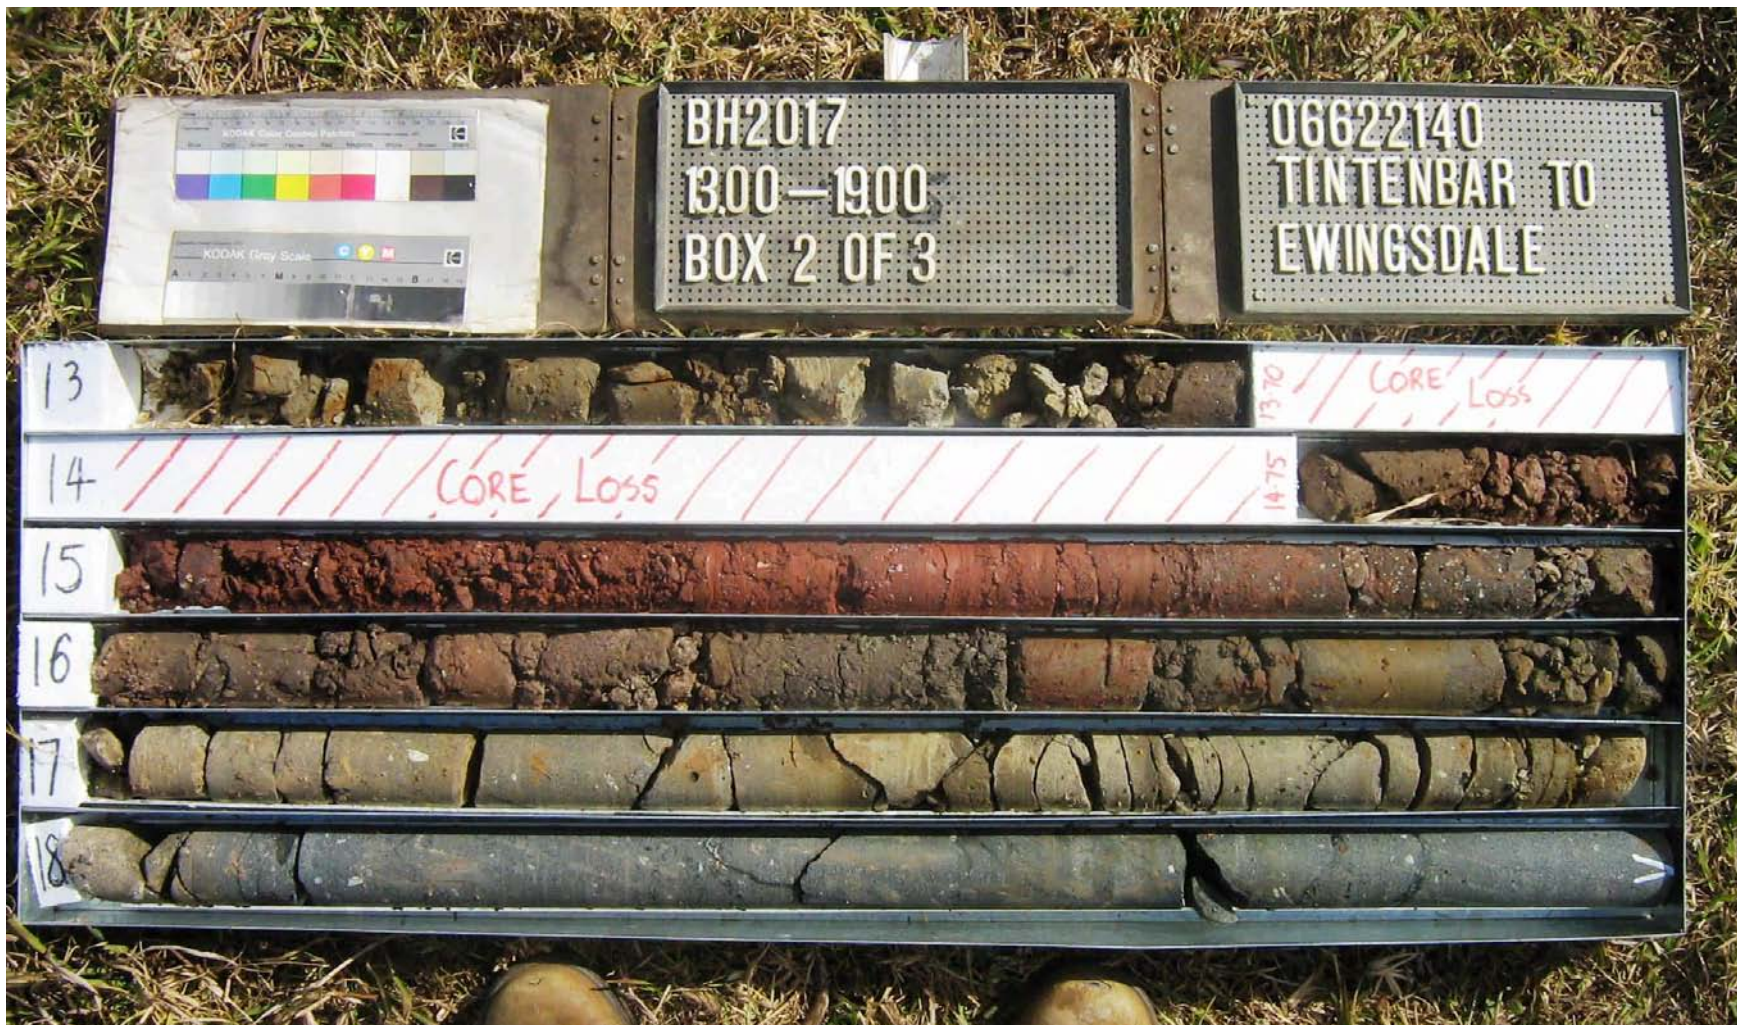
SHEET: 2 OF 3
 DRILL RIG: Gemco
 DRILLER: Drillsearch
 LOGGED: BC DATE: 23/7/07
 CHECKED: CSC DATE: 13/8/07

COORDS: 553228.9 m E 6828420.4 m N 56 MGA94
 SURFACE RL: 54.77 m DATUM: AHD
 INCLINATION: -90°
 HOLE DIA: 100/76 mm HOLE DEPTH: 21.00 m
