# Warrell Creek to Nambucca Heads Landscape Rehabilitation Monitoring – Operational Phase Winter 2022

## 1 Introduction

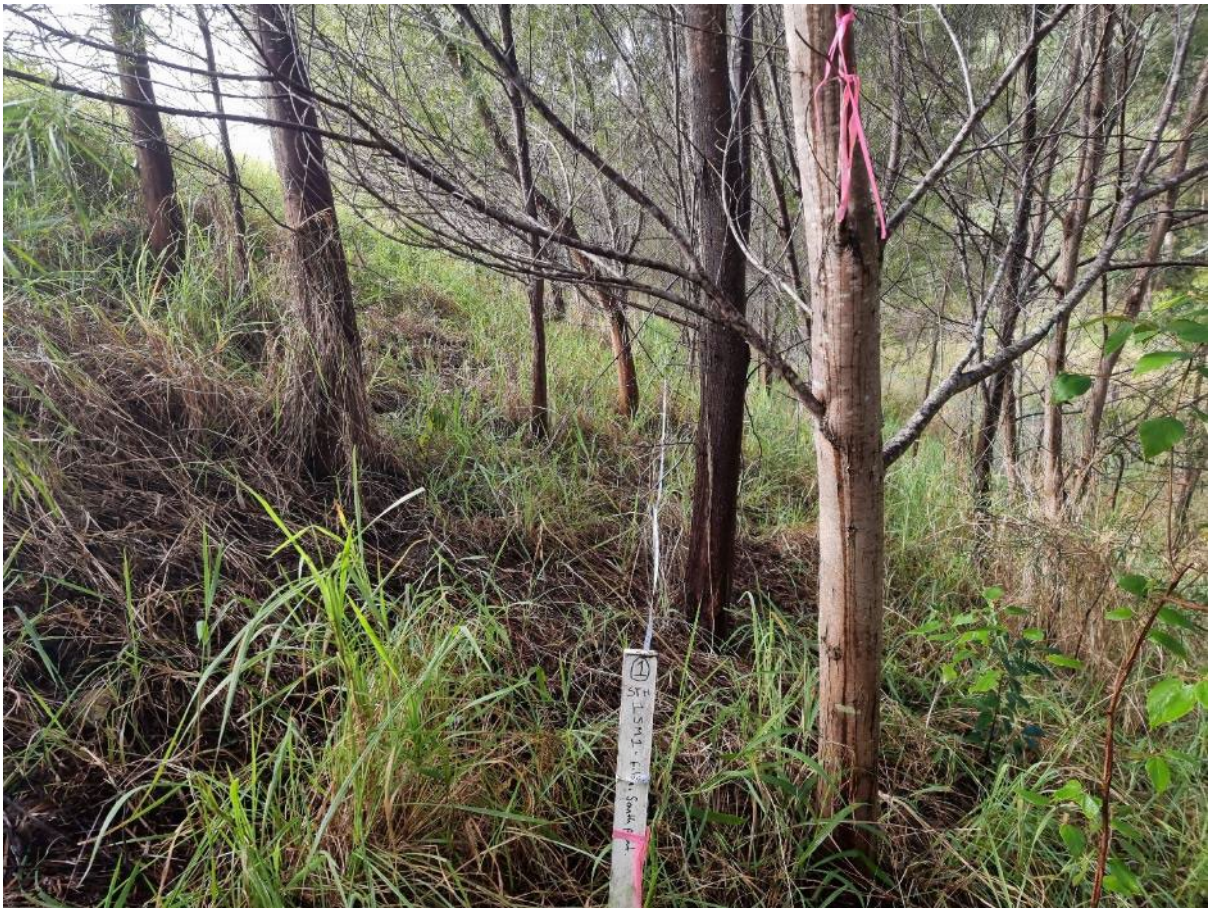
**Site 1:** southern end, Winter 2022

- *Setaria sphaecelata* and *Acacia fimbriata* still dominant

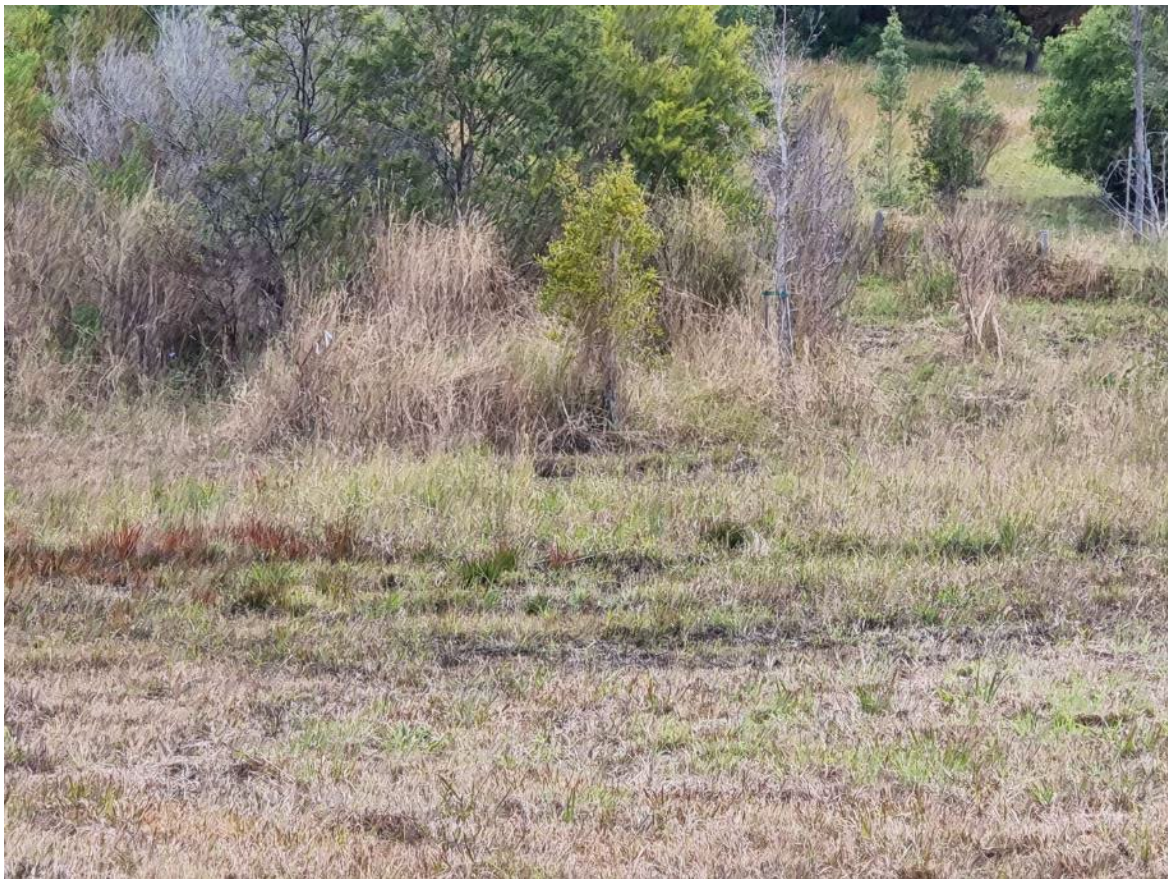
**Site 4:** southern end, Winter 2022

- This treatment was applied to only one location. This Site is dominated by exotic pasture grasses and maintained by tractor slashing.

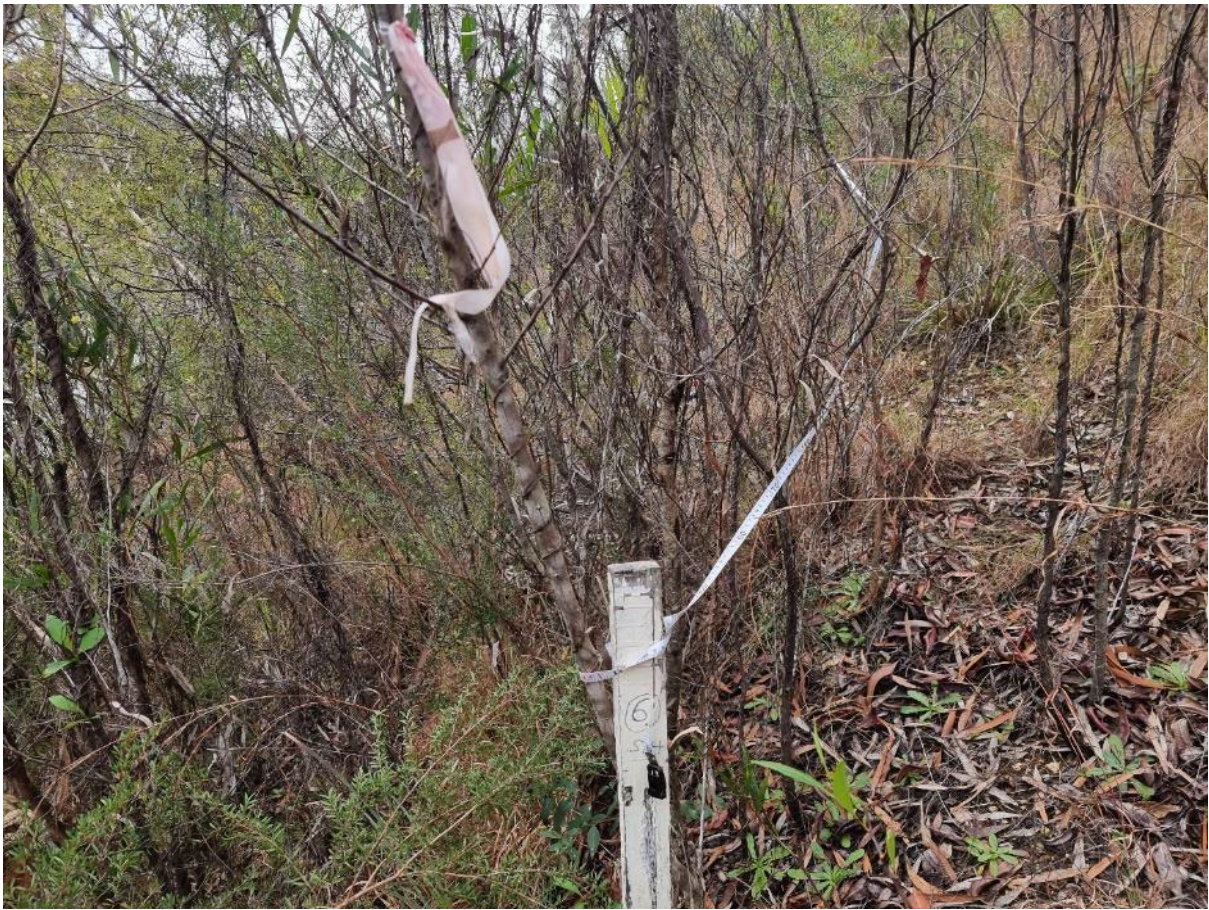
**Site 6:** southern end, Winter 2022

- *Setaria* absent at Sites on cut batters where a thin layer of topsoil salvaged from bushland was applied over gravelly subsoil.
- Sites continued to have relatively high native species diversity; cover of exotic species very low, except for Site 9.
- The native parasitic vine *Cassytha melantha* was not quite as dense in plots 6 and 7
- Good native grass cover - *Cymbopogon refractus* and *Themeda australis* in all plots.
- Eucalypt saplings that seeded from adjoining forest are growing fast, some 5 m.
- Site 9 was half slashed from roadside but native grasses have persisted.

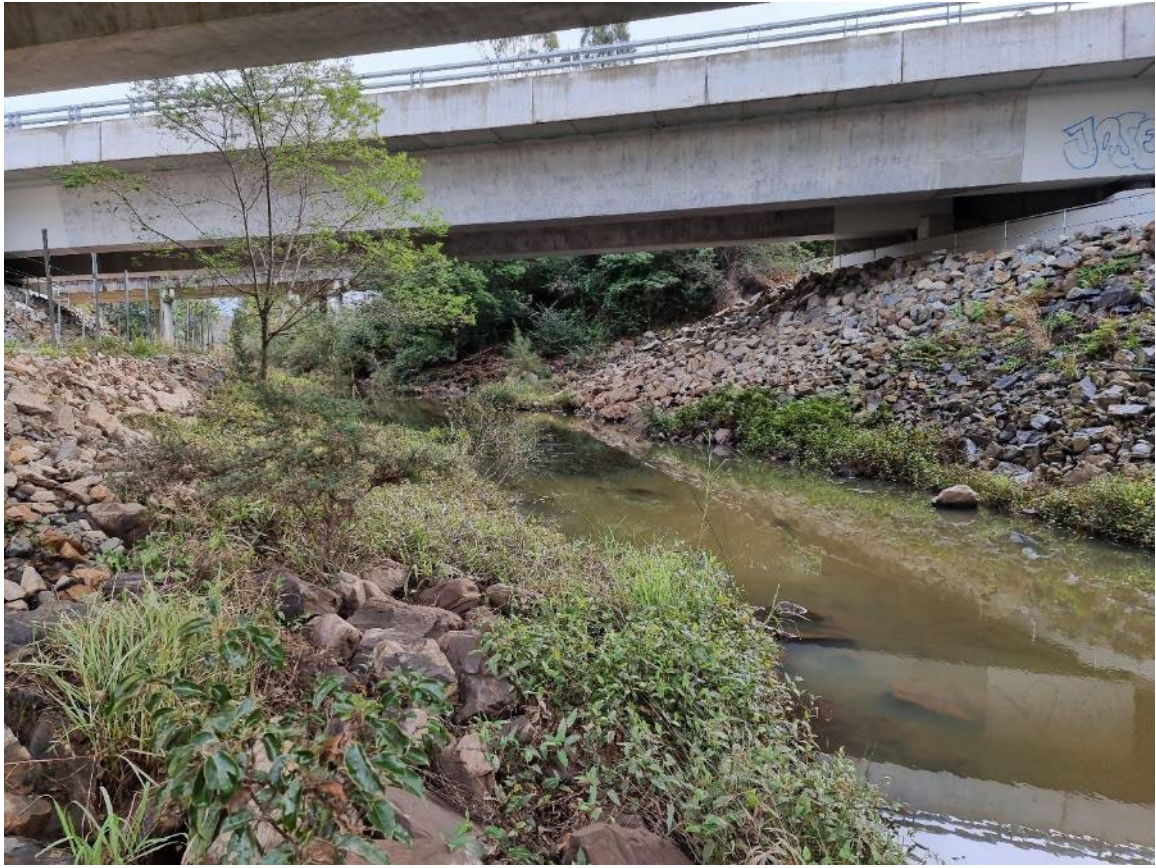
**Site 10, eastern end, Winter 20**

- These Sites are all on creek drainage lines that were revegetated after diversion during construction. Vegetation was disturbed by floods in 2021, although maintains a dense cover of exotic and native grass and herbs.
- *Maundia* almost gone from translocation below bridge at Site 10, probably due to scouring out of shallow layer of mud placed over rock lined drainage works.
- Large in situ patch downstream just outside project boundary.
